Case Studies in Engineering Failure Analysis

Failure analysis of the boiler water-wall tube

S.W. Liu, W.Z. Wang*, C.J. Liu

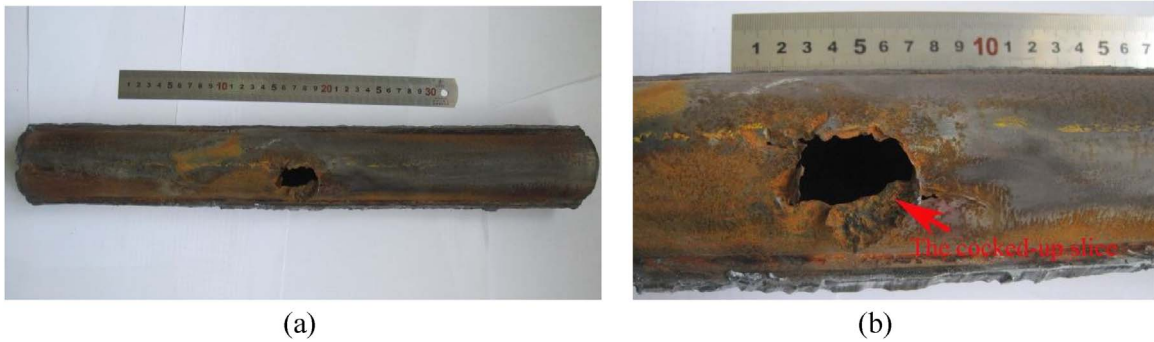
Fig 1. General view of the failed tube (a) and the enlarged view of the fracture (b).

During inspection a hole has been found on the fire-facing side of the tube as shown in Fig. 1. The cocked-up metal was around the hole. Close visual inspection also revealed that the wall thickness of the fire-facing side is less than that of the back side (see Fig. 2). It may indicate that the tube has significant localized wall thinning and is eventually followed by a sudden failure. Based on this finding, wall thickness measurements on the failed tube were carried out. The thickness of the thinnest area is about 1.90 mm on the fire-facing side, far less than the wall thickness of the back side (6.08 mm). In addition, scale was observed on the internal and external surface of the failed tube, and no significant bulges were found on the ruptured part of the tube.

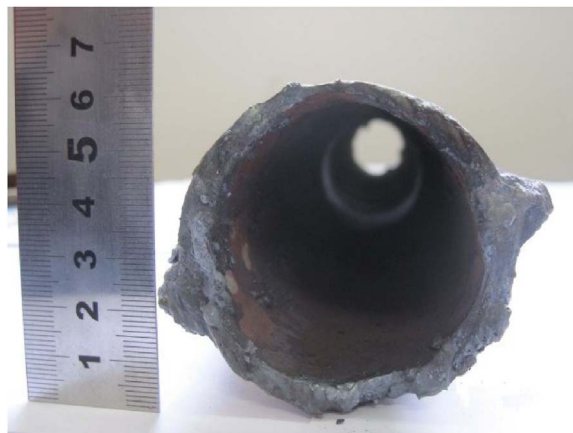
Fig. 2. Cross section of the failed tube.

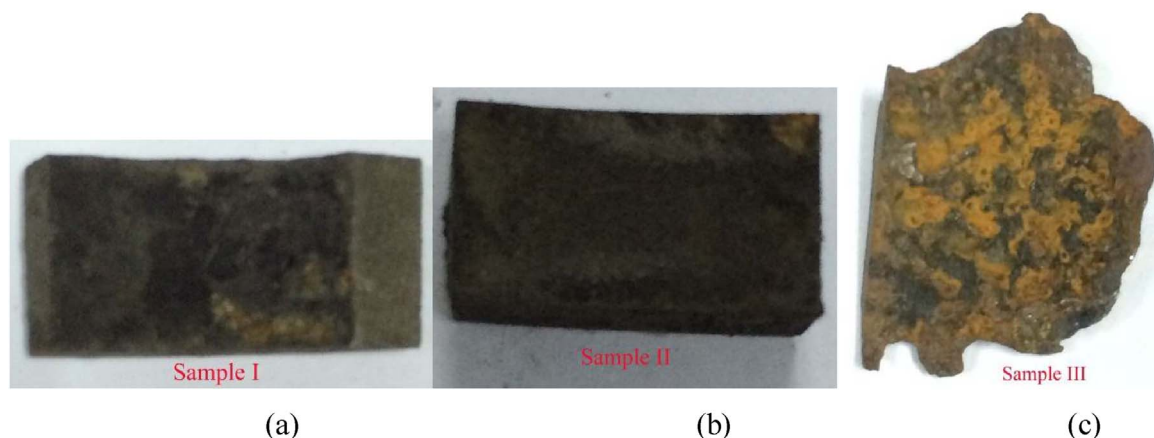
In order to analyze the failure reason of the tube, the sampling and analysis on the as-received tube at the rupture part and in some distance away from the rupture region were carried out. Two small pieces of specimens shown as Fig. 3a and b were cut from the fire-facing side and the back side of the tube and labeled as Sample I and Sample II, respectively. The cocked-up slice around the burst hole was also cut down (Fig. 3c), labeled as Sample III. It can be seen that the pits are very obvious on the internal surface of the fire-facing side (Sample I) and the cocked-up slice of the burst hole (Sample III), while they could hardly be found on the inner wall of the back side (Sample II). It reveals that corrosion on the fire-facing side of the failed tube is more serious than the back side.

Fig. 3. The inner wall surface of the fire-facing side (a), the back side (b), and the cocked-up slice around the burst hole (c).

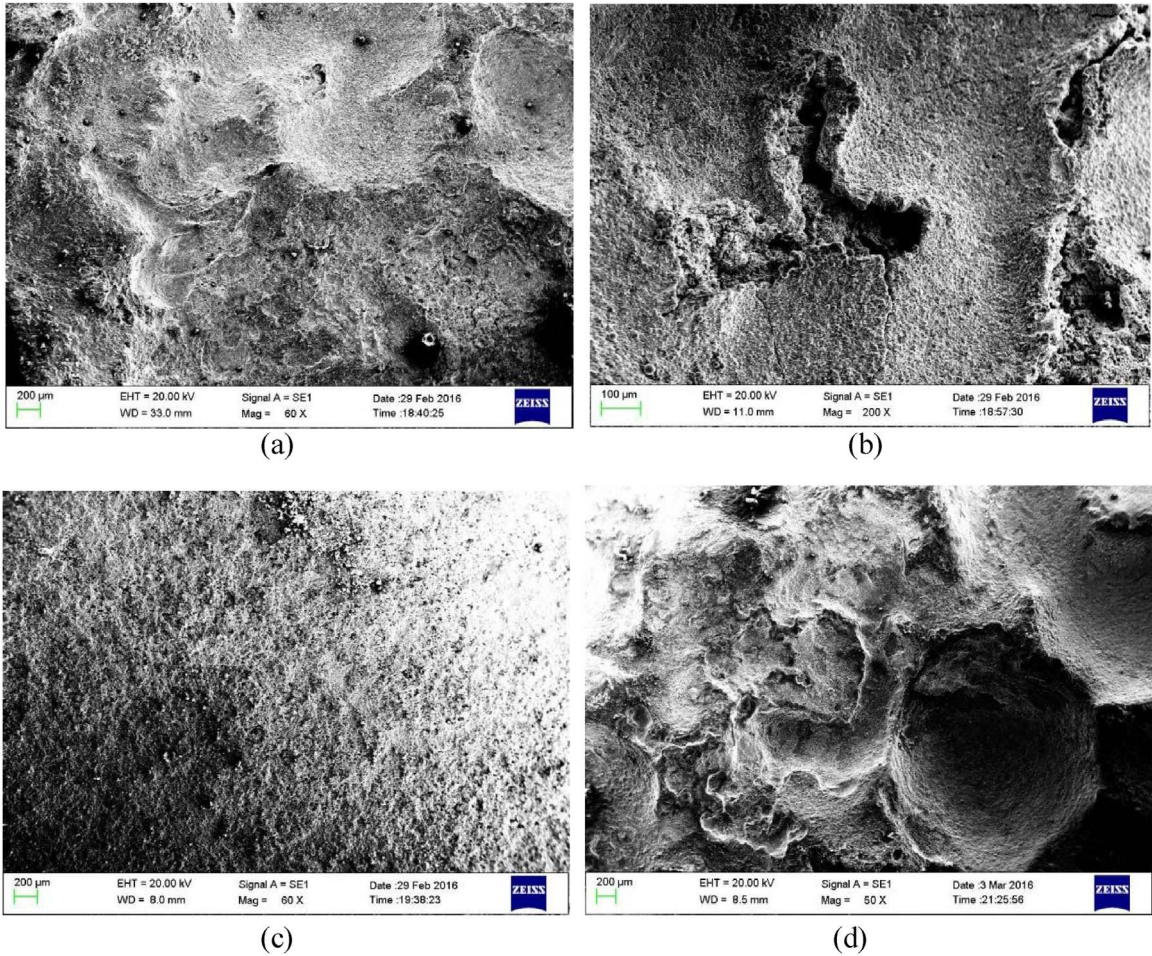
Acetone solution was used to clean the three samples with ultrasonic washer, and then a solvent softened acetate strip was applied to remove the impurities on the surface of the samples. The surface morphology of the three samples was analyzed by scanning electron microscope, as shown in Fig. 4. It can be found that the inner wall surface of the fire-facing side, especially of the thin slice of the rupture part, has a large number of corrosion pits. The inner wall surface of the back side is relatively flat, and the pits are much less. In addition, obvious scales are observed on the inner wall surface of the fire-facing side, some of which have been cracking and peeling off the fouling layer. This is consistent with the macroscopic observation results. EDS results (Table 2) show that the scale layer contains a lot of oxygen, iron, and a small amount of calcium, silicon etc. No chlorine and other abnormal elements were found. It indicates that the boiler tube has severe oxygen corrosion. And the iron-to-oxygen ratio of the fire-facing side is smaller than that of the back side, especially at the cracked part where the ratio reaches the minimum, which shows that the oxidation of tube on the fire-facing side is more serious than that on the back side. The continuous occurrence of oxidation may result in thinning of wall thickness.

The chemical composition of tube meets the standard requirements. The ferrite-pearlite structure is found from the microstructure of the failed tube, which shows no obvious microstructural degradation, including no apparent pearlite spheroidization. However, a large number of corrosion pits exist on the inner wall surface of the fire-facing side. That corrosion pits could hardly be found on the inner wall of the back side could be related with the relative low temperature. The similar failures owing to the oxidation thinning have also been observed for the carbon steel grade SA213-T22 [11] and INCONEL alloy 601 [12] used as super-heater tubes and radiant tube, respectively. Oxidation corrosion of steels is easily to happen due to the high affinity of oxygen to react with steel to form oxides. The kinetic of oxidation is higher at high temperatures than that at room temperature. The inner wall surface of the fire-facing side is exposed to both the deaerated water and high temperature, and therefore undergoes oxidation corrosion.

Fig. 4. Surface morphology of the inner wall of Sample I (a, b), Sample II (c) and Sample III (d).

Correspondingly, reducing the oxidation contents in the deaerated water or reducing the maximum temperature would help minimize the fireside oxidation. However, the latter action has a direct impact on the efficiency and output of the boiler so as not to be applied.

Since the oxidation is the root failure cause of the tube, it is recommended that the standards of water quality of the boiler water-wall tube should be implemented strictly in the operation process, in order to improve the operating environment of the boiler tube, especially to control the oxygen content in the water. In addition, preventing the boiler tube from exceeding the working temperature

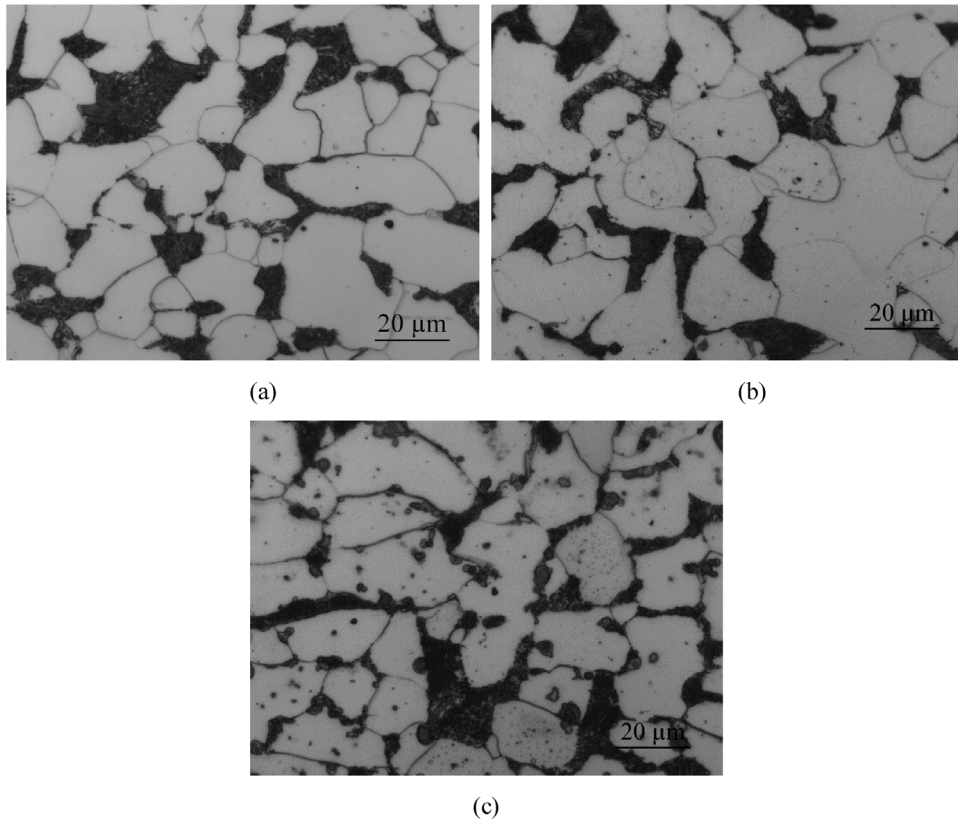
In order to investigate the potential cause of the failure due to any microstructural anomaly or degradation, metallography specimens were cut from the Sample I, Sample II and Sample III, respectively. The microstructure of the failed tube was shown in Fig. 5, which is typically ferrite-pearlite structure. Microstructural degradation/anomalies in the form of carbide rounding or grain boundary void generation were not obvious in the base material. Hence, the possibility of creep damage can be ruled out [9].

The pearlite in the specimens on the fire-facing side of tubes and the slice around the burst hole shows a certain degree of spheroidization, the latter of which is more serious. During service, the original lamellar pearlite forms into spherical pearlite due to cementite developing toward spherical driven by the decrease of the surface energy. Previous studies [10] have showed that the tensile strength of 20G is reduced by 6.5% when the testing temperature increases from room temperature to 475 °C though the pearlite spheroidization is different. Therefore, the pearlite spheroidization has little effect on the mechanical properties of 20G when the temperature is lower than 475 °C. In this study, the pearlite spheroidization effect is not very obvious, and then it could be concluded that the mechanical properties of 20G are not degraded significantly.

Fig. 5. Optical micrographs of Sample I (a), Sample II (b) and Sample III (c).
