Case Studies in Engineering Failure Analysis

Failure analysis of edge discoloration of galvanized fuel tank

R&D and Scientific Services, Tata Steel Ltd., Jamshedpur 831001, India

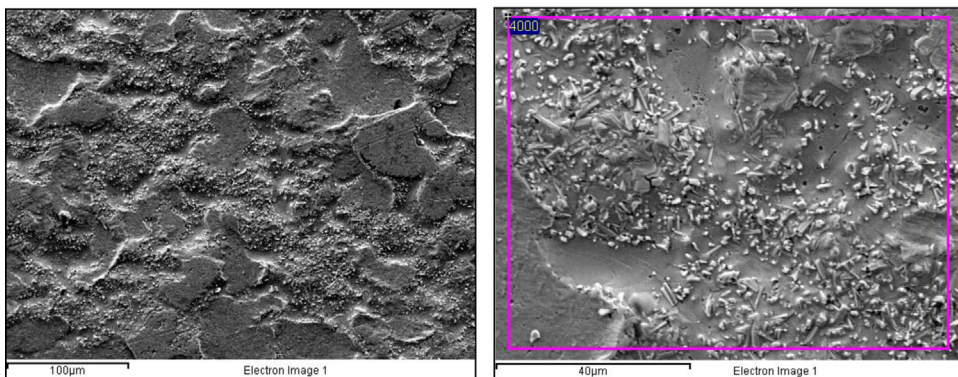
The SEM microphotograph from the defect region, having grain structure like appearance on the galvanized fuel tank is shown in Fig. 5a. Fig. 5a shows two distinct regions, viz. Region A is the partially zeta crystals, region B is the skin pass marks. Fig. 5b is the high magnification SEM micrograph of region A and B in Fig. 5a. From Fig. 5b we can see that the zeta crystals are partially appeared over the surface indicating transition zone of Galvannealing and Galvanizing at this region. EDS analysis was carried out at this transition region showing the concentration in wt.% of Zn, Fe and Al in these regions as mentioned in Table 2.

Fig. 5. (a) SEM Microphotograph of transition region of Galvannealing and Galvanizing at 1000 \times magnification. (b) High magnification (4000 \times) SEM microphotograph of transition region.
