Failure Analysis of Metallic Components of a Battery Fitted in a Naval System

Abstract A battery based on Mg–AgCl with sea water as electrolyte was developed for propulsion of a naval system. In one occasion, the tie rod, conduit pipe and the copper bus rod each covered with polymer sleeve were found damaged. The copper bus rod was melted probably by amplified resistance and subsequent heating. Localized cross-sectional reduction (and thus increased resistance, R) seems to have aggravated heating by Joule heating ($J = I^2R$) effect. Subsequently, it led to partial dissolution, embrittlement, softening and final fracture of the steel tie rod in the said sequence. There was no material deficiency. Chemical composition, microstructure and hardness values of the failed components indicate that the steel tie rod was made of the as-specified EN 24 type of low alloy steel in hardened and tempered condition, while copper bus rods were made of pure copper of 99.50% purity. Damage of the conduit tube was not related to the failure of steel tie rod and copper bus rod, although it indirectly offers clues that melting of copper happened and the molten copper reached many locations within the

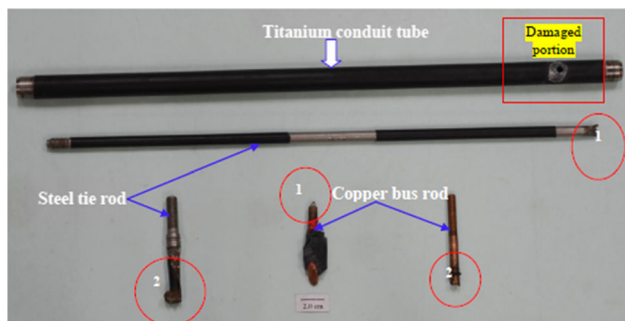
Fig. 2 Photographs of the as-received failed components

Figures 2–5 show photographs of the failed components in as-received condition. Figure 2 shows three failed parts, titanium conduit tube, steel tie rod and copper bus rod. Through hole is observed on titanium tube. No other metallic deposition was observed on the areas surrounding the hole. Mating failed surfaces of the tie rod and bus rod has been marked as 1 and 2.

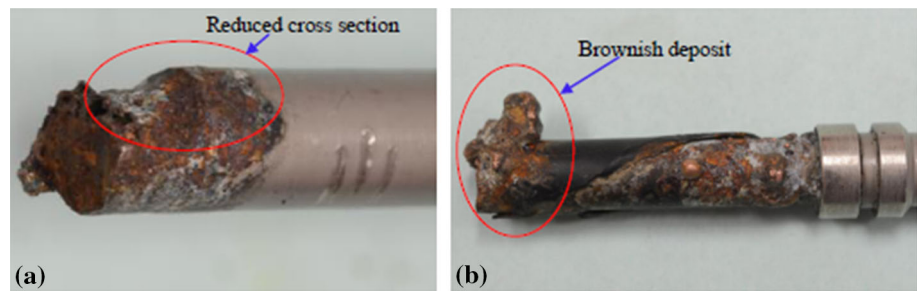
Fig. 3 Magnified views of as-received failed steel tie rod surfaces 1 and 2

Figure 3a and b shows tie rod failed surfaces 1 and 2, respectively. A reduction in cross section is clearly visible

on failed surface 1 (Fig. 3a). On the other hand, a brownish deposit is found on mating surface 2 (Fig. 3b). Figure 4a and b shows copper bus rod failed surfaces 1 and 2, respectively. A loss of area is observed on failed surface 2 (Fig. 4b), while mating surface 1 exhibits a sharp tipped cone type of appearance (Fig. 4a). It is also noteworthy that the base of the said conical-shaped feature is at locations away from the bus rod original surface and a plane surface joins the two. In other words, the surface joining the cone and bus rod surface is a plane one and has an appearance of a properly machined surface. Figure 5 shows locally damaged portion of the titanium conduit tube. The damaged surface revealed very rough appearance. Very clear evidence of the presence of peeled off polymer sleeve is seen. Also, traces of reddish-brownish deposit were also seen, as marked in Fig. 5.

melted probably due to localized higher resistance heating (Figs. 8, 10), (2) molten copper came in contact with the steel tie rod and dissolved part of the tie rod and thus resulted in reduction in tie rod cross section (Fig. 3a), (3) liquid copper also caused embrittlement in the tie rod in the next step leading to the intergranular fracture (Figs. 8, 9), (4) remaining section of tie rod failed due to overload caused (Fig. 11). The final (overload) fracture has been assisted by three prior events, viz. (a) reduced cross section due to partial consumption of the rod by molten copper, (b) intergranularly failed part of the cross section, and (c) elevated temperature of the tie rod coming in contact with the molten copper and resultant material softening. Intergranular fracture is an indication of extreme material embrittlement that happens along the material grain boundary. In the present case, it seems that liquid metal embrittlement (LME) by melted copper has led to the intergranularity of the steel fracture [1, 2]. The exposure of the steel tie rod to elevated temperature is evident from the fact that the fractured ends of the rod got hardened (500 HV hardness, Fig. 15) as compared to the locations away from the fractured end (300 HV hardness). This has probably happened as a result of austenitizing at some temperature by effect of molten copper, subsequent water quenching by available sea water and low temperature or nil tempering. This is quite plausible when one considers the as-specified heat treatment schedule of the steel tie rod (austenitizing at 860 °C/3 h + oil quenching, tempering at 580 °C/3 h + air cool) and hardness level (300 HV), as was provided by the user. However, this hardening is most likely to be a post-fracture event. And thus, in the process

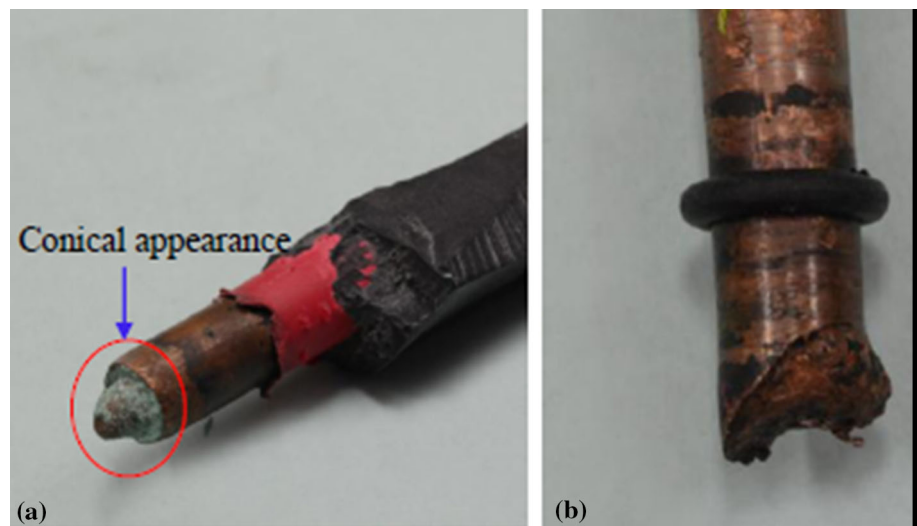
Fig. 4 Magnified views of as-received failed copper conductor rod surfaces 1 and 2

There is a conical-shaped feature of one failed copper rod surface (Fig. 4a), in middle of the copper rod and a uniform annular surface at periphery. One plausible cause of formation of such feature could be a uniform cut in the copper rod. The reduced cross section of the copper rod would have increased the localized electrical resistance significantly.

Thus, localized cross-sectional reduction (and thus increased resistance, R) would lead to the aggravated heating by Joule heating ($J = I^2R$) effect.

It is desirable to inspect the copper terminal rod for any surface damage before placing sleeve on the rod.

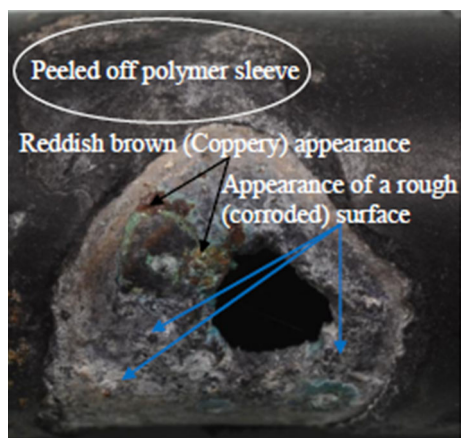
Fig. 5 Magnified view of as-received (locally damaged) titanium conduit tube

Damage of the titanium conduit tube is a separate phenomenon and has no relationship with fracture of the steel tie rod, as is clear from observations on failure type, failure nature and arrangement of components within the battery chamber (Fig. 1). However, it indirectly indicates the melting of copper rod and deposition of the same on the titanium tube, as is supported by Figs. 5 and 12. Damage of the tube seems to have happened by the following sequence: (1) steel tie rod melted and got deposited on the tube, (2) polymer sleeve in contact with the molten copper got damaged and the tube became exposed to the hot molten metal, (3) creation of a very rough surface under the action of molten copper on titanium surface, (4) subsequent failure (thinning of the tube and creation of a hole) happened by corrosion of the tube under Mg–AgCl and/or sea water.

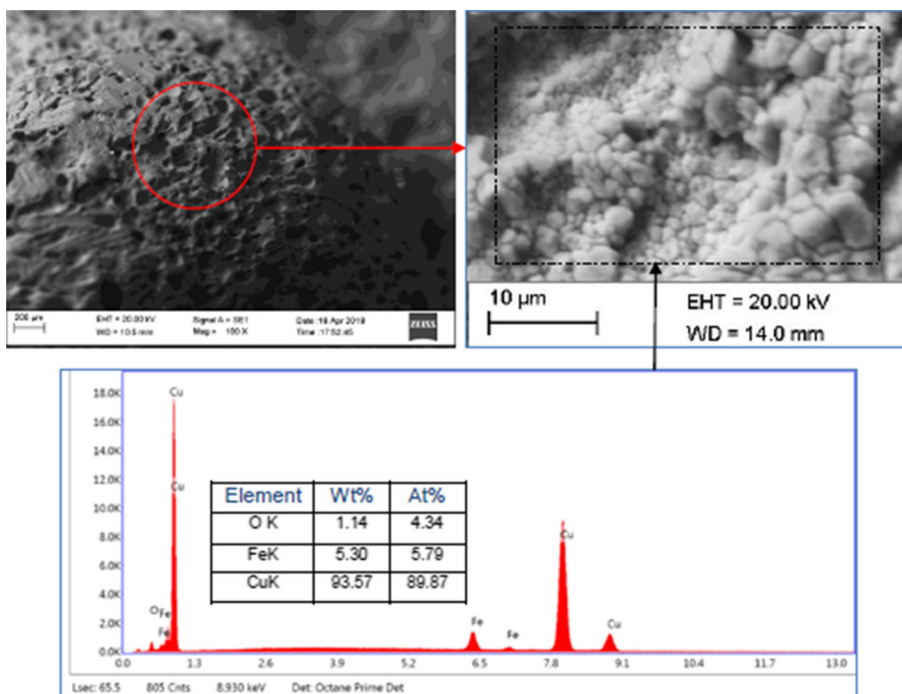
Fig. 6 Failed surface 2 of copper conductor rod as seen under SEM

Figures 6 and 7 show failed copper surfaces as observed under SEM. Signature of melting and re-solidification is vivid in each of the surfaces. Figures 8–11 present SEM images of the failed SS tie rod surface 1, shown in Fig. 2. Evidence of melted and resolidified copper along with rust was prevalent in major part of the periphery of the SS tie rod cross section (Fig. 8). This has been consistently supported by the EDS spectra taken from various regions on the failed surface. The magnified view of the box marked region in Fig. 8 is shown in Fig. 9. Intergranular failure is observed in that region. Some of the big granular steel fracture facets were found to be covered with a layer of melted and resolidified fine copper grains (Fig. 10). Other portion of the fracture surface exhibited ductile overload fracture (Fig. 11). Damaged part of the tube as seen under SEM, after cleaning with Branson liquid, is shown in Fig. 12. Evidence of corrosion is well revealed by both appearance of the damaged surface and EDS analysis. Trace amount of copper is revealed in EDS analysis as well.

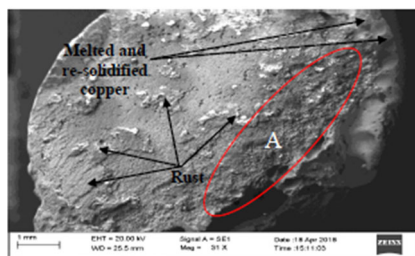
Fig. 8 Failed surface 1 of steel tie rod as seen under SEM

Composition of melted and resolidified copper

Element	Wt %	At%
O K	7.18	22.11
AlK	0.35	0.63
SiK	4.98	8.73
ClK	0.18	0.25
FeK	5.35	4.72
CuK	81.97	63.56

Composition of rust

Element	Wt %	At %
O K	18.23	43.62
ClK	0.72	0.78
CrK	0.93	0.69
FeK	80.11	54.91

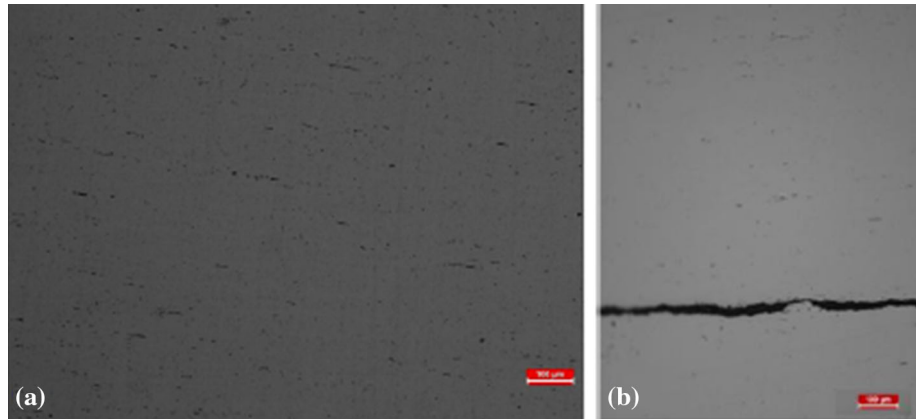
Fig. 13 Longitudinal steel tie rod section at two different locations (a, b), as observed under optical microscope. Unetched

Figure 13a and b shows longitudinal metallographic section of the steel tie rod in unetched condition for two different locations. One may notice here that stringer types of inclusions are present in the whole structure. EDS analysis under SEM reveals those to be the alumina type (Fig. 14). Inclusion type was found to be of 2B thin type, as per ASTM E 45.

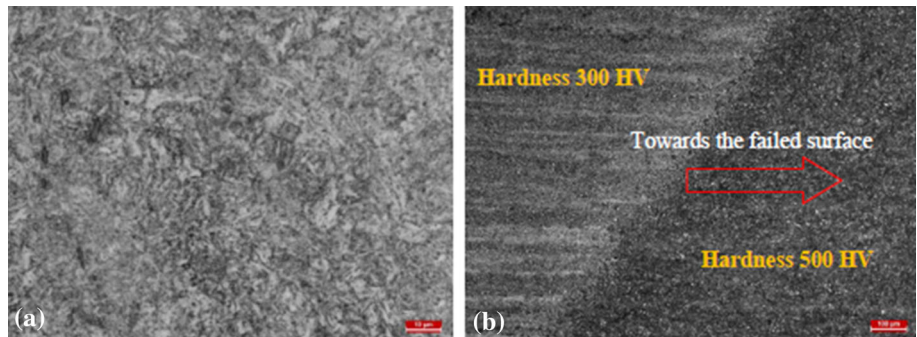
Fig. 15 Longitudinal steel tie rod section along with the failed surface, as observed under optical microscope. Etchant: 3% nital

Microstructure of the locations far away from the failure reveals the presence of tempered martensite, after etching with 3% nital (Fig. 15a). On the other hand, microstructure at close to the failure region showed difference in contrast when compared to that at far away from the failure (Fig. 15b). A sharp boundary is noticed between these two varieties of microstructure (Fig. 15b), when etched and examined repeatedly for several times. Copper bus rod microstructure after etching with acidified potassium dichromate reveals the presence of alpha copper grains with twins (Fig. 16a), at location far away from the failure location. Figure 16b shows microstructure of a longitudinal section at close to the failed surface. Here, one can notice the melted and resolidified fine copper grains, in sharp contrast to the microstructure at away from the failed surface.

Vickers hardness values taken at 1 kgf load are 300 HV and 70 HV for steel tie rod and copper bus rod, respectively, at locations far away from the failed surfaces (Figs. 15, 16).

The hardness values at close to the failed ends of the tie rod and copper bus rod are 500 HV and 50 HV, respectively.
