Failure Analysis of Bearings of Aero-Engine

Manish Roy

Abstract Failed bearings of various aero-engines were subjected to investigations. The bearing of cooling turbine of aircraft designated as B-1 was found to fail due primarily to misalignment and overloading. Bulk fatigue and permanent dimensional changes also accelerated the failure. The center main bearing of another aero-engine designated as CMB-1 was found nonfunctional because of ‘Brinelling’ action. Lack of lubrication caused over heat and deformation of rollers by metal to metal contact, and this resulted in formation of untempered martensite, leading to failure of center main bearings referred as CMB-2 of another helicopter engine. Stationary race and rotating race of thrust bearing of positive displacement reciprocating hydraulic pump bearing denoted as EDP-1 failed by abrasive action of foreign particles and oxidized metallic particles. In contrast, balls of the same bearing failed because of abrasive action of oxidized metal debris and rolling contact fatigue.

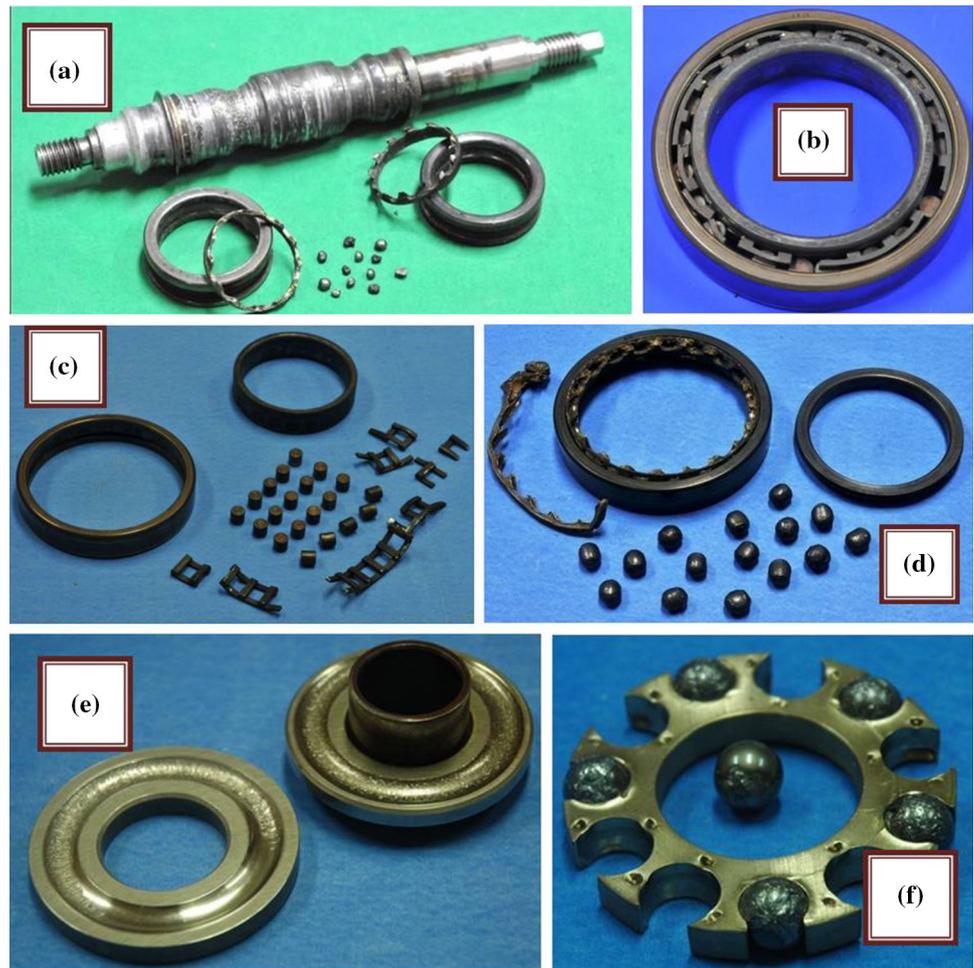
The failed components of B-1 in the as-received condition are shown in Fig. 1a. The inner surface of the outer race indicates the presence of wearing marks due to rubbing by bearing. The inner races were welded with the shaft and damaged completely. Bearing balls were rubbed badly and got damaged. Cage was broken and destroyed totally. The damaged parts of CMB-1 in the as-received condition are provided in Fig. 1b and c. The outer surface of the inner race indicates the presence of marks due to indentation by rollers. The inner surfaces of outer race were also rubbed extensively. Rollers were rubbed and worn out badly. Cage was broken and highly damaged. Figure 1d represents defective parts of CMB-2 in the as-received condition. The outer surface of the inner race and the inner surface of outer race were worn out showing rubbed features. Both races were completely darkened. Rollers were deformed badly and found to lose their original shape. Cage was broken, twisted and damaged. Part of the cage was welded to the inner surface of the outer race. Finally, the damaged components of the thrust bearing (EDP-1) in the as-received condition are shown in Fig. 1e and f. The inner surface of the stationary race (tight ring) and the inner surface of the rotating race (free ring) were heavily rubbed. Balls were rubbed and deformed badly. No apparent damage of the cage is noticed. It is also to be noted that outer surface has not been damaged.

Fig. 1 Photographs of the failed components of various bearings in as-received condition: (a) bearing B-1, (b) bearing CMB-1, (c) bearing CMB-1, (d) bearing CMB-2, (e) EDP-1 and (f) EDP-1

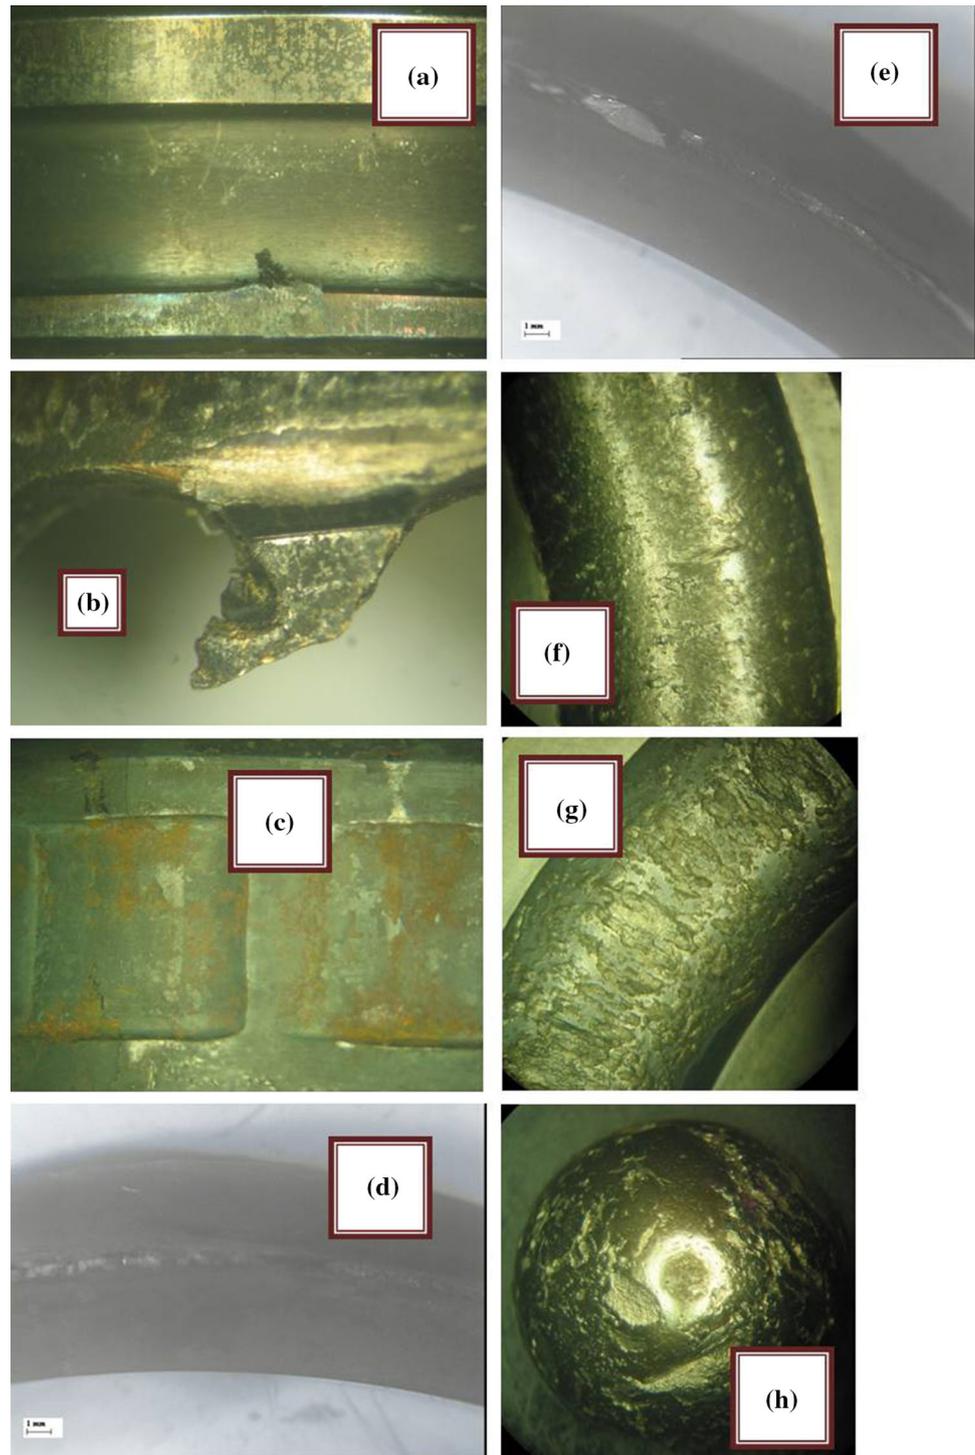
Images of outer race and cage of as-received B-1 obtained from stereo microscopy are also illustrated in Fig. 2a and b. This image also supports damage of components by excessive wear. The races exhibit off center damage from misalignment. The cage shows marks due to scoring, scuffing and plastic deformation. Observation confirming similarity between stereo microscopic image and image of as-received sample of CNB-1 supporting indentation by roller on the outer surface of inner race is presented in Fig. 2c. Stereo microscopic images of outer race and inner race of damaged CMB-2 are given in Fig. 2d and e. These images are also in conformity with images of Fig. 1d. Images of stationary race (tight ring), rotating race (free ring) and ball obtained by stereo microscopy of the EDP-1 bearing are shown in Fig. 2f, g, and h. Highly deformed and uneven surfaces are evident. Careful examination of the ball indicates the presence of surface cracks.

Fig. 2 Stereo microscopic images of (a) inner race of CMB-1, (b) cage of CMB-1, (c) inner race of CMB-1, (d) outer race of CMB-2, (e) inner race of CMB-2, (f) stationary race (tight ring) of EDP-1, (g) rotating race (free ring) of EDP-1 and (h) balls of EDP-1

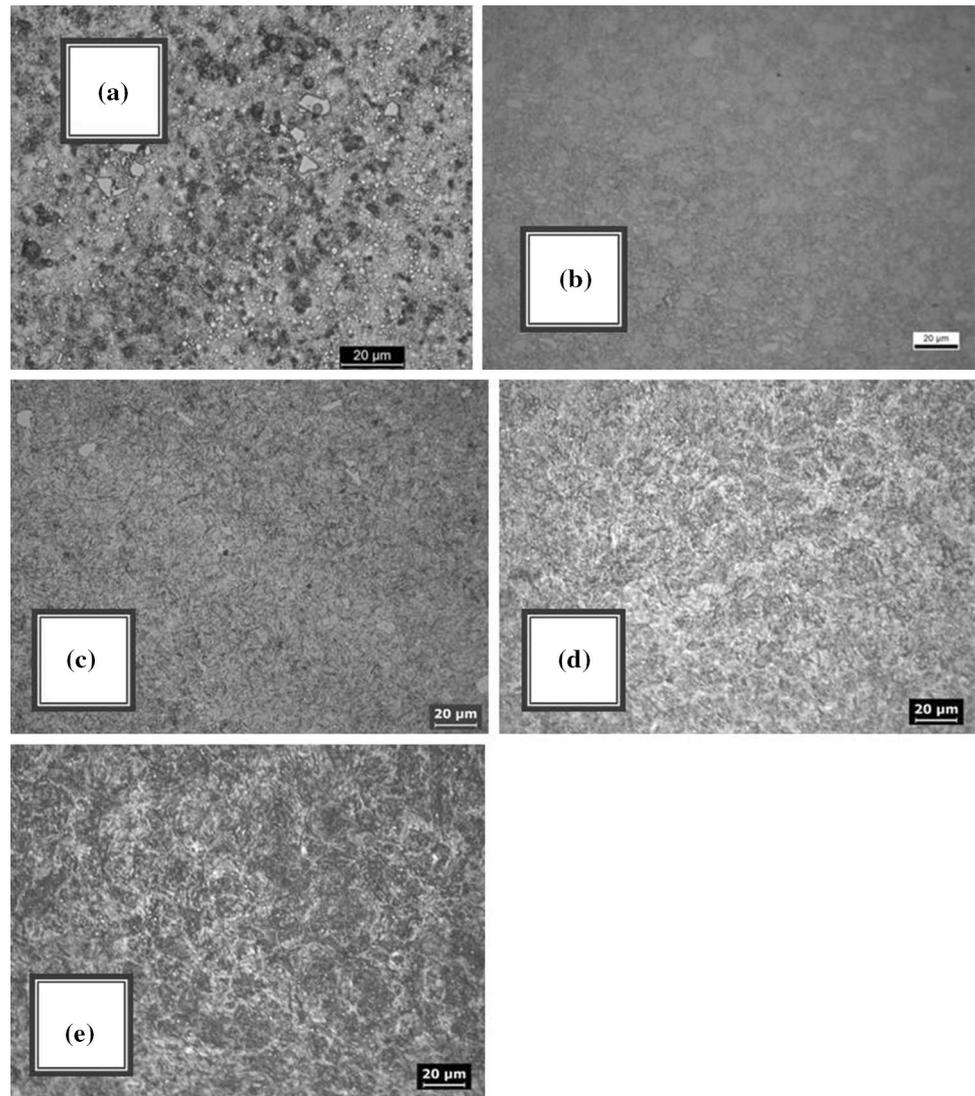
Fig. 3 Optical micrographs of the (a) shaft of B-1, (b) inner race of CMB-1, (c) inner race of CMB-2, (d) stationary race (tight ring) of EDP-1 axial and (e) stationary race (tight ring) of EDP-1 radial

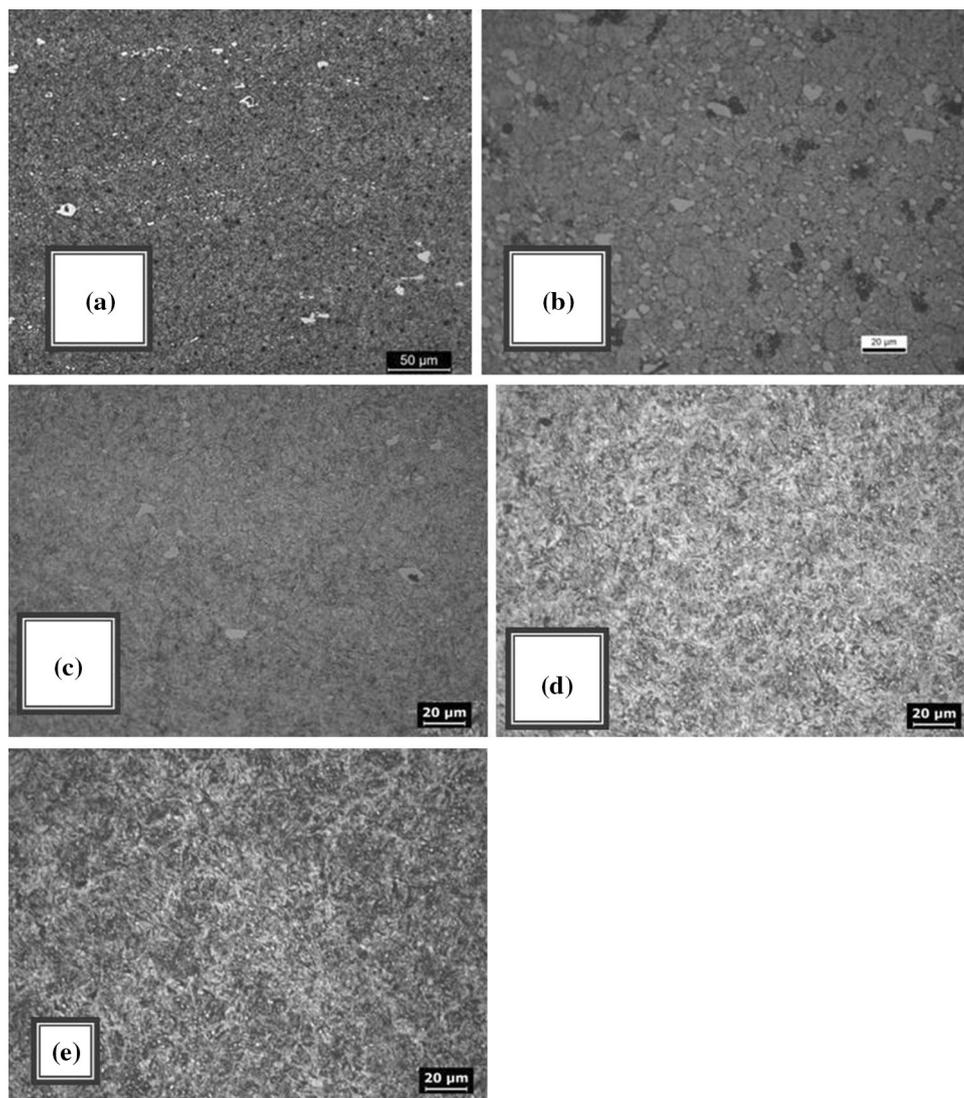
Fig. 4 Optical micrographs of the (a) outer race of B-1, (b) outer race of CMB-1, (c) outer race of CMB-2, (d) rotating race (free ring) of EDP-1 axial and (e) rotating race (free ring) of EDP-1 radial

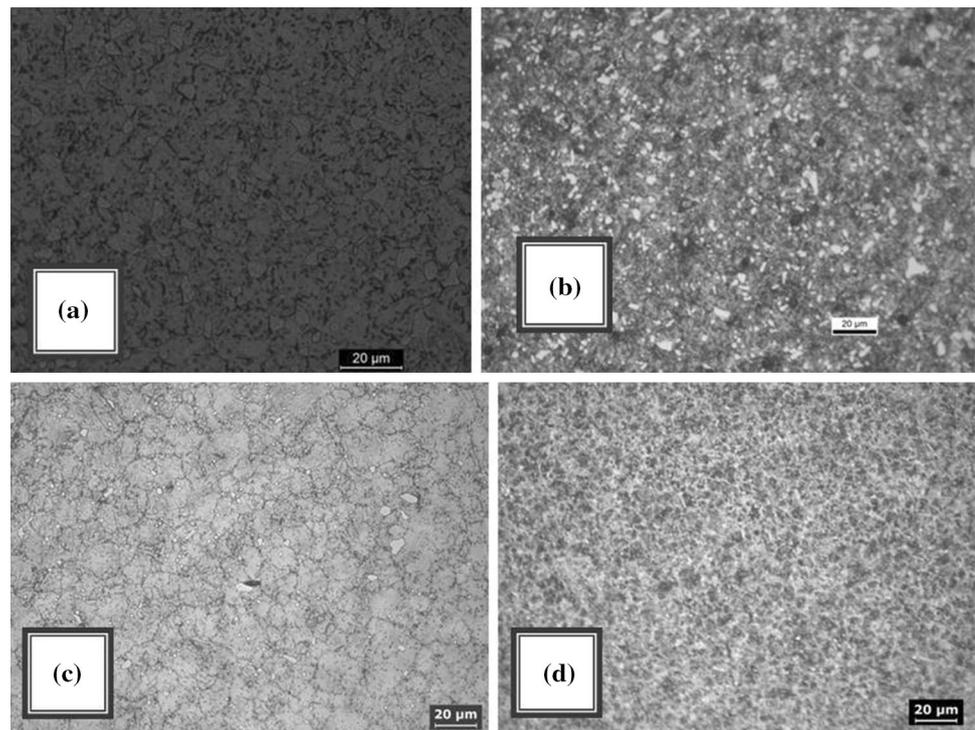
Fig. 5 Optical micrographs of the (a) ball of B-1, (b) roller of CMB-1, (c) roller of CMB-2 and (d) ball of EDP-1

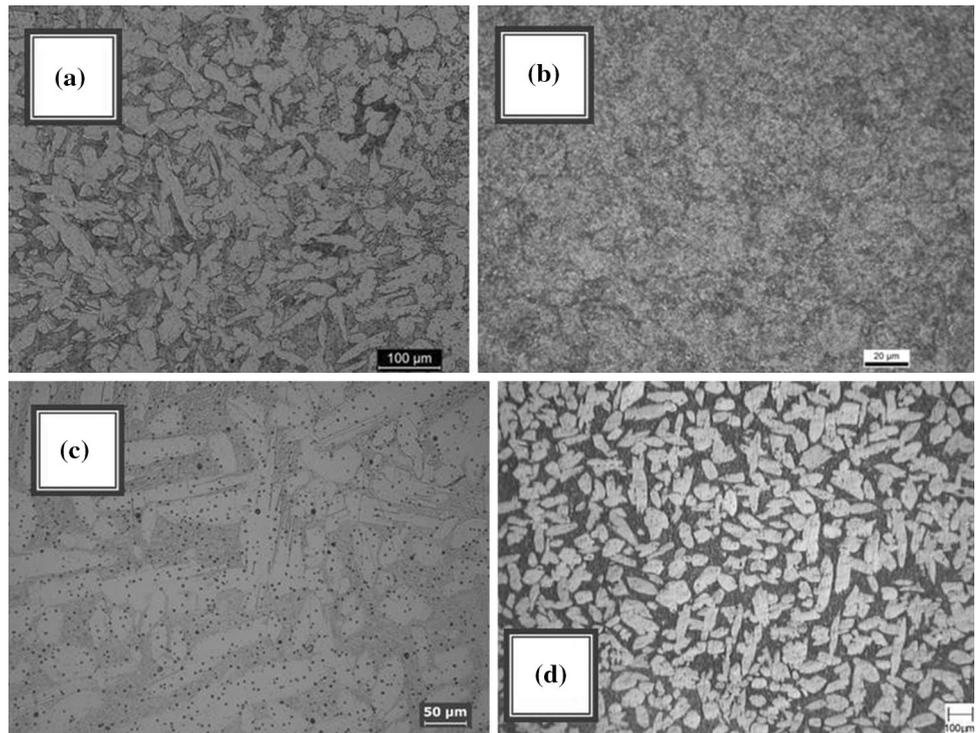
microstructure of the cage of CMB-2 consisted of dendrites of primary α and transformed β in interdendritic region (Fig. 6d). The cage microstructure of EDP-1 revealed dendrites of primary α and transformed β in interdendritic region on etching with acidified potassium dichromate solution.

Fig. 6 Optical micrographs of the cages of (a) B-1, (b) CMB-1, (c) CMB-2 and (d) EDP-1

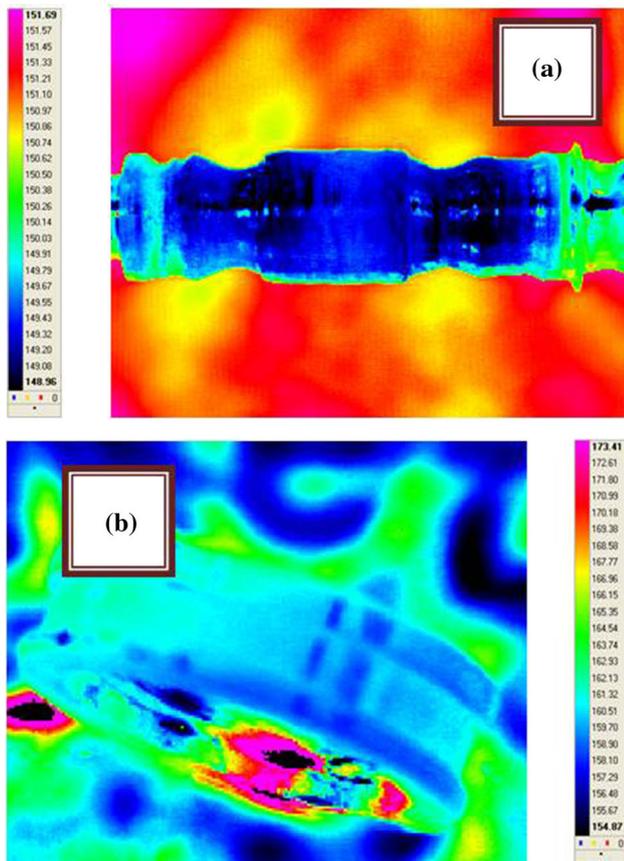
Thermal imaging of the shaft and one outer race of bearing B-1 was carried out. Thermal image obtained immediately after flash heating is presented in Fig. 7. Minor stress concentration in some places of the race can be noticed. However, shaft appears to be completely stress free. Image

Fig. 7 Thermal imaging of the (a) shaft and the (b) outer race of bearing B-1 immediately after flash heating

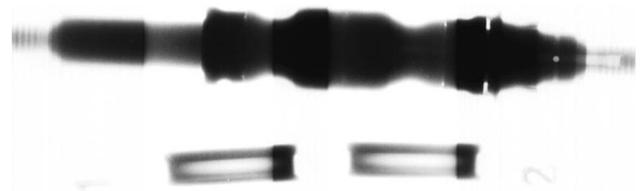
of the shaft obtained after radiography is shown in Fig. 8. A completely defect-free component is evident.

Fig. 8 Radiographic image of the shaft and the races

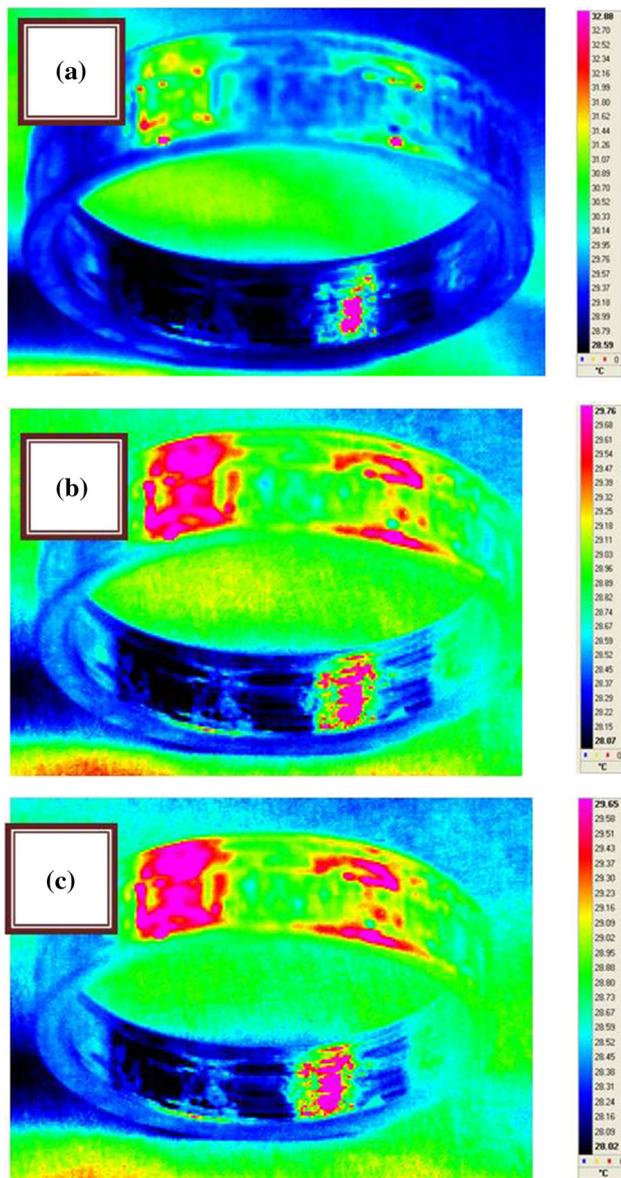
Thermal imaging of the race of CMB-1 was carried out and is presented in Fig. 9. Thermal image of the race is shown immediately after flash heating (Fig. 9a), 15 s after flash heating (Fig. 9b) and 30 s after flash heating

(Fig. 9c). Stress concentration in some places of the race can be noticed.

Fig. 9 Thermal images of the outer race of bearing CMB-1 (a) immediately after flash heating, (b) after 15 s and (c) after 30 s

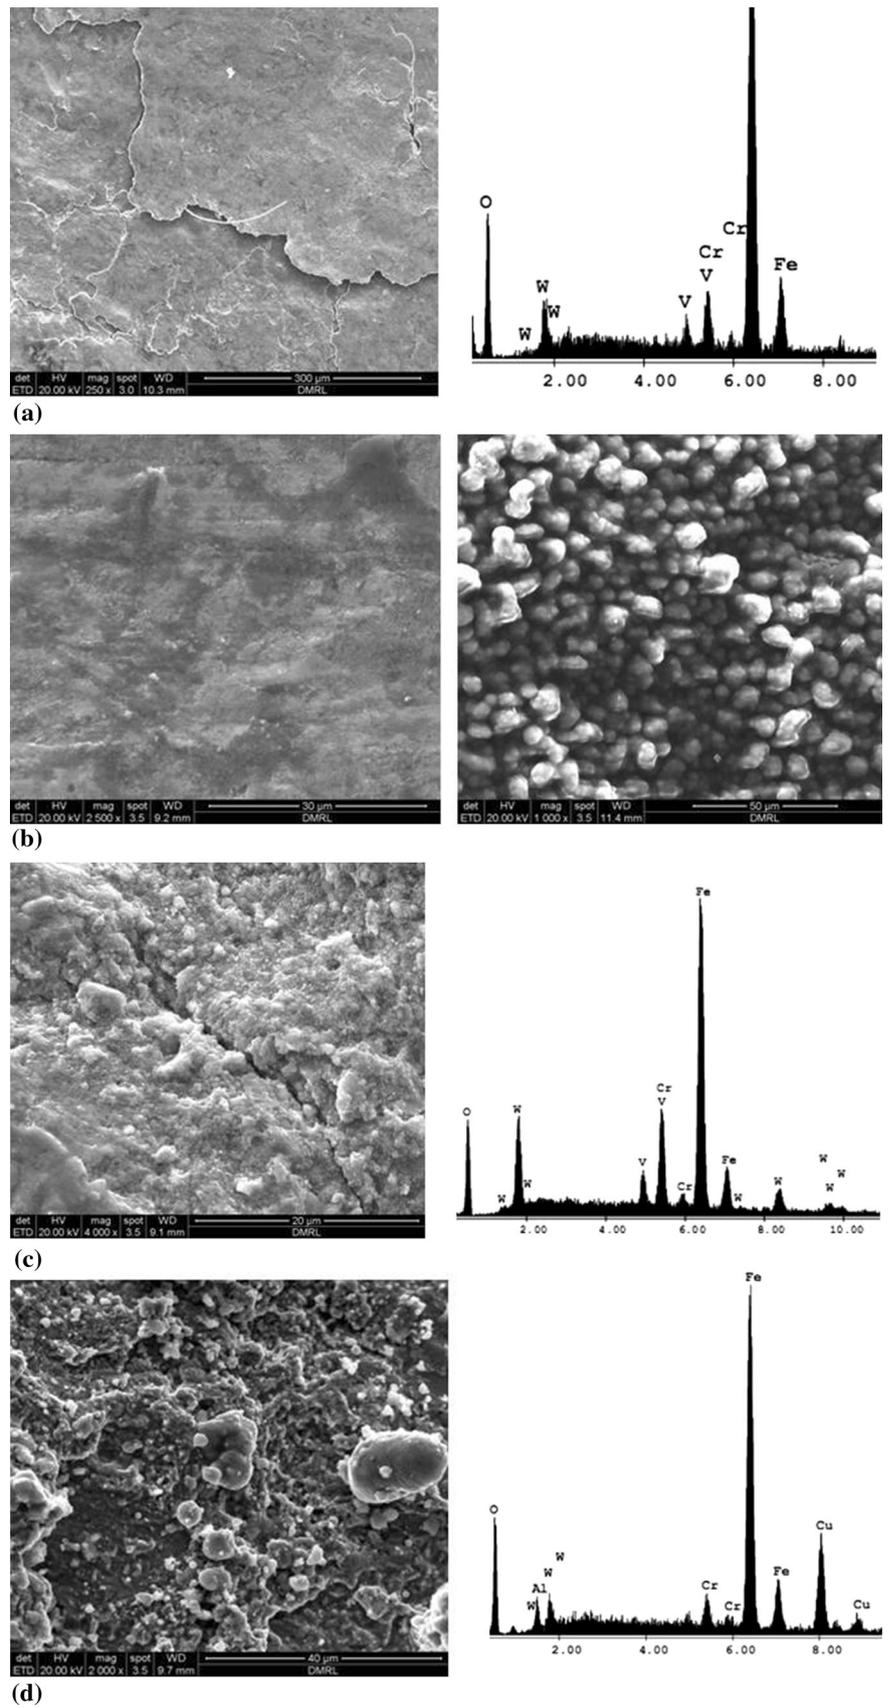
The high-magnification images obtained by scanning electron microscopy (SEM) of the damaged surface of outer race of CMB-2 along with spectra obtained by energy dispersive spectroscopy (EDS) are presented in Fig. 10a. Extensive plastic deformation of the damaged surface is

evident [9–11]. The presence of delamination crack can clearly be seen on the worn surfaces [12, 13]. Significant amount of debris can be noted on the inner surface of outer race. The SEM images of the damaged surface of the inner race are given in Fig. 10b. Portion of rubbed surface is covered with oxide scale (Cr_2O_3). Damaged surface of the cylinder shows severely deformed surface and the presence of crack and oxide scale (Fig. 10c). The morphology of damaged surface and the corresponding EDS pattern of the cage are presented in Fig. 10d. Significant oxidation of outer race and inner race is evident. The compositions of these two races obtained by EDS of SEM are close to the measured composition obtained by fluorescence and optical emission spectroscopic analysis. The composition of cage shows the presence of several other elements indicating transfer of materials from the races on the damaged portion along with oxidation [12, 13].

Fig. 10 The SEM images showing morphology of worn surface of **a** outer race, **(b)** inner race, **(c)** rollers and **(d)** cages of CMB-2 along with EDS patterns

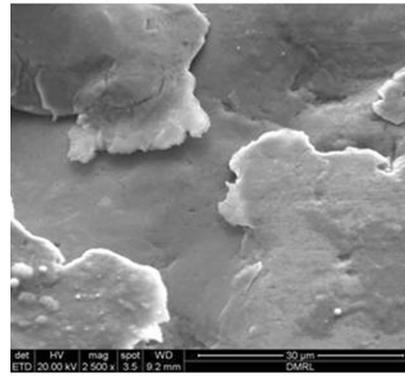
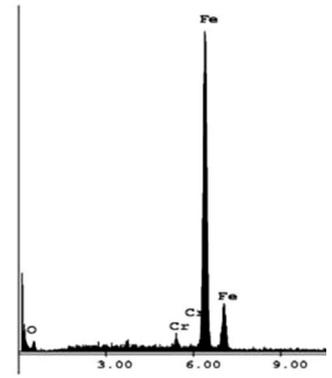
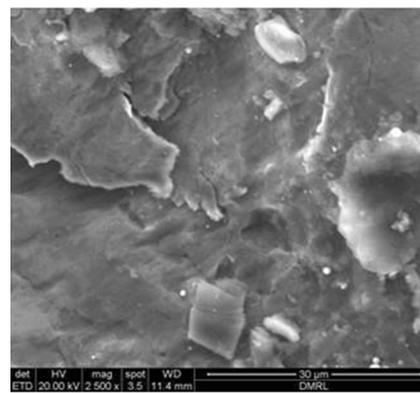
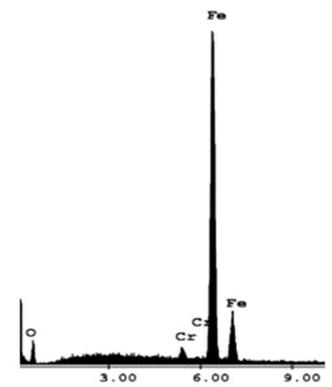
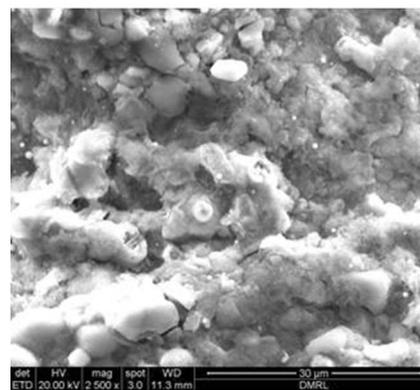
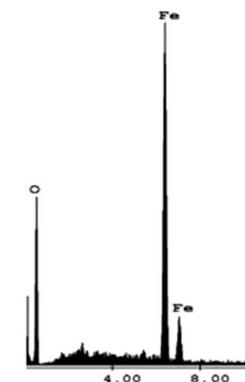
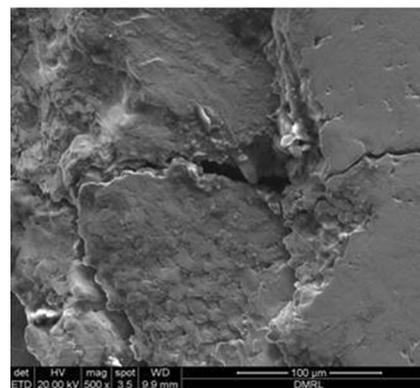
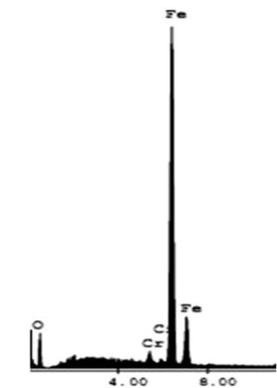
The high-magnification images obtained by scanning electron microscopy (SEM) of the damaged surface of stationary race (tight ring) and rotating race (free ring) of EDP-1 bearing along with spectra obtained by energy dispersive spectroscopy (EDS) are presented in Fig. 11a and b. The presence of extensive plastic deformation characterized by delamination/crack can clearly be seen on the damaged surfaces. In addition, crack due to fatigue can also be observed. The composition obtained by EDS for the main alloying elements from the damaged surface is summarized in Table 6. Clearly, the composition is close to the measured composition obtained by fluorescence and optical emission spectroscopic analysis indicating negligible oxidation, homogeneity of the composition even in the damaged portion and the absence of any transfer layer on the damaged portion. Significant amount of debris can be noted on the rotating race (free ring). SEM micrographs of debris on the rotating race (free ring) along with EDS

spectra are illustrated in Fig. 11c. In addition to increased amount of oxygen, the presence of foreign element Si can be noticed on the damaged surfaces. SEM images of the damaged surfaces of the ball along with EDS spectra are provided in Fig. 11d. Again severely deformed surfaces and the presence of extensive cracking can be noted. The damaged surface exhibits features of shear dimple and ductile fracture. EDS from debris of the ball did not show the presence of any foreign element although higher wt percentage of oxygen is noted. Optical micrograph of the transverse section of the stationary race (tight ring) is given in Fig. 12. Subsurface crack can be seen in the damaged portion. It can also be seen that some cracks lie completely below the surface, indicating that the crack is generated beneath the surface. However, no crack perpendicular to the surface can be noted. Optical micrograph of the transverse section of the ball is given in Fig. 13. Interestingly subsurface cracks show the presence of delamination

Fig. 11 SEM images of the damaged surfaces of **(a)** stationary race, **(b)** rotating race, **(c)** debris and **(d)** the ball along with EDS spectra of EDP-1 bearing

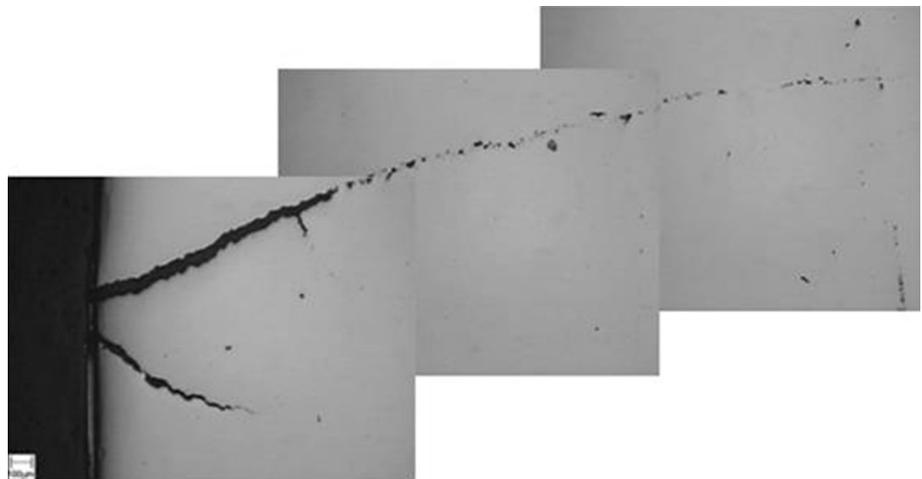
Extensive plastic deformation of the damaged surfaces of stationary race (tight ring), rotating race (free ring) and ball and the presence of delamination/cracks in the region beneath the surfaces of these components clearly suggest

Fig. 12 Optical image of the subsurface crack from the stationary race (tight ring)

that all these components were subjected to delamination wear [20]. As significant amount of debris is noted on the damaged portion of rotating race (free ring) and balls, the wear is primarily due to abrasive action of the debris [21–23]. The debris may be ingested either during overhauling or generated during operation due to insufficient lubrication [24, 25]. The presence of foreign element on the damaged surface of the rotating race (free ring) confirms that some of the debris is due to foreign particles. Metallic debris can also be generated due to metal and metal contact as a result of insufficient lubrication. Insufficient lubrication has already been reported by preliminary visual inspection. All the debris was oxidized as temperatures were well above normal due to heat generated as a result of improper lubrication. The damaged surface of the balls exhibited vertical crack. These vertical cracks may be due to contact fatigue. Damaged surfaces of the balls did not show the presence of foreign element. Thus, the failure of balls could be due to abrasive action of oxidized metal debris generated by metal-to-metal contact and also by rolling contact fatigue [26, 27].

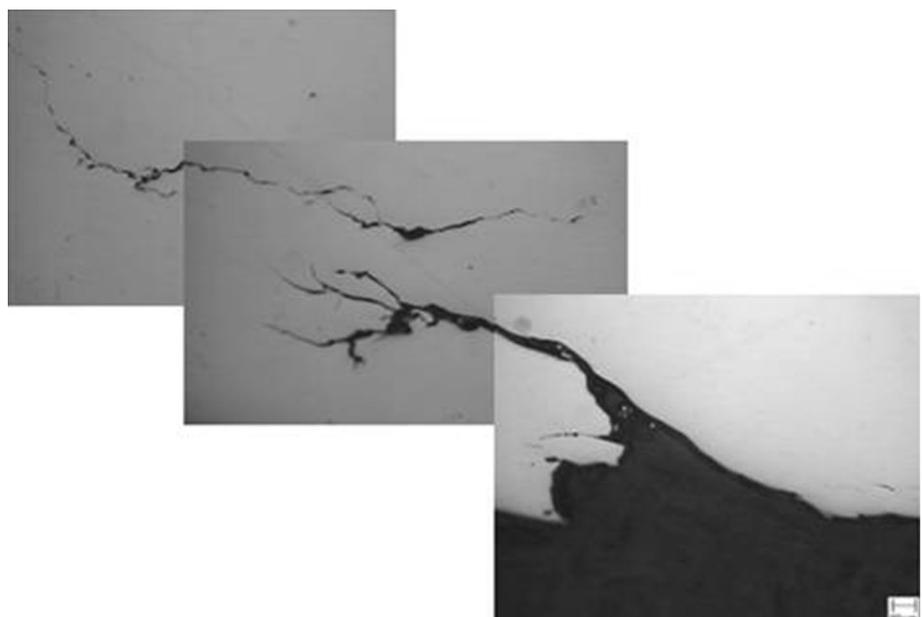
Fig. 13 Optical image of the subsurface crack of the ball
