Engineering Failure Analysis

Failure analysis of an aircraft APU exhaust duct flange due to low cycle fatigue at high temperatures

Gyu-ho Kim ^{a,*}, Bok-won Lee ^b, Hongbing Lu ^a, Jong-hyun Park ^c^a Department of Mechanical Engineering, The University of Texas at Dallas, Richardson, TX 75080, USA^b Aero-Technology Research Institute, R.O. Korea Airforce, Dae-gu 701-799, South Korea^c CNF Co., Ltd., Jeon-buk 561-844, South Korea

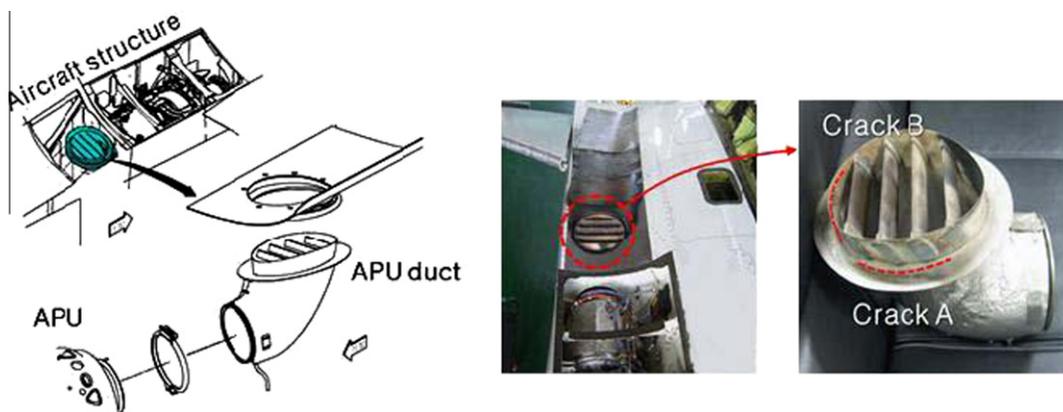
Visual observation of the crack-damaged area identified the crack length, its initiation location and propagation path as well as any surface topography features. Subsequently, that section was cut to expose the damaged surface induced by cracks. The fractograph was acquired using a Scanning-Electron Microscopy (SEM: Hitachi SU-70) with analytical energy-dispersive X-ray spectrometer (EDS) to further analyze and find the crack initiation location, its propagation pathway, damage types and/or overall failure characteristics. Thermal-stress analysis was conducted on the crack-damaged area to determine whether any environmental effects (heat) played a role. The overall features of the APU exhaust duct are shown in Fig. 1. APU exhaust duct has a flange, which was attached to the upper part of the fuselage structure. It has a circular type and includes guided outlet vanes that assist the gas to exit the aircraft. The figure shows cracks and damage in the flange.

Fig. 1. Overall features of the APU exhaust duct.

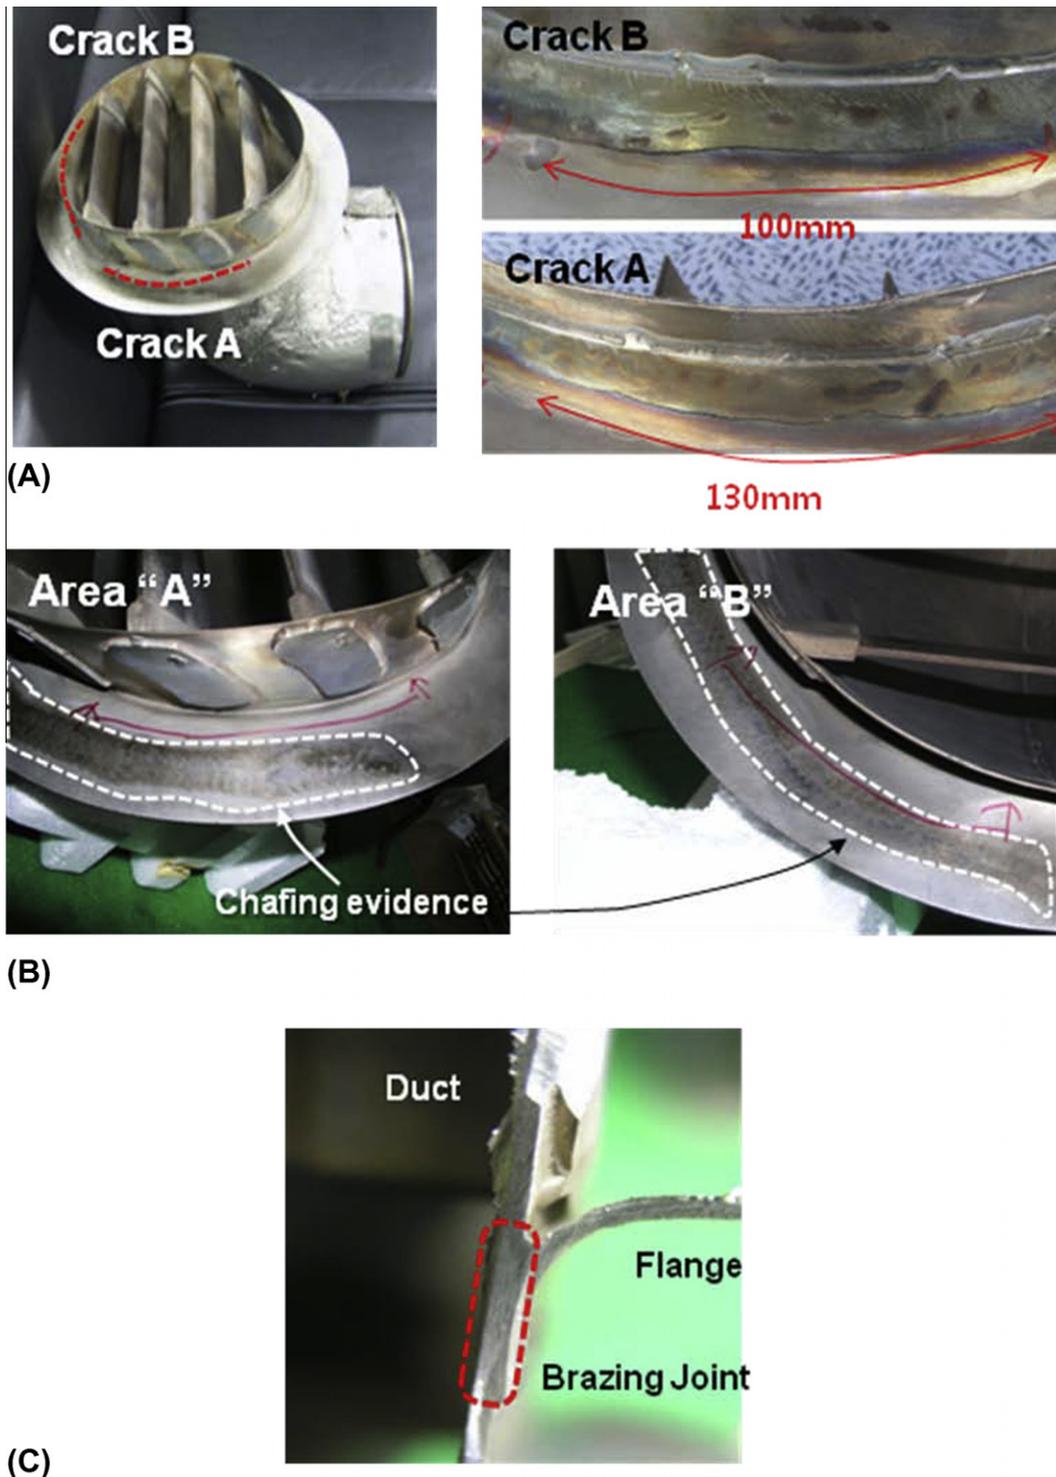
Visual inspection of the damaged duct reveals cracks and chafing sites around the duct flange and its fillet as shown in Fig. 2. Two major cracks exist along the duct flange fillet as shown in Fig. 2A. The crack lengths are approximately 13 cm and 10 cm. In addition, there is considerable chafing developed on the flange (Fig. 2B), and the chafing sites are very close to crack sites.

The existence of chafing reveals that there is an extensive wear by friction between contacted surfaces of flange and the corresponding structure. Then the duct and flange were cut away to find the brazing state and its quality as shown in Fig. 2C. Brazing is a typical process for joining metals using a filler metal [2]. A careful observation of the brazing area was performed to find any defects from structures or associated filler metal. It shows that there is no considerable defect on the brazing joint and manufacturing quality of brazing may not have any connection with this failure.

Fig. 2. Visual inspection of the failed duct (A) cracks, (B) chafing and (C) cut-away.

widely distributed on the flange surface. It implies that a uniform load has been consistently applied to induce cracking. Chafing sites, as shown in Fig. 2B, give evidence that there exists mechanical contact between two solids. It may occur during APU operation. Widely distributed chafing area and creep damage area are very close and it can be said that chafing condition is closely related to creep situation. Fracture surface in Fig. 5 clearly shows striations by fatigue. It indicates that cycle

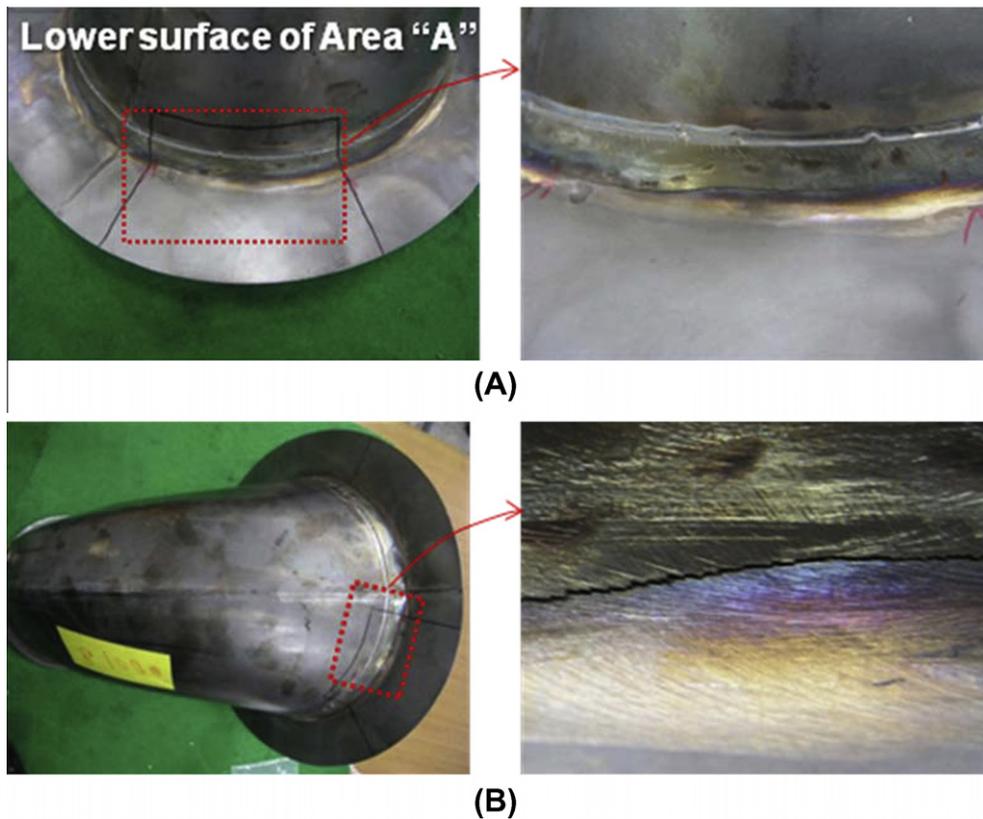
A closer visual inspection of duct and lower surface of flange shows that there is a considerable discoloration around the crack as shown in Fig. 3A. The discoloration of metallic surface usually means that the part has been exposed to high temperature condition. The APU gas flows through the duct for exit and the temperature of gas reaches up to 600 °C when fully developed. Another observation is that there is a distributed trace of scratch on the lower surface of flange as shown in Fig. 3B. It has been reported from manufacturers that those scratches can be made possible during the removal process of beads that were created during brazing work. Overall visual inspection of the damaged duct shows that cracks, heat, and chafing may have an effect on the failure of APU exhaust duct.

Fig. 3. Visual inspection of lower surface of the flange (A) discoloration and (B) scratches.

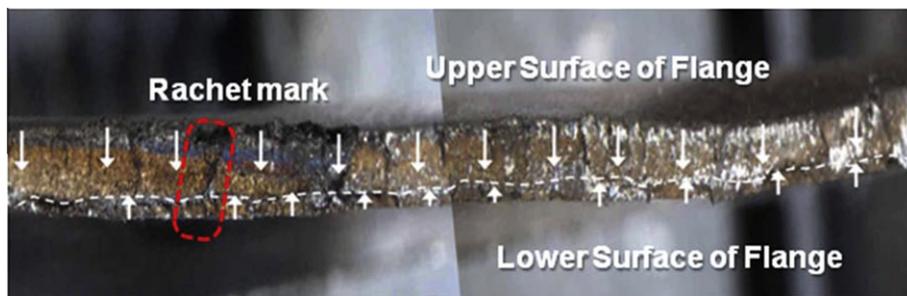
Fig. 4 shows fracture surface of flange created by the crack. Visual observation of fracture surface shows that the surface is mainly divided into two parts by different crack propagation. The entire area of the upper part is much bigger than that of the lower part. In addition, a ratchet mark appears. Ratchet marks usually occur on a surface where high stress concentration is present [3]. It also means that the crack has been initiated from multiple origins [4,5]. Many crack initiation sites were found under a closer observation.

Fig. 4. Macroscopic investigation of the fracture surface.

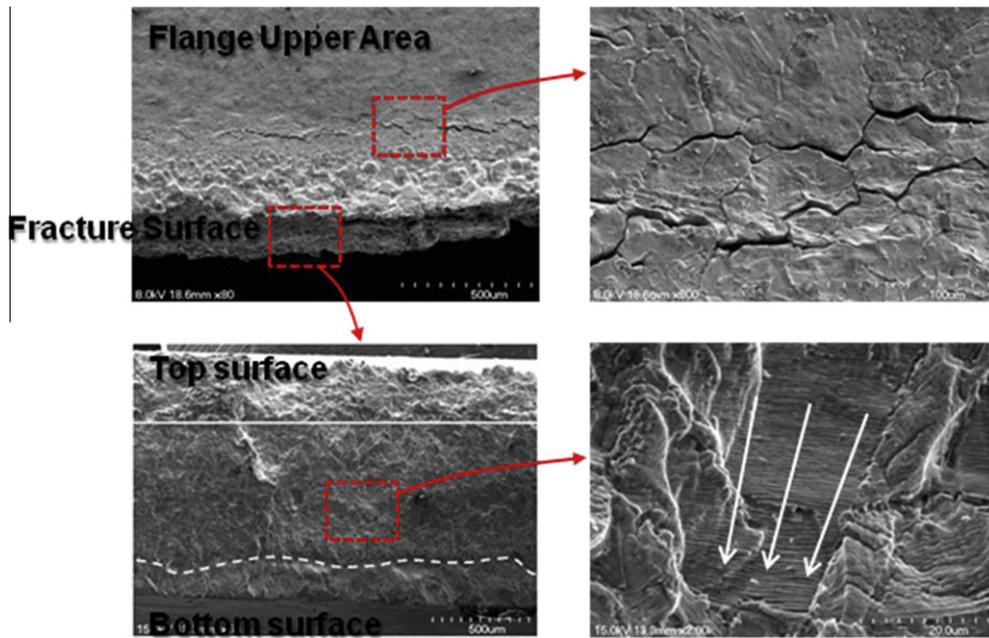
A more detailed fracture surface investigation has been conducted using the Scanning Electron Microscopy (SEM). There are creeps on the flange upper surface and fatigue crack propagations (striations) on the fracture surface as shown in Fig. 5. Creep is a slow deformation phenomenon under stress condition in solid materials below yield strength [6]. Creep damage is

loads were applied on the flange and that the fatigue cracking direction is from top to bottom. It also means that the fatigue cracks originated from the flange upper surface, where creep damage is found.

In addition, creep crack and fatigue crack formations shown in Figs. 5 and 6 look transgranular dominant in crack growth or propagation stage. Creep crack extension shows relatively beeline zigzag formations and fatigue crack fracture surfaces

Fig. 5. SEM image of the upper surface and fracture surface.

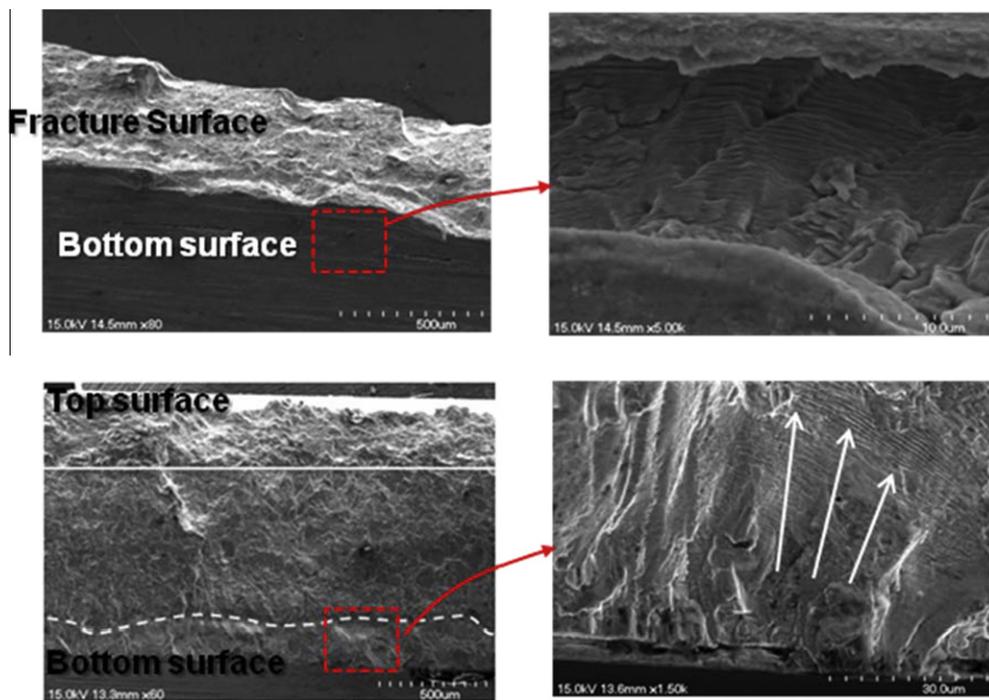
Fig. 6 shows scratches on the flange lower surface and fracture surface. Many scratches are widely distributed on the surface and they have arbitrary directions as shown in Fig. 2A and B. However, only two macro-scale fatigue crack initiation points can be seen in circumferential direction. It implies that the fatigue cracks are mainly induced and developed by mechanical loading and has little connection with scratches.

Fig. 6. SEM image of the lower surface and fracture surface.

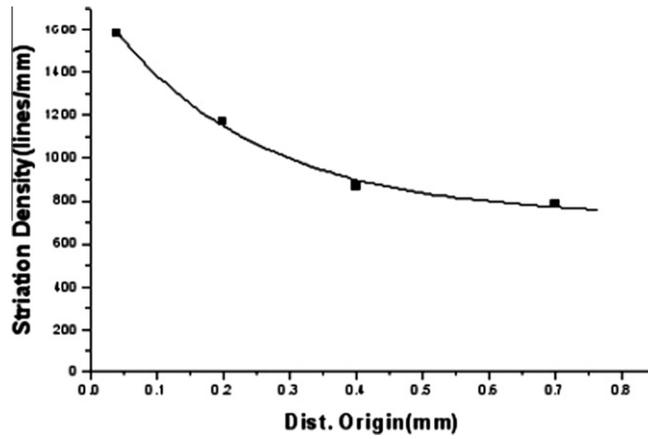
Striation density of fatigue crack was calculated and the result is shown in Fig. 7. Striation means a line mark left on a fatigue fracture surface as a result of the growth of the fatigue crack with one load application [7]. The striation density decreases as it becomes more distant from crack origin. Overall trend of striation density reveals a typical low cycle fatigue where stress level is relatively high. Such trends are usually dominant in plastic deformation processes [8–11]. From this point of view, it can be said that creep environment may have close relations with low cycle fatigue.

are relatively flat and they have well defined striations. Striation density in Fig. 7 tells that there may be a typical situation for low cycle fatigue with high stress and large strain. Duct and flange material is Hastelloy X, which has good qualities for furnace applications because of its special resistance to oxidation under high temperature conditions [12,13]. Actually, the temperature of gas that flows through the duct reaches up to 600 °C when fully developed. It is reported that Hastelloy X material exhibits transgranular dominant crack growth characteristics under high temperature creep conditions [14,15].

Fig. 7. Striation density of fatigue crack B.

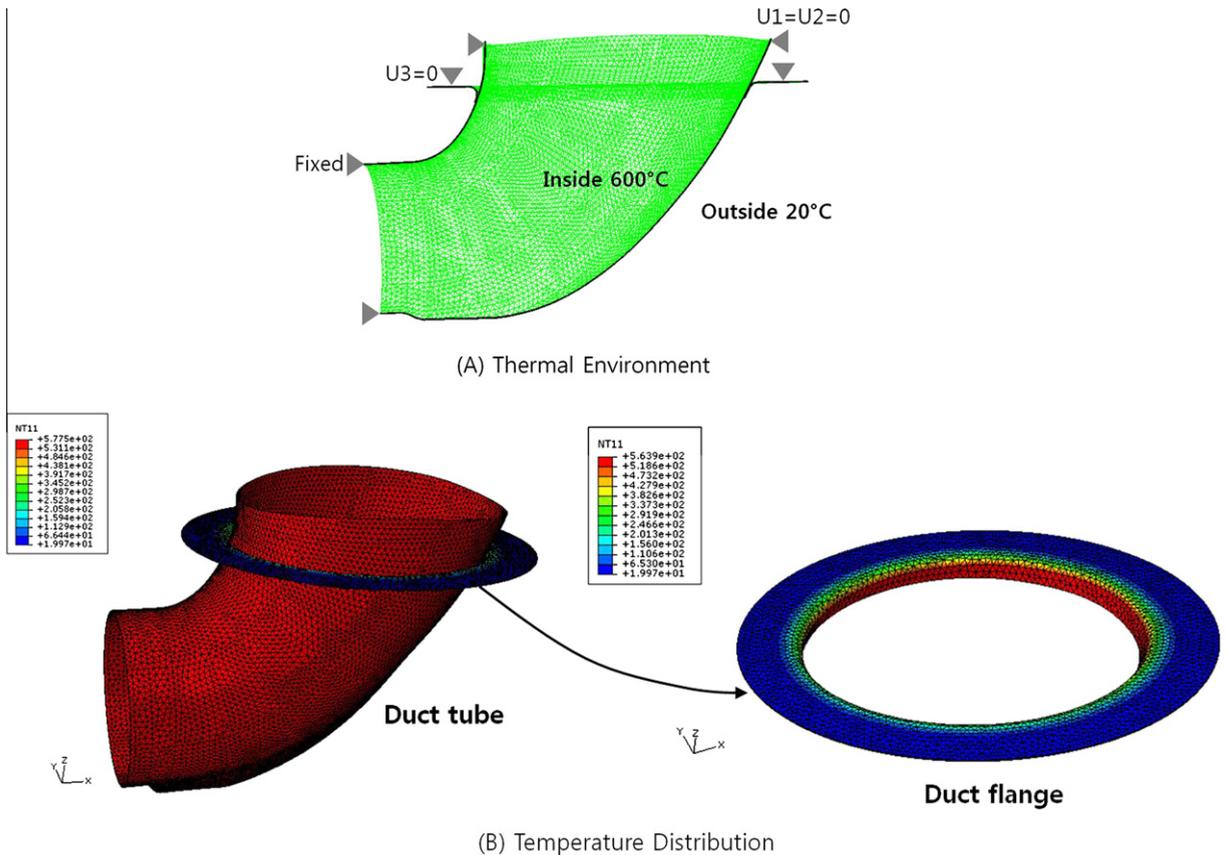
Fig. 8. Temperature profile of the APU duct (A) thermal environment and (B) temperature distribution.

Fig. 8 shows the boundary conditions and temperature distribution of flange under constant internal temperature of 600 °C for 10 min, which is the typical temperature of the actual exhaust gas for real running time while normal main engine's start up. Fig. 9 shows the temperature profile of flange along the calculation line (A–D). The highest temperature gradient zone ranging from 408 °C to 102 °C is located on the curved surface between point B and point C. This area is exactly corresponding to the area where actual fatigue cracking occurs. The upper surface of the flange was constrained to simulate actual installation conditions. The result shows that the temperature gradient associated with this constraint may cause thermal stress situations on the curved surface of the flange.

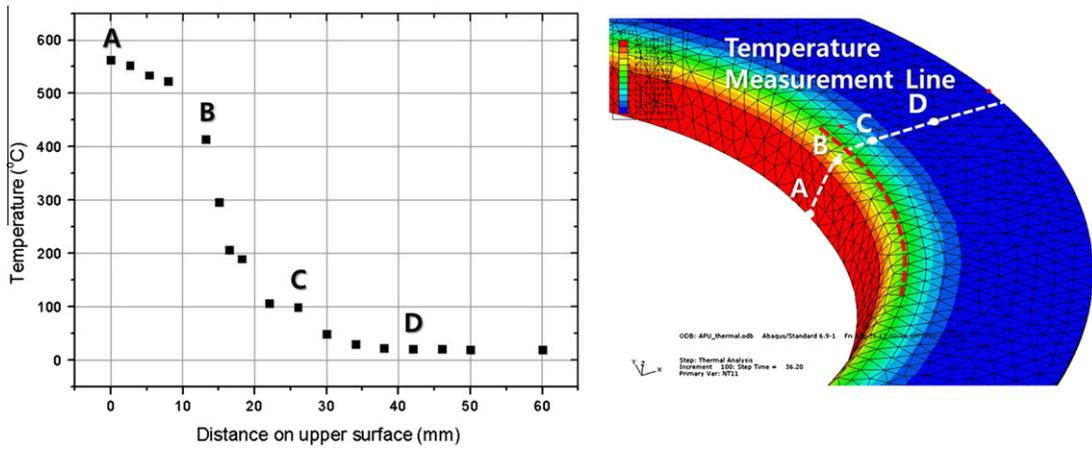
Fig. 9. Temperature distribution along the flange corner.

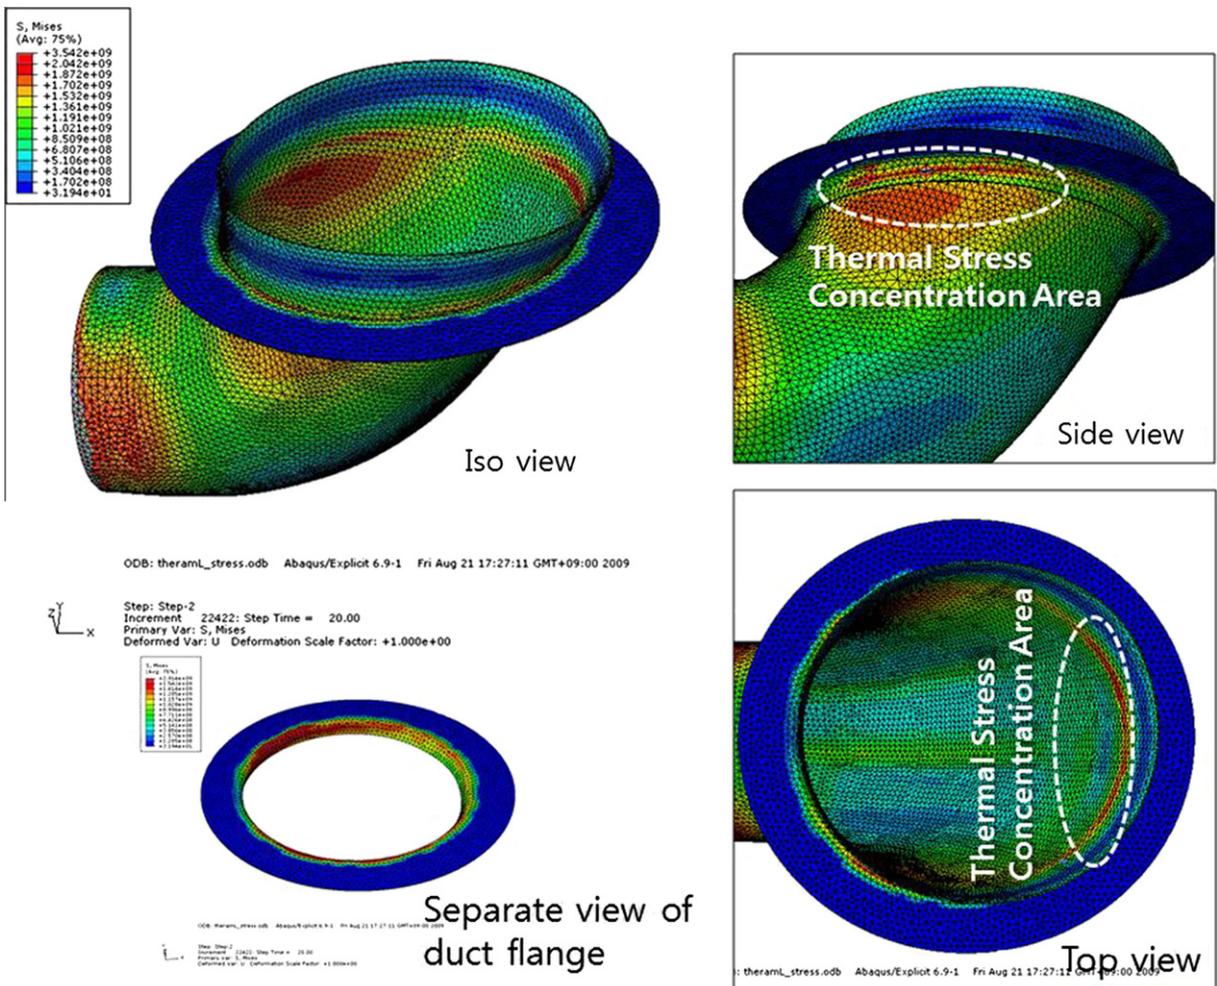
Fig. 10. Thermal stress distribution of the APU duct.

Fig. 10 presents von-Mises stress resulting from the temperature distribution. The result shows that the high thermal stress on the curved surface of the flange creates asymmetric stress concentration along the circumference of the flange. It is mainly due to the geometrical feature of the duct. Moreover, those stress concentration areas are identical to the location where actual damage occurred. It can be concluded that the temperature gradient caused by exhaust gas, which flows through the duct, plays a major role in raising stress on the failed structure. Also, additional mechanical stress as a result of cyclic thermal expansion associated with constraints makes subsequent contributions to fatigue crack acceleration.
