Failure analysis and finite element simulation of deformation and fracture of an exploded CNG fuel tank

Majid Mirzaei *, Mohammad Malekan, Ehsan Sheibani

Department of Mechanical Engineering, Tarbiat Modares University, Tehran, Iran

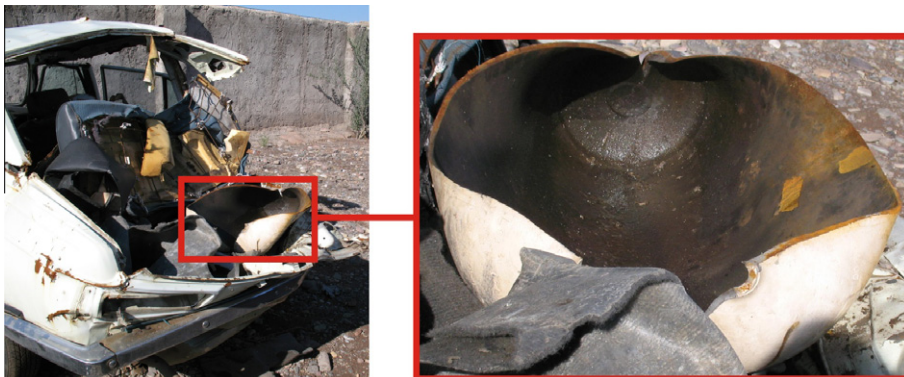
any injuries. As shown in Fig. 2 the explosion partially destroyed the rear part of the car but there was no burn marks on the wreckage. As the CNG tank ruptures usually lead to the outer combustion of the leaked gases, this simple observation was an initial indication of the fuel consumption prior to the burst of the tank. Moreover, the cracking pattern of the tank, along with a few specific features of the crack initiation and growth, indicated that this failure was not caused under normal operation

Fig. 2. Left: the wreckage of the car after the explosion. Right: the ruptured CNG tank. No burn mark was found on the wreckage.

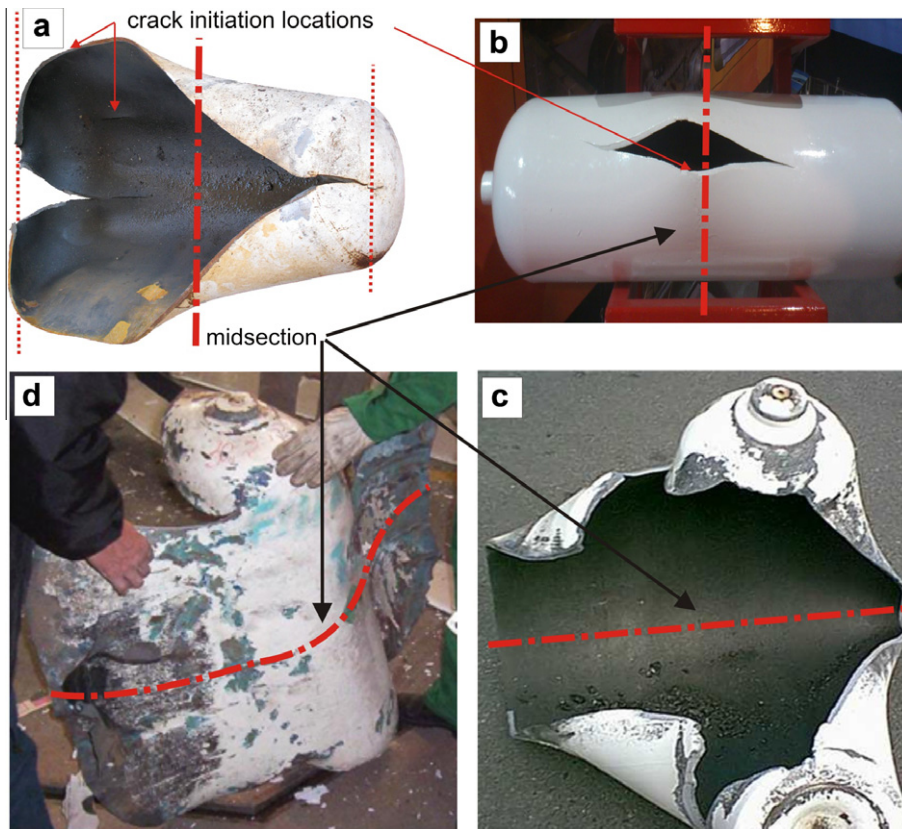
The overall fracture pattern of the tank, as depicted in Fig. 3a, represented an *asymmetric* initiation and growth of the main crack with respect to the midsection of the tank. This was in contrast to the usual burst pattern of these tanks due to overpressure, which naturally initiates at the midsection region and propagates towards the caps, creating an almost symmetric fracture pattern with respect to the midsection (Figs. 3b–d). Fig. 3b a typical symmetric rupture caused during the hydrostatic burst test of CNG cylinders using incompressible liquids. This type of loading naturally causes more inflation in the midsection which is less affected by the constraints imposed by the caps. Moreover the crack growth is stable and the crack arrest occurs because of the fast reduction in the energy release rate caused by leakage of a nearly *incompressible liquid*. Fig. 3c and 3d show two CNG incidents which occurred during refilling [24,25]. These cases show other types of symmetric burst caused by overpressure of gas which naturally leads to a more violent and unstable crack growth because the *compressed gas* can deliver energy to the crack even after the leakage. Based on the above arguments it was suggested that the cause of the observed asymmetric fracture was either a preexisting *flaw* outside the midsection or an *asymmetric pressure loading* (with respect to this section). In the next step, the chevron markings on the fracture surfaces were followed and the

Fig. 3. Different types of CNG tank failure. (a) The asymmetric fracture pattern (with respect to the midsection) of the exploded tank. (b) Typical symmetric bulging and rupture of CNG tanks due to overpressure during hydrostatic testing. (c and d) Symmetric fracture patterns of two CNG tanks due to overpressure during refilling [24,25].

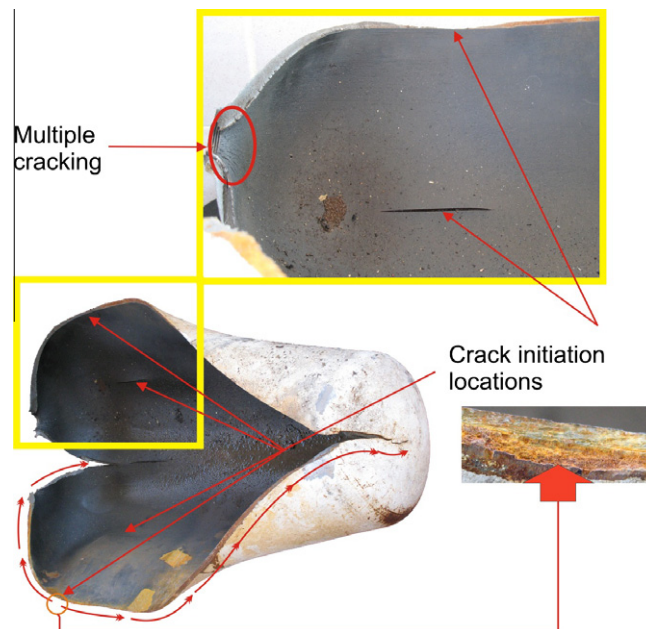
initiation site of the main crack was identified. This was below the neck portion of the tank and at the beginning of the cylindrical portion. Other very interesting features of this failure were the existence of parallel cracks at the same section of the tank and multiple small cracks just below the neck (see Fig. 4). The examination of the initiation site of the main and parallel cracks showed *no evidence of pre-cracking* caused by fatigue, stress corrosion, material defects, or manufacturing flaws. Moreover, examination of the wall thickness at different locations and measurement of the tensile properties of the cylinder showed that these quantities were within the standard range (see Table 1). Accordingly, the application of an asymmetric loading with respect to the midsection was considered as a plausible scenario. The chevron markings on the crack surfaces was used to specify the cracking pattern of the cylinder and the directions of crack growth as depicted in Fig. 4. The self similar growth of the main crack was in both directions towards the head and the bottom of the tank. The upper front of this crack continued growing until it severed the neck from one side and the growth of the lower front sized near the center of the bottom cap. Based on the above observations and analyses, it seemed plausible that this type of cracking was caused by an asymmetric loading such as a moving pressure traveling from the neck towards the bottom of the cap. In practice, this type of loading can occur either due to a sudden pressure rise at the neck by fast filling of a partially filled tank, or by initiation of an internal combustion of a flammable gaseous mixture at the neck. The former cause was discarded because the magnitude of such pressure wave can naturally be tolerated by a healthy cylinder. Since there was no proof that the cylinder was faulty, the latter cause was considered as the most plausible scenario for further investigation. As mentioned before, based on the type of combustion (deflagration or detonation), the speed of the moving pressure can be either subsonic or supersonic. However, the FE simulations of detonation-driven fracture of experimental tubes [22] and the evidences found on the fracture surfaces of an exploded gas cylinder containing hydrogen [20] showed that an important characteristic of the detonation-driven fracture of cylinders is that the crack propagation phase can be mostly or entirely driven by the *structural waves*. Thus, the whole cracking process and fragmentation can occur after the passage of detonation front. Among other features of detonation-driven fracture are a specific flap bulging process, the resultant crack branching, and the formation of special markings on the fracture surface which can be used to quantify the crack growth increments [20,21]. Since *neither of the above mentioned features* was distinguished on the failed fuel tank, it was suggested that the speed of the moving pressure was not supersonic and this failure could have occurred due to a subsonic *deflagration* of a gaseous mixture.

Fig. 4. Various features of deformation and fracture of the exploded tank. The crack initiation locations of the main and parallel cracks are pointed by arrows. The growth directions of the main crack are shown by double-arrows. The multiple cracking at the neck of the tank is shown by an ellipse.

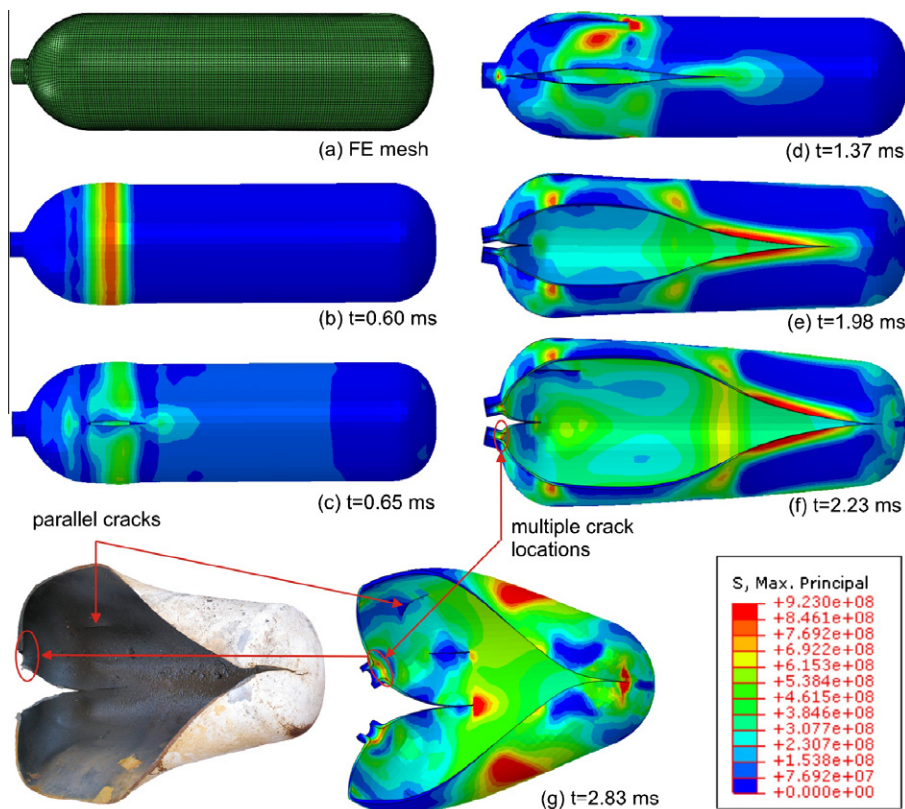
Fig. 6 depicts the results of the elasto-plastic transient-dynamic FE analysis of deformation and fracture of the tank, caused by traveling of a *sonic* pressure wave from the neck towards the bottom. The development of a ring stress which causes longitudinal parallel cracks at the beginning of the cylindrical portion of the tank is shown in Fig. 6b. This is the same location that the initiations of axial cracks were recognized on the exploded tank. The initiation and partial growth of parallel cracks at the same section can be attributed to the ring loading nature of the deflagration-induced moving pressure. Ideally, the ring loading is expected to cause axisymmetric radial displacements, strains, and stresses. In reality, however, the inherent *material heterogeneity* can cause local cracking at relatively weaker locations around the ring. In case of *high-pressure* sonic front the parallel cracking is abundant and naturally leads to severe fragmentation. Nevertheless, for a *medium-pressure* sonic front the parallel crack growth can be aborted due to the fast consumption of strain energy by the advancement of a favorite crack. Fortunately, in the FE model, the inherent *numerical heterogeneity* of the mesh plays a similar role and the initiation and partial growth of parallel cracks can naturally occur as depicted in Fig. 6.

Another interesting feature of this failure is the existence of multiple small cracks at the neck. The FE simulation shows that these surface cracks were created by the concentration of bending stresses on each severed half of the neck. These stresses were in turn developed by the rapid movement of the flaps of the main crack in the opposite directions. The simulation also clearly shows that the neck was first ruptured on the front side by the self-similar growth of the main crack, and next on the back side as a result of the bending of the crack flaps.

Fig. 6. FE simulation of deformation and fracture of the CNG tank. The snapshots show the initiation and growth of the main crack, the parallel cracks, and the multiple cracks caused by traveling of a *sonic* pressure wave from the neck towards the bottom of the tank. The snapshot (g) has been rotated to a viewpoint similar to the failed cylinder. The stresses are in MPa.
