Engineering Failure Analysis

Failure analysis of a pressure vessel bolt in a nuclear fuel fretting wear simulator

This paper presents a failure analysis on a pressure vessel bolt of a fretting wear simulator. After 500 h tests, in an upper pressure vessel of a fretting wear simulator, one bolt among eight was fractured near the bolt neck regions. The fracture surface was examined by using a scanning electron microscope (SEM) to determine the failure initiation and failure mode. The result indicates that the fracture surface shows intergranular fracture features. Based on the mechanical property data of a bolt material, it is concluded that the exerted stress on the bolt applied by an internal pressure of the pressure vessel has a negligible effect on the major failure causes. In order to verify the mechanical properties of the fractured bolt, tensile test has been performed and its result was compared with material specification. As a result, it is thought that both excess heat treatment during the surface hardening procedure and loose parts in the thread hole have significant effects on the pressure vessel bolt failure. In this paper, the reasons for this failure were discussed

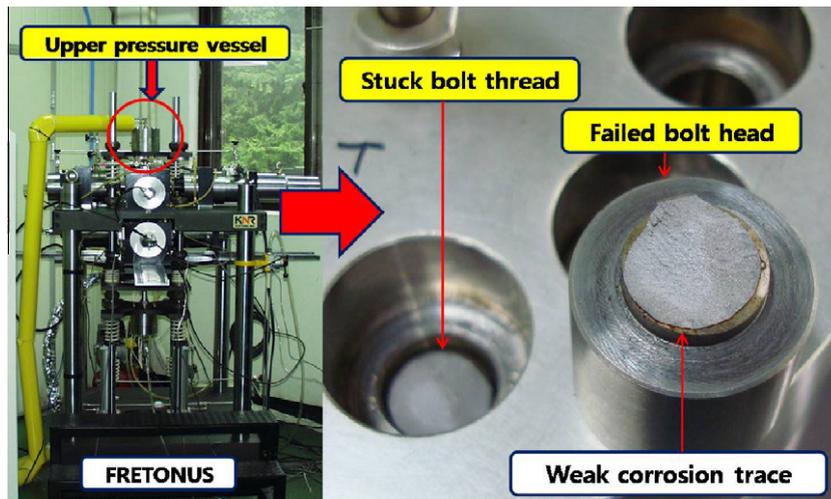
Fig. 1. The schematic views of a fretting wear simulator (FRETONUS) and photograph showing the failed bolt in a upper pressure vessel.

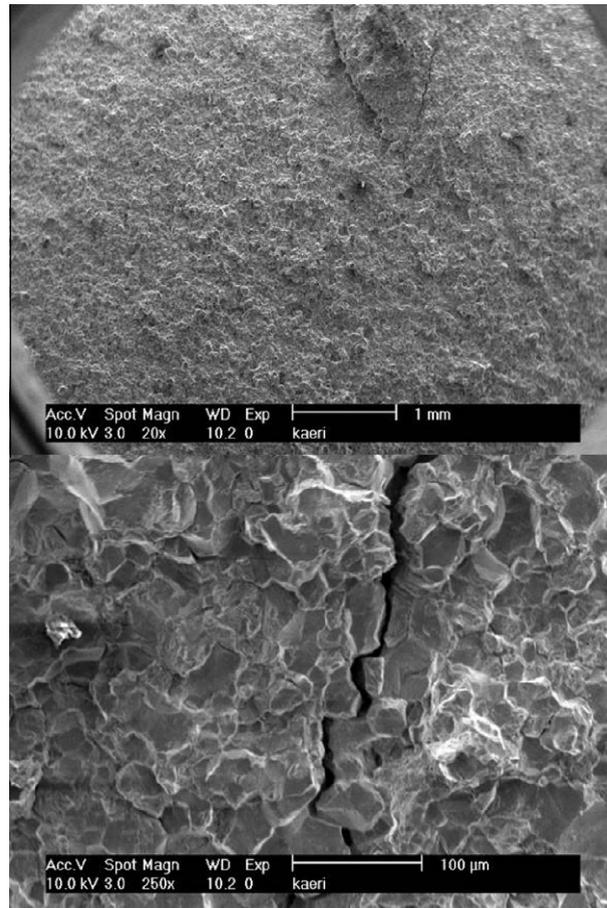
Fig. 2 shows the SEM result on the fracture surface of the pressure vessel bolt. It is apparent that the fracture surface shows the intergranular fracture feature. There is no fatigue failure mode such as regular striation traces on the fractured surface. In addition, corrosion damages as shown in Fig. 1 were distributed around the thread region of the bolt neck while the fracture surface was not oxidized regardless of the high temperature condition. However, it is difficult to detect the circumferential cracks on the fracture surface. These results indicate that the pressure vessel bolt was expected to rapid rupture after the fretting wear test has been finished because there was no leakage in an upper pressure vessel of the fretting wear simulator during the test. The important result of the failure surface analysis is that the pressure vessel bolt has been fully heat-treated during the surface hardening procedure. It can cause a brittle fracture mode if the stress condition was rapidly changed by thermal stress during the system cooling. So, it is necessary to examine the variation of the mechanical properties of the failed bolt.

**Fig. 2.** SEM micrograph of the fractured surface of the pressure vessel bolt.

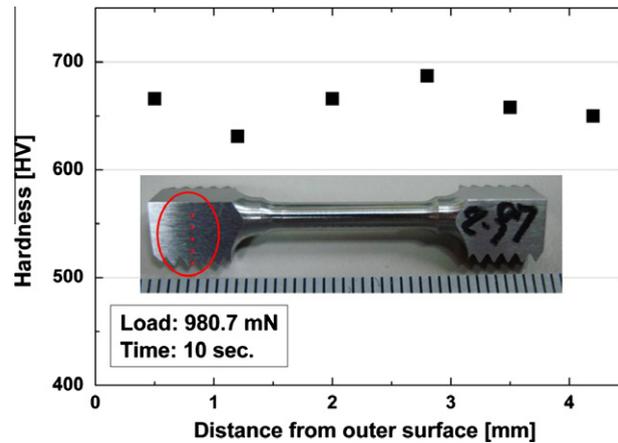
Fig. 3 illustrates the preparation of the tensile specimen by using the failed bolt. First, the thread region of the failed bolt was carefully removed from the pressure vessel. Next, the removed bolt thread region was machined and parted to four sections. Finally, four tensile specimens were fabricated with 18 mm of the gauge length and 3 mm of diameter. Before the tensile test, it is necessary to verify whether the excess heat treatment was carried out during the surface hardening process. So, a micro-vickers hardness of the fractured pressure vessel bolt was measured by using a conventional hardness tester (SHIMADZU HMV-2T) with 10 s of loading time and its result was shown in Fig. 4. It is apparent that the micro-vickers hardness value did not show a noticeable change between the bolt surface and internal matrix. So, it is expected that the applied heat treatment condition was not suitable for the bolt surface hardening.

Fig. 4. Measurement result of the micro-vickers hardness.

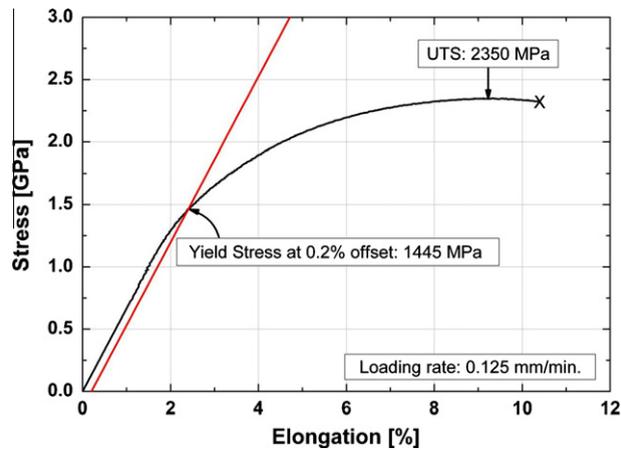
The tensile test has been performed by using a universal tensile tester (INSTRON 8801 model) with a loading rate of 0.125 mm/s and the typical result was shown in Fig. 5. As a result, the yield stress at 0.2% offset and ultimate tensile strength (UTS) show higher values when compared with the material specification of a conventional SUS 440C as listed in Table 2. This result confirms that the failed bolt was fully hardened by the faulted surface hardening condition. Generally, martensite stainless steel with a relatively higher carbon is likely to retain a large amount of untransformed austenite phase [3]. So, the operating temperature at upper autoclave region was expected about 150 °C, which had a negligible effect on the stress relieving of the pressure vessel bolt. Consequently, the fully heat-treated pressure vessel bolt shows some loss in ductility and failed due to the rapid change of the stress condition after service.

Fig. 5. Typical result of the tensile tests by using the failed bolt.

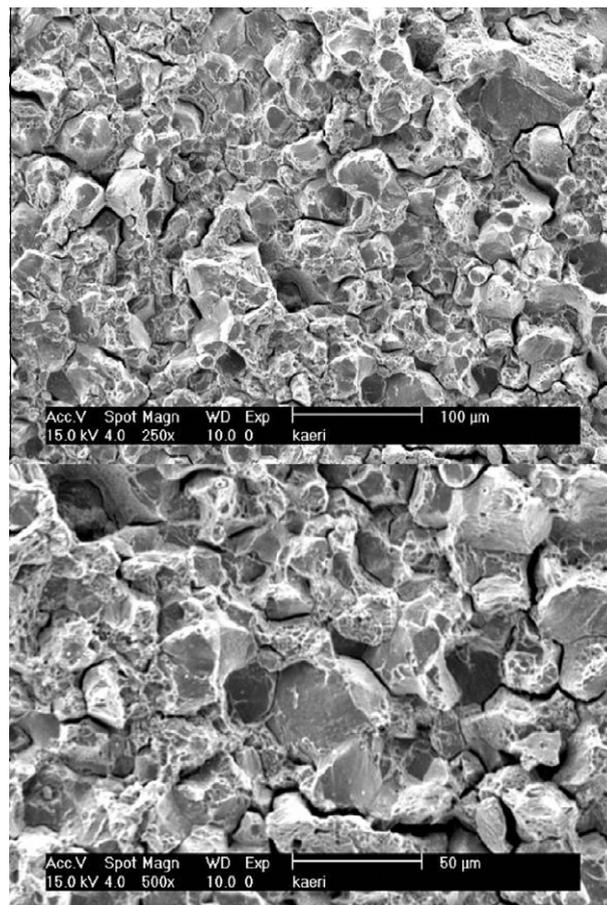
Fig. 6 shows the morphology of fracture surface of the tensile specimen by using SEM. The fracture surface of the tensile specimen was mixed with the intergranular fracture and the dimple rupture. Also, it is difficult to detect the cleavage or quasi-cleavage fracture, which is the evidence of the brittle fracture. When compared with the failed bolt surface, the micro-crack network was well-developed and propagated to the intergranular mode in the fracture surface of the tensile specimen while relatively large cracks were propagated in the failed bolt as shown in Fig. 2. This morphology difference was expected to result from the loading rate. Consequently, the unexpectedly excessive stress was generated and exerted on the pressure vessel bolt because it is difficult to explain only the small amount of tensile force due to the internal pressure and the ductility loss of the failed bolt.

Fig. 6. SEM micrograph of the tensile specimen by using the failed bolt.

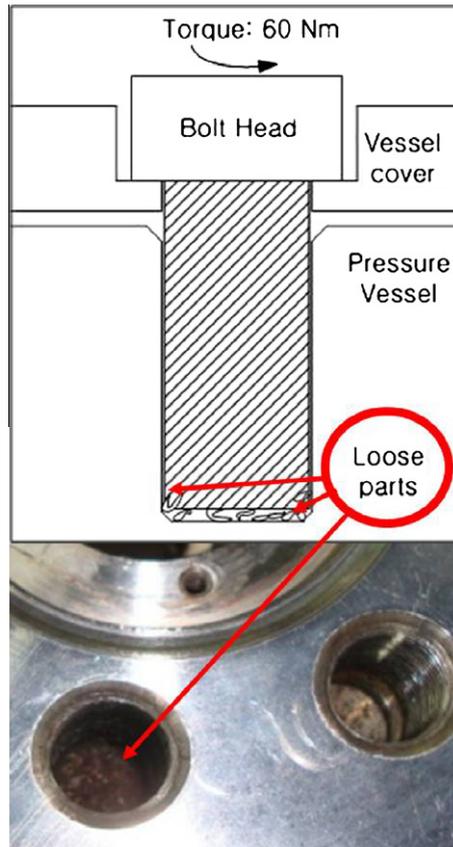
From a careful inspection of the autoclave thread hole, however, some loose parts were found and these consist with heavily oxidized taper chip and unknown parts as shown in Fig. 7. It is thought that, when the pressure vessel cover was bolted with the torque of 60 N m on each bolt, the excess stress could be generated if the end region of the bolt thread were contact with the loose parts or these were trapped in the gap between the bolt and thread hole. In order to verify this possibility, it is necessary to examine the stress distribution exerted on the bolt neck region with considering the remained loose parts in the thread hole of the autoclave.

Fig. 7. The possibility of excess stress due to the loose parts in the thread hole.

- (1) The fracture surface shows the intergranular morphologies but has no evidence of fatigue failure. Also, it is difficult to explain the bolt failure with the exerted tensile stress on each bolt generated by internal pressure.
- (2) Based on the results of the micro-vickers hardness and tensile test with the failed bolt, it is confirmed that the failed bolt was fully hardened by the faulted surface hardening condition.
- (3) Due to the loose parts in the thread hole, it is possible to generate the excess stress induced by the torque during fastening. Also, the stress concentration region of the FE analysis results corresponded well with the bolt failure.
- (4) It is recommended that the bolt material is changed to austenite stainless steel in order to increase the fracture toughness and the thread hole of the autoclave is always cleaned before each fretting wear test.

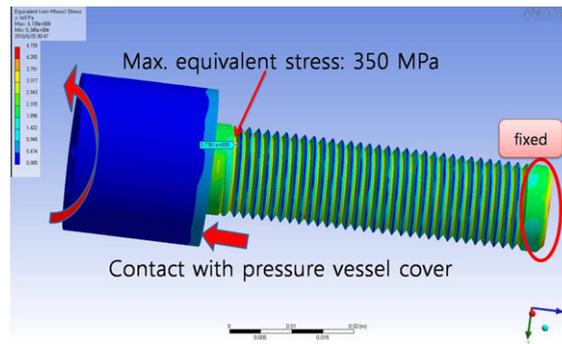
Fig. 9. Model of Von-Mises stress distribution in the pressure vessel bolt.

bolt where loose parts are contacted is fixed and the torque of 60 N m is applied on the bolt head. The FE model consisted of about 28,900 nodes and 16,200 elements. The material properties used in this analysis such as elastic modulus, yield strength, density and Poisson's ratio of commercial SUS 440C are listed in Table 2. The commercial code, ANSYS[®] Workbench V10.0, was used to post-process the model in order to calculate the Von-Mises stress exerted on the bolt. The Von-Mises stress distribution in the pressure vessel bolt showed that the high stress concentrations were appeared at the neck region of the bolt as shown in Fig. 9. In particular, the maximum stress was approximately 350 MPa and this value is about a quarter of the yield stress of the failed bolt even though the thermal stress due to the temperature change and the contact condition between the bolt head and the autoclave cover were not considered in this analysis. Therefore, the failure position of the pressure vessel bolt is in good accord with the FE analysis result. Consequently, the faulted heat treatment condition and loose parts in the thread hole of the autoclave played major role of the bolt fracture. Based on this result, the bolt material was changed to austenite stainless steel in order to increase the fracture toughness and the thread hole of the autoclave is always cleaned before each fretting wear test.
