# Case Studies in Engineering Failure Analysis

# Failure analysis of a helical compression spring for a heavy vehicle's suspension system

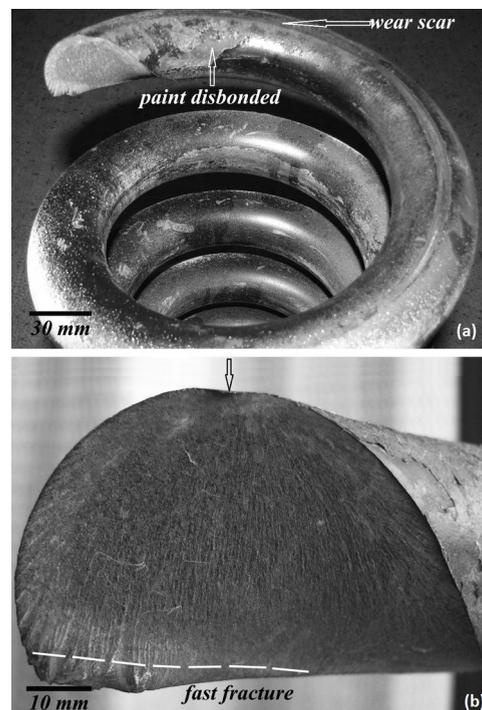
As Fig. 1 suggests, the edge of the fracture surface extended at an angle of  $45^\circ$  with respect to the wire's axis, e.g., cracks grew as a spiral around the surface of the axis, typical of torsional fatigue of a round axle under cyclic torsion. Wear scar could be seen clearly on the upper surface of the first active coil due to contact and friction with the bearing coil and the wear scar, as indicated by the arrow in Fig. 1, was flat and smooth. Painting close to the wear scar was disbonded, resulted in direct exposure of metal to environment. In Fig. 1(b), radiating ridges radiating from the wear scar could be caught easily on the fracture surface, suggesting metal fatigue, and the focus of the radiating ridges was supposed to be the site of fatigue origin. A plastic extrusion as a result of contact and impact, near the fatigue origin, was also visible, referring to the arrow in Fig. 1(b). In addition, contamination and corrosion product due to exposure to the environment after the fracture could also be observed on the fracture surface.

Fig. 1. Fracture photographs of the failed spring. (a) Fractured spring and (b) close-up of the fracture surface.

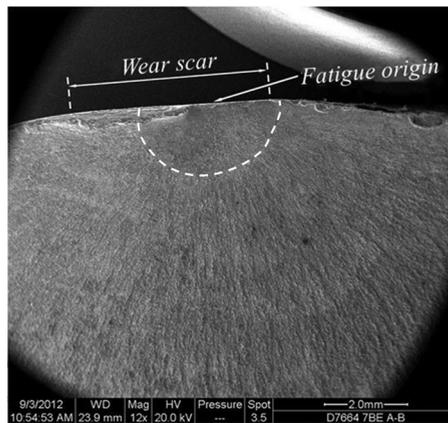
A fracture surface specimen was cut near the wear scar of the failed spring and was cleaned ultrasonically in acetone to remove the contamination and corrosion, whereafter, a QUANT-200 scanning electron microscope (SEM) was used to examine the detailed features of the fracture surface. Refer to Fig. 2, a crescent shaped region and beach marks were visible, which are typical fatigue features. Corrosion pits can be observed on the surface of the spring, especially, a corrosion pit was formed at the center of the fatigue origin. Fig. 3(a) is a close view of the fatigue origin indicated by the arrow in Fig. 2. Fig. 3(b)

Fig. 2. SEM photograph of the fracture surface after ultrasonic cleaning.

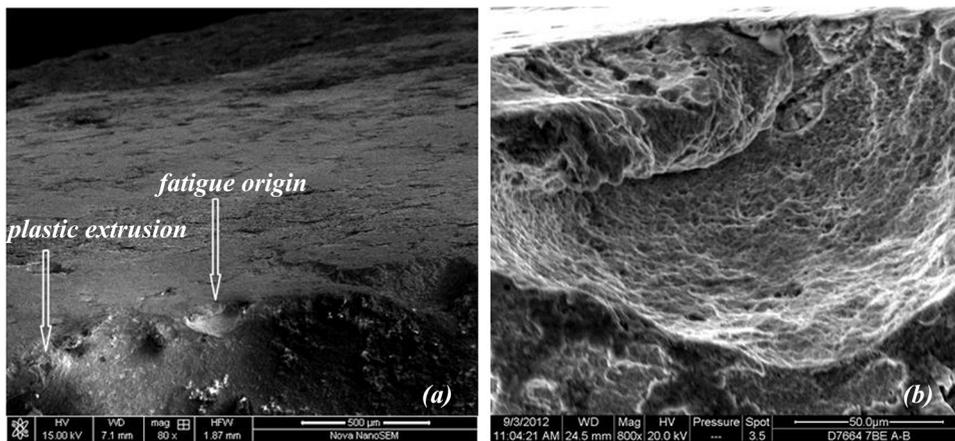
Fig. 3. SEM photographs of the fatigue origin after ultrasonic cleaning. (a) Close view of the fatigue origin and (b) magnified view of the corrosion pit, see the right arrow in (a).

is a SEM image showing a magnified view of the corrosion pit with depth of about  $100\ \mu\text{m}$ . It is believed that it was the corrosion pit which induced stress concentration and contributed to fatigue nucleation. Corrosion was formed as a result of disbonding of the protecting paint and rupture of the ZnCaph phosphate layer due to impact and wear of the closed end. Noteworthy is that the fatigue origin (focus of the radiating ridges or center of the crescent), as indicated by the white arrow, was located at the right hand side of the wear scar. The reason for this phenomenon will be discussed latter in Section 3.

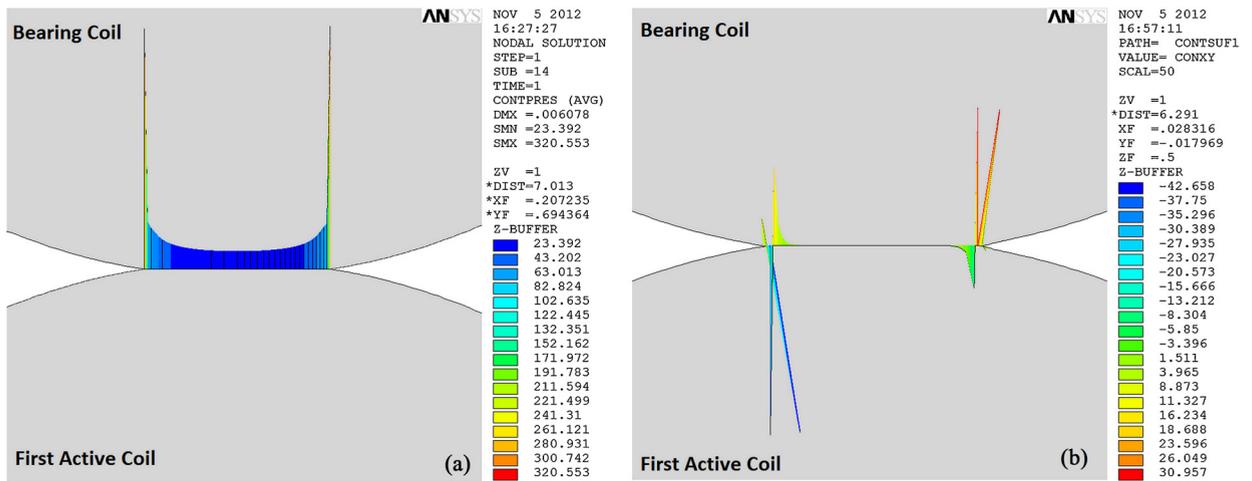
Fig. 4. FEM results of stress distributions in the contact zone. (a) Contact pressure and (b) shear stress.

time. At earlier stage of the contact, stress singularity at the edge of the contact caused fatigue crack initiation, whereafter, the fatigue crack developed continuously while the contact zone increased gradually. As a result, the fatigue origin was not precisely at the edge of the final contact zone.

Contact stress analysis showed that stress singularities presented at the edges of the contact zone, and it was the severer shear stress at these locations that facilitated cycle slip and resulted in crack nucleation. This result interpreted the observation that fatigue initiated at the right hand side of the wear scar.
