Creep failure of low pressure turbine blade of an aircraft engine

A low pressure turbine blade of an aircraft engine was fractured during the ground test run. The failed as well as neighboring unfailed blades were studied during failure investigation. Microstructure of a virgin blade was also analyzed for reference.

After a general overhaul, during the test bed run of an aircraft engine, severe vibration and change in the engine noise were observed. In the visual inspection, airfoil of a low pressure (LP) blade was found fractured near the root region. The hours since new (HSN) of the engine was 270 h. The failed blade, its two neighboring unfailed blades and an unused blade were analyzed during the study.

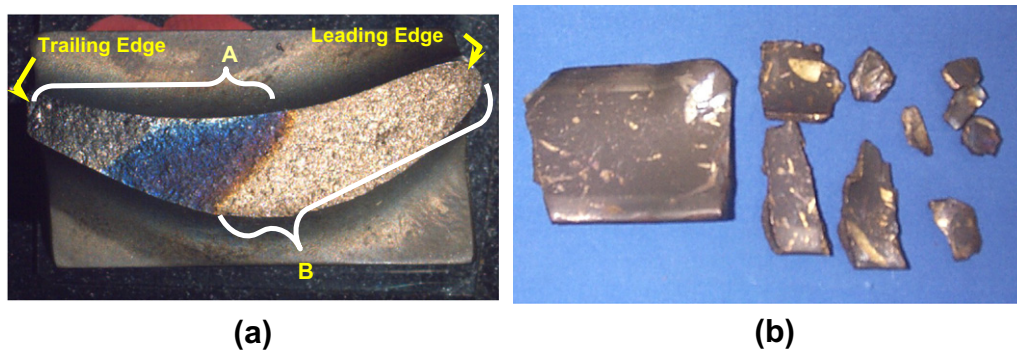
Fig. 1. Failed blade, (a) fracture surface, (b) remains of the airfoil.

Fig. 1a shows the fracture surface of the failed blade. Two distinct regions were observed on the fractured surface; one was bluish colored region A, covering approximately half of the fractured area, and the remaining light-grayish colored region B. Based upon the variation of color density, the region-A further incorporated into two regions. The airfoil was recovered in severely damaged condition, see **Fig. 1b**. The complement fracture surface on the damaged airfoil was smeared probably due to rubbing with other parts of the engine.

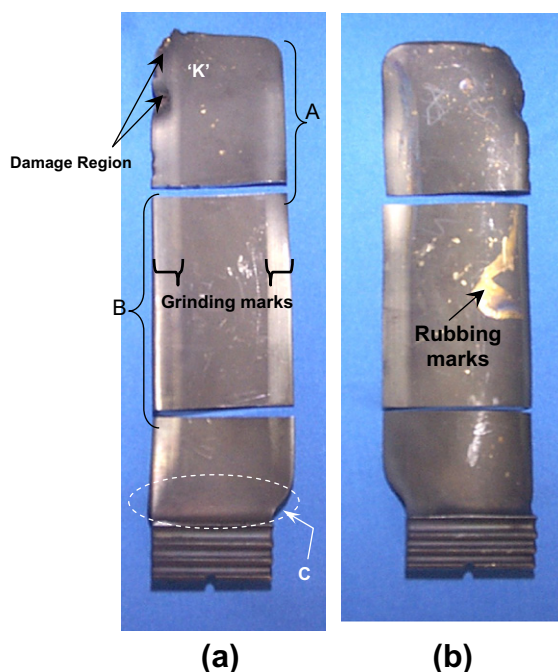
Fig. 2 shows the front and rear views of an un-failed turbine blade. The blade surface was dark grayish in color. On the airfoil, approximately 5–6 mm wide grinding marks were observed on the trailing and leading edges. They were observed on both pressure and suction side of the airfoil. Damage was observed on the airfoil tip of the blades.

Fig. 2. Un-failed blade, (a) pressure side, (b) suction side.

Moreover, the trailing/leading edges of the blades were observed grinded. According to user, as per OEM directions, the edges are grinded up to 1 mm for safer operation after some specified operating hours of the blades.

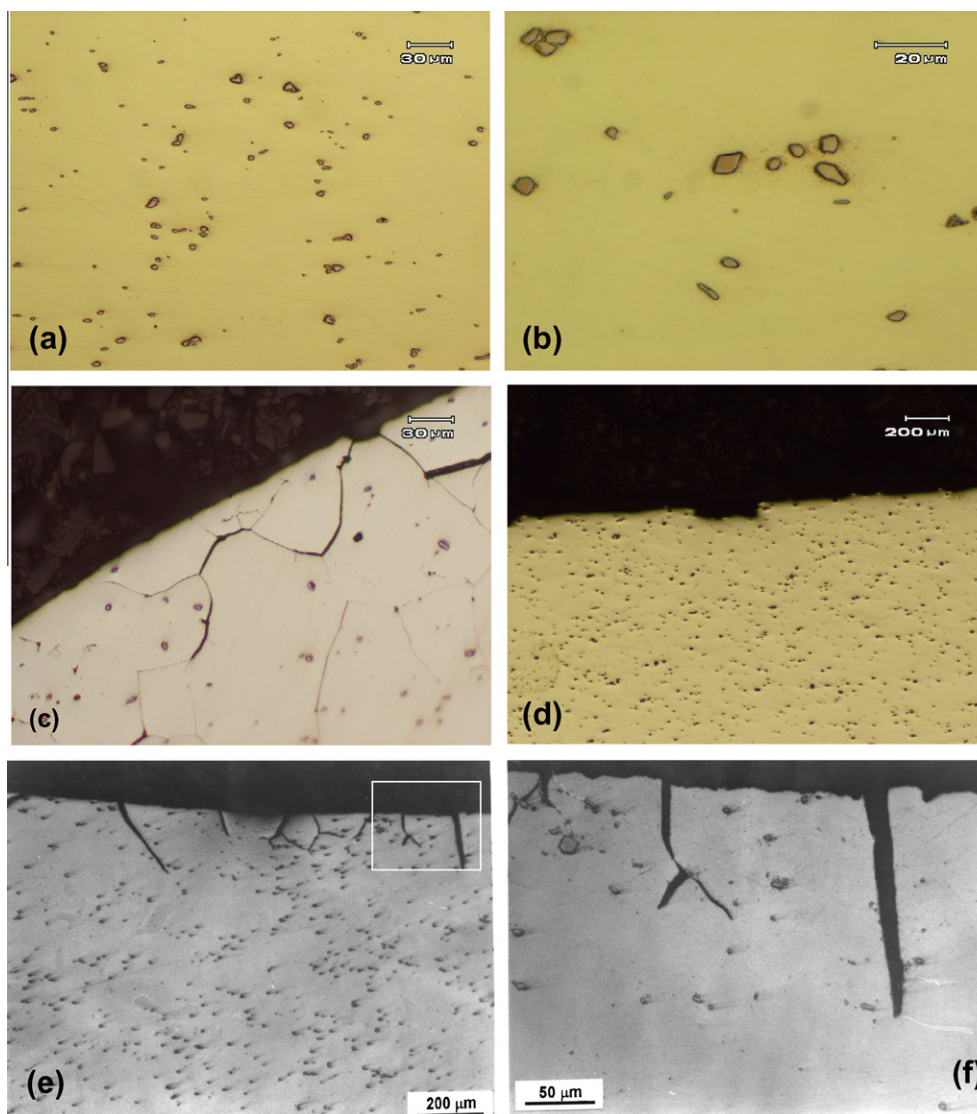
Sample of airfoils of failed and un-failed blades were prepared for metallography. In the polished condition carbides were observed, see Fig. 3a and b. Fig. 3c shows the optical micrograph of the region 'C' (as marked in Fig. 2) of un-failed blade. Intergranular cracking was observed in the surface grains. Such cracking was not present in the mid-airfoil region (region 'B' as marked in the Fig. 2), see Fig. 3d. Cracks were also observed in the region 'C' of the neighboring blades; see Fig. 3e and f. These cracks were seemed to be of mixed type i.e., Intergranular as well as transgranular. The grains at the cracks regions were seemed to be dislocated from their initial locations.

Fig. 3. Polished sample of failed blade, (a) revealing primary carbides, (b) same as (a) at high magnification, (c) cracks at the grain boundaries at region 'C' (see Fig. 2), (d) region 'B', (e and f) neighboring blade at region 'C'.

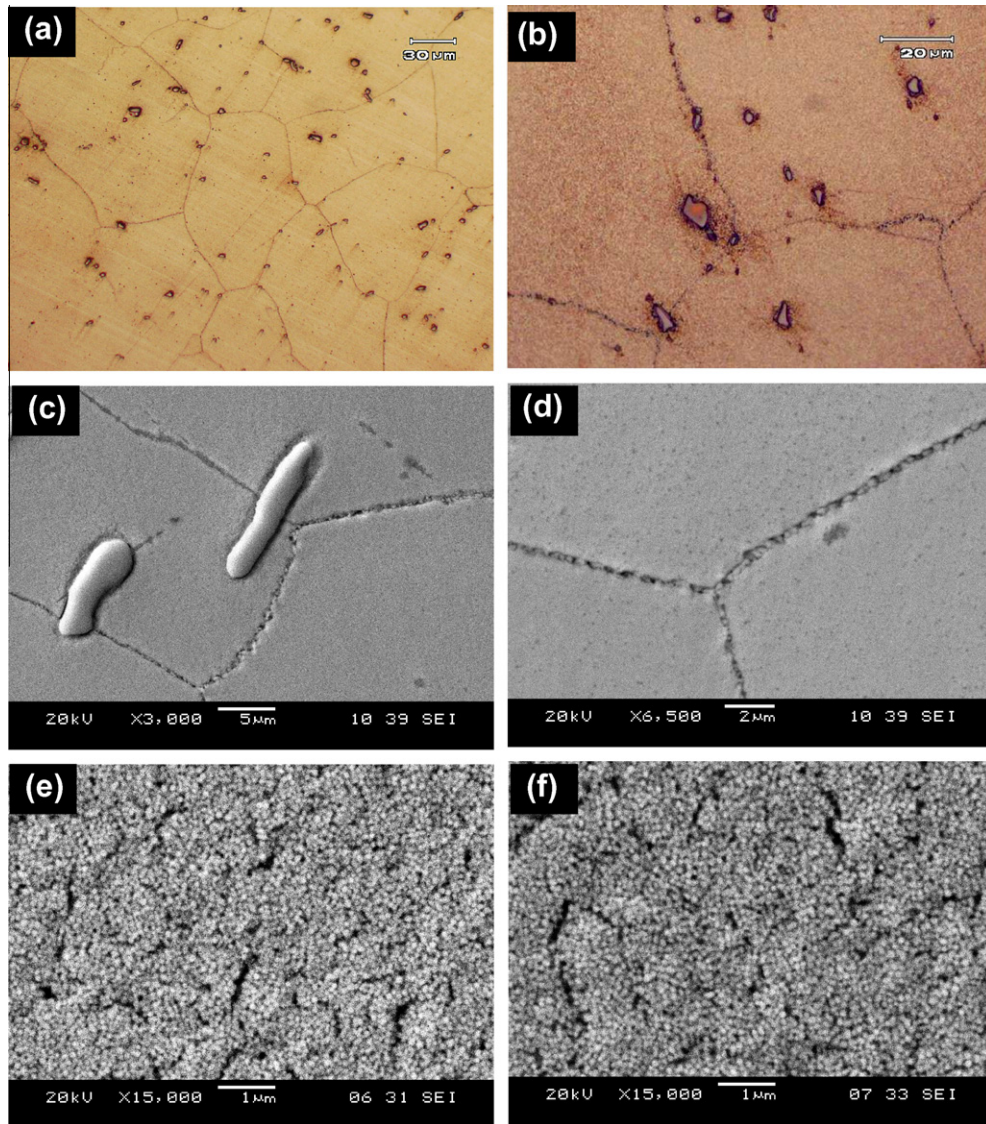
Samples were etched using Marbles reagent. Fig. 4a and b shows the general microstructure of the mid region of the un-failed adjacent blade revealing grain boundaries structure and primary carbides. Grain-boundary secondary carbides were also observed using scanning electron microscope, see Fig. 4c and d. At higher magnification gamma prime (γ') in the matrix was also revealed, see Fig. 4e. Similar microstructural features were observed in the failed and unused blade samples. The size of γ' was measured using an image analyzer; its diameter was 0.1 μm in the failed as well as unused blade, see Fig 4e and f.

The microstructure including the gamma prime size of the failed as well as adjacent un-failed blades was similar to that of unused blade. It shows that there was no basic microstructural degradation in the failed blade. However, at region 'C' of the airfoil of the un-failed blades as well as on the complement airfoil section of the failed blade wedge type triple point creep cracks were observed. These cracks were present up to $\sim 2\text{ mm}$ depth from the surface and were confined to trailing edge at region 'C'. Surface grains were also observed dropped probably due to these cracks. Fig. 11 shows the schematic of a blade and the gas flow. The region 'C' may be considered as a critical region of the airfoil of blade, as maximum stresses are applied there due to its cantilever state.

Fig. 4. (a and b) optical micrographs revealing the general microstructure, (c and d) high magnification revealing secondary carbides at the grain boundaries, (e) high magnification revealing the gamma prime, (f) gamma prime in the new blade sample.

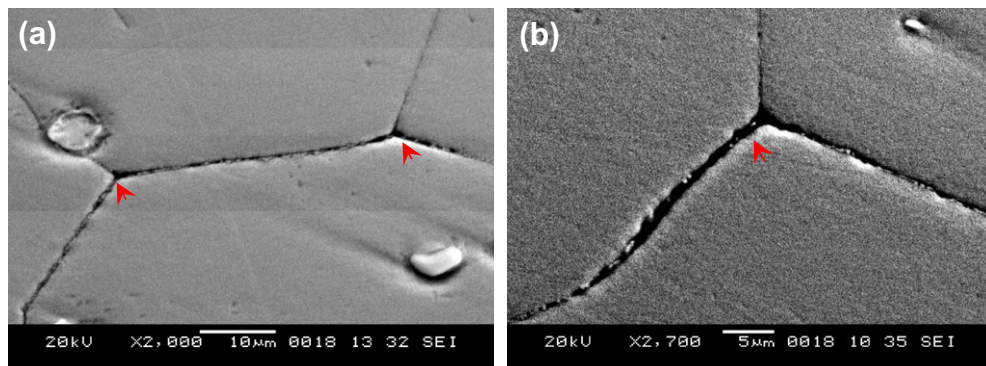
At region 'C' (as marked in the Fig. 2) triple point wedge type cracks were observed in the failed and un-failed neighboring blades; see Fig. 5a and b. They were present up to ~2 mm deep from the surface as observed after progressive grinding followed by polishing. Such cracks were not present at the middle and top region of the blade airfoil (marked as 'A' & 'B' in the Fig. 2).

Fig. 5. Triple point wedge type cracks near the root region of airfoil in, (a) failed blade, (b) adjacent unfailed blade.

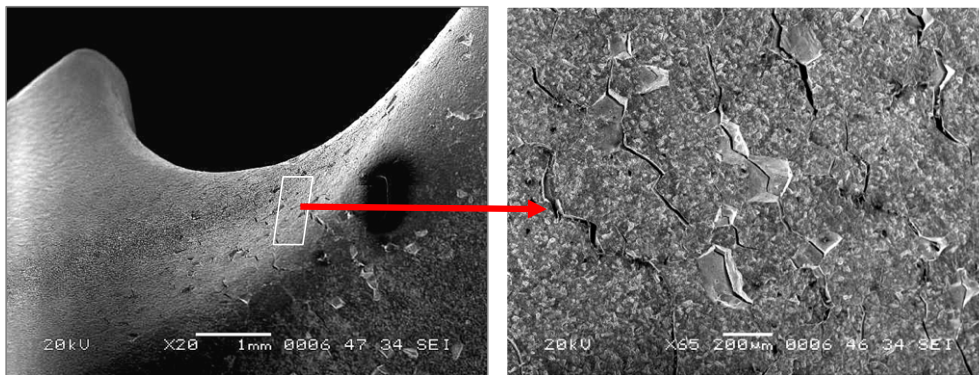
Surface of the unfailed blades were also observed using scanning electron microscope. At trailing edge of one of blade, opened wedge type cracks were observed at region 'C', see Fig. 6. Grains dropping were also evident at this location (Fig. 6).

Fig. 6. Opened cracks with dropped grains at the 'C' region of an unfailed blade.

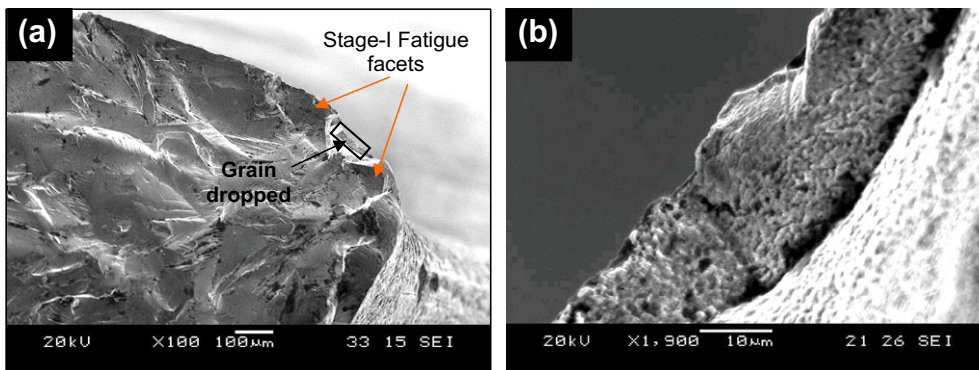
Fractured surface of the failed blade was examined using scanning electron microscope. Crack origin was located at the trailing edge next to the root section on the fractured surface as shown in Fig. 7a. This was the thinnest curve shape region of the airfoil; see Fig. 2a, region 'C'. Grain was found dropped/missed from the crack initiation region as shown in Fig. 7a. High concentration of oxygen was detected in EDS (energy dispersive spectroscopy) analysis on the surface of missed grain region, see Fig. 7b.

Fig. 7. Failed blade fractured surface revealing crack initiation from a dropped grain region as well as stage-I fatigue facets; (b) is the high magnification of boxed region in the (a).

On the fractured surface, crack started from the trailing edge next to the root region. A grain was found dropped from the crack initiation region. It shows that the primary crack was triple point creep crack as was also observed in the adjacent un-failed blades. On the fractured surface of the failed blade two flat regions was observed in the vicinity of dropped grain region. It would be the stage-I fatigue facets [8,9]. It often resembles cleavage, and do not exhibit fatigue striations. Next to the stage-I fatigue region, fatigue striations along with tear ridges were observed. The mode of fracture was transgranular, typical of stage-II fatigue [8,9]. It covered almost 50% of the fracture area on the failed fractured surface. When the crack had progressed to critical depth or size, the airfoil fractured in the overstress mode [8,9]. Triple point cracks were also present on other locations but depending upon service conditions, only one crack was favored to grow under fatigue.

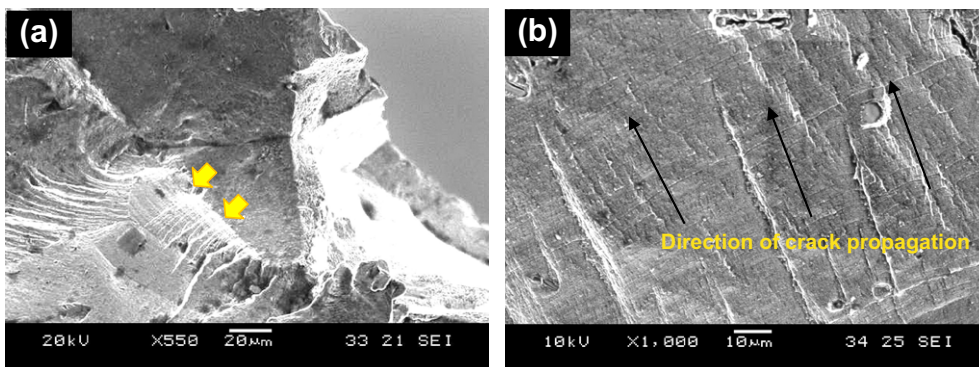
Two flat regions (facets) were observed in the vicinity of this missed grain. These facets could be developed during the stage-I of the fatigue crack propagation. Very next to this region striations were observed along with tear ridges as shown in Fig. 8a and b. This is the stage-II crack propagation under fatigue. This region (region-II of the fatigue) of the crack succession had covered almost 50% of the fracture surface area. Relatively coarse striations were observed near the end of the stage-II fatigue region as shown in Fig. 9a and b.

Fig. 8. Failed blade fractured surface showing start of stage-II fatigue, (a) fatigue striations (arrows) next to the stage-I fatigue along with tear ridges, (b) high magnification showing striations and tear ridges.

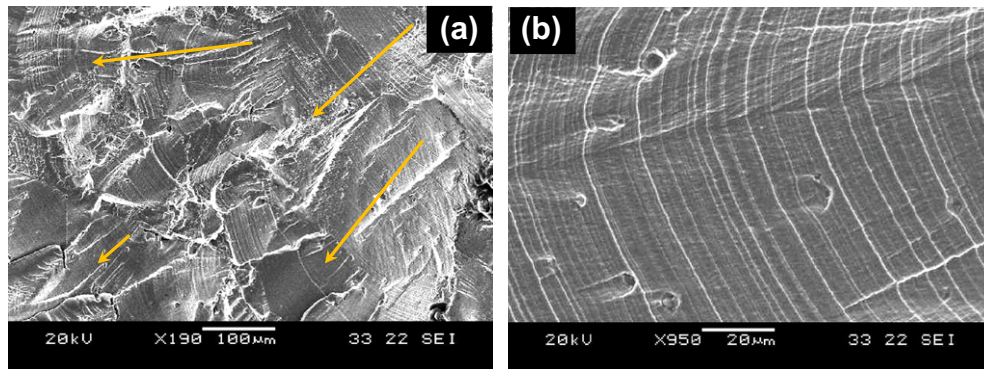
Fig. 9. Failed blade; fractured surface revealing coarse striations near overload region, (a) low magnification, (b) high magnification.

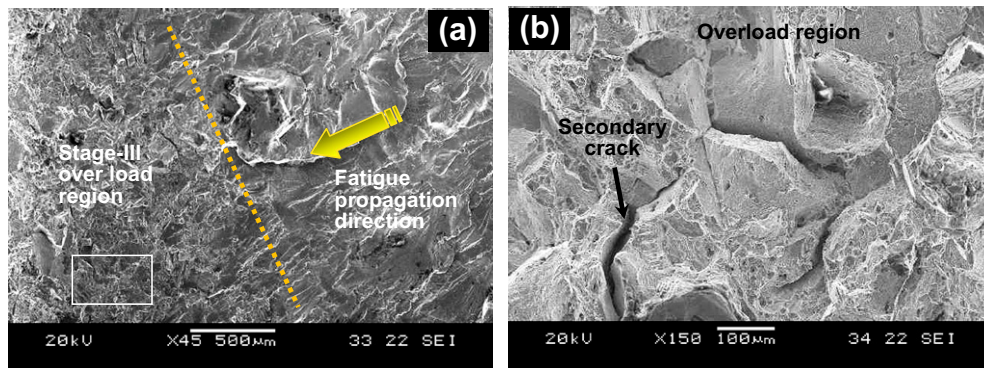
Fig. 10a shows the transition from stage-II crack propagation to stage-III. Dotted line in Fig. 10a separates the two regions. Stage-III is the final overstress area. The magnitude of the cyclic stress increases with the crack propagation in a stage-II mode. The overstress area shown in Fig. 10b is mixed type having intergranular and dimpled fracture surface.

Fig. 10. Failed blade; fracture surface showing, (a) transition between fatigue crack propagation and final overload area, (b) stage-III over load region (high magnification of boxed area in (a)).

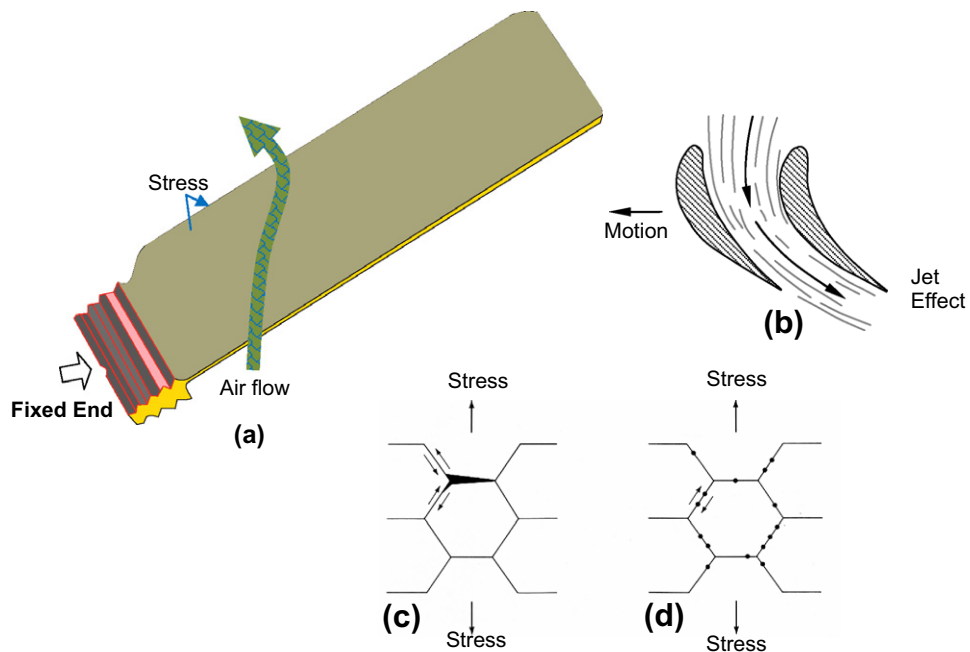
Intergranular creep usually occurs by either of the two fracture processes [3]; (1) triple point cracking, and (2) grain boundary cavitations. Fig. 11c and d shows how the triple point crack and grain boundary cavitations occur due to grain boundary sliding at high temperature under conditions of stress. The small arrows in figures show the grain boundary sliding direction. Further, the strain rate and temperature determine the dominating fracture mode. Relatively high strain rates and

Fig. 11. Schematic revealing, (a) blade pressure side, (b) movement of the gases and motion of the turbine, (c and d) triple point cracking and cavitation, respectively in intergranular creep; small arrows show the grain boundary sliding direction.
