Failure Analysis of an Automobile Coil Spring in High-Stress State

Abstract The present work details a study for the determination of causes of a prematurely failed automobile spring. Several tools consisting of visual observation, optical microscope, scanning electron microscope (SEM), energy-dispersive spectrometer (EDS) analysis, etc., were used on the failed product to investigate the underlying causes. Photographs of the failed spring showed large wear marks and machinery indentations on the surface. These wear marks indicated an improper installation which could cause additional stresses under service loads. SEM images of one of the indentations showed radiating ridges emanating from the indentation tip which indicated that it served as the fatigue initiation. EDS results showed foreign elements in the fatigue origin implying the existence of microcracks. Under the effect of service and additional load, a stress concentration point was formed and fatigue crack originated from the indentation tip resulting in the final rupture.

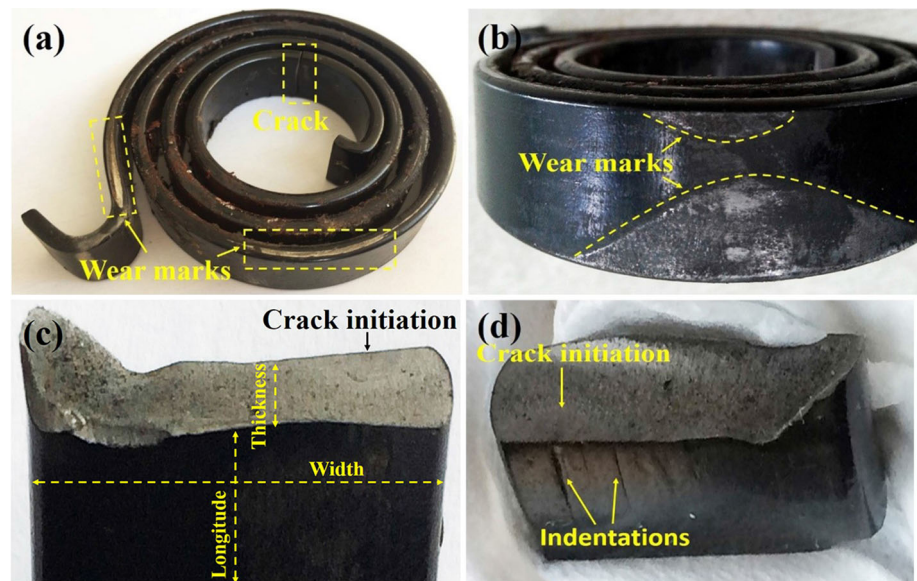
As shown in Fig. 1a and b, heavy wear marks could be identified on both horizontal and vertical external surfaces of the B48 coil spring. These two parts of marks are located on counterpositions which indicates that the spring was not installed properly and bore an additional stress to make its surface tore seriously. This installation deviation existed during the whole service time and therefore caused a high-stress concentration state.

As shown in Fig. 1c, the crack initiated from the outer side of the spring chip. The crack initiation region locates on one edge rather than the intermedium of the fracture surface. Generally, coil spring is failed by the mode of fatigue due to the alternating load. However, there is no obvious characteristic of fatigue fracture which implies it suffered a complex stress situation. A small semicircular region is observed on one end of the fracture surface that we regard as the fatigue crack initiation and propagation region. It is worth noting that the area of crack initiation region (the semicircle) is much smaller than that of the whole fracture plane. The area of the total fracture surface could be estimated as about 50 mm², but the crack initiation region only occupies 5 mm² of it, which indicates that this coil spring was under an extremely high level of stress while at service. A fractured morphology inclined at about 45° could

Fig. 1 (a) and (b) Photographs of the failed position and wear marks of the B48 coil spring; (c) and (d) Macro-morphology of the fractured surface

be clearly observed on the other end of the failure plane. This indicates that the crack propagated from the semi-circle along the width direction and shear cut the spring at the inclined region (final rupture region). This crack propagation mode is quite different from the similar coil spring failed under a fatigue rupture model. Figure 3b shows the macro-morphology of fracture surface of the similar type of coil spring that we have analyzed before. It could be observed that, under the service load, crack initiated from the center of one intersecting surface and propagated along the direction of thickness. Also, this fatigue fracture surface shows a large expansion region and clear fatigue arcs, which are typical fatigue fracture characteristics. As shown in Fig. 1d, several surface indentations are visible and one of them reaches exactly to the heart of the crack initiation region. These indentations could be produced during coiling process involuntarily. The exterior indentation is apparently one of the reasons that accelerate the formation of crack.

As shown in Fig. 1a, wear marks resulting from the improper installation could be observed on the top surface of this B48 coil spring. This is one of the primary sources of additional stresses. Two indentations could be observed at one lateral surface of the failed spring chip as marked in Fig. 1d. However, one of the indentations extended exactly to the center of the crack initiation region as mentioned above. Microcracks formed in the tip of the indentation and caused a stress concentration state. This indentation served as crack initiation point from which crack propagated ultimately reaching opposite edge of fracture surface and causing final failure [15]. Severe wear marks as shown in Fig. 1b could be observed on the lateral surface. This part of marks resulted from the improper installation which is

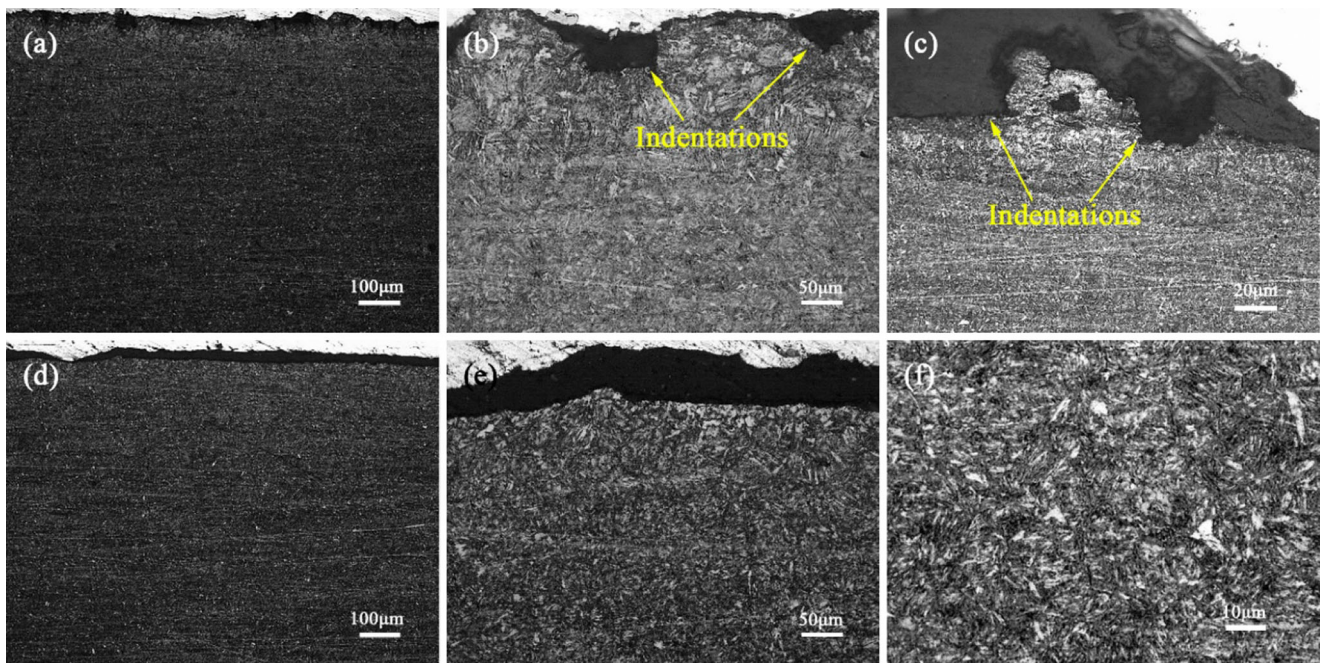
OM specimens were taken from both transversal and longitudinal directions and mounted to exhibit their surface characteristics. Figure 2 shows the OM images of prepared specimens after etching. It reveals that the matrix microstructures of the two directions are all tempered troostite and a small amount of tempered sorbite. This is in accord with standard microstructure after quenching and tempering of this material. Indentations could also be observed in Fig. 2b and c which were produced under manufacturing process.

Fig. 2 OM images of the near surface of transversal (a–c) and longitude (d) and (e) specimens. (f) The matrix microstructure in higher magnification

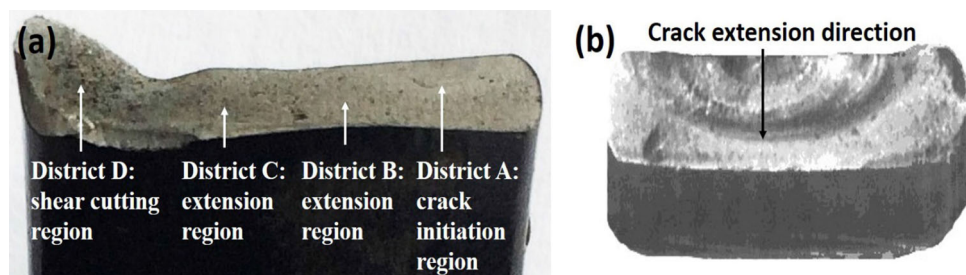
Fig. 3 (a) Illustration of districts on which SEM observations were conducted. (b) The common fracture surface morphology of B48 coil spring

According to common failure cases of B48 coil (Fig. 3b), under a normal alternating load, fatigue fracture mode is the major failure mechanism, and the crack initiated from the center of the rupture surface and then propagated along the direction of thickness. However, in this case, crack

initiated from one edge of the coil spring chip and propagated along the direction of width (Fig. 1c). As shown in Fig. 3a, the failure plane could be divided into different districts, and they are not on the same altitude which denotes additional stresses were loaded on the B48 spring while at service. Under a regular service load, the final fracture region “D” usually locates on the side with smaller radius of coil chip and is vertical to the longitude axis. Meanwhile, the final rupture region in this B48 coil spring is situated on one side of width direction which also indicates the existence of additional stress. The common failure cases we have analyzed before (Fig. 3b) show a large fatigue extension area and a much smaller final rupture region. The failure morphology of this case (as shown in Fig. 3a) exhibits a large area of final rupture region. This indicates the B48 coil spring analyzed in this work suffered a high service stress which could be estimated to 1000 MPa. The micromorphology of crack extension region near the initiation region (Fig. 5c and d) shows secondary cracks which indicates the existence of three-

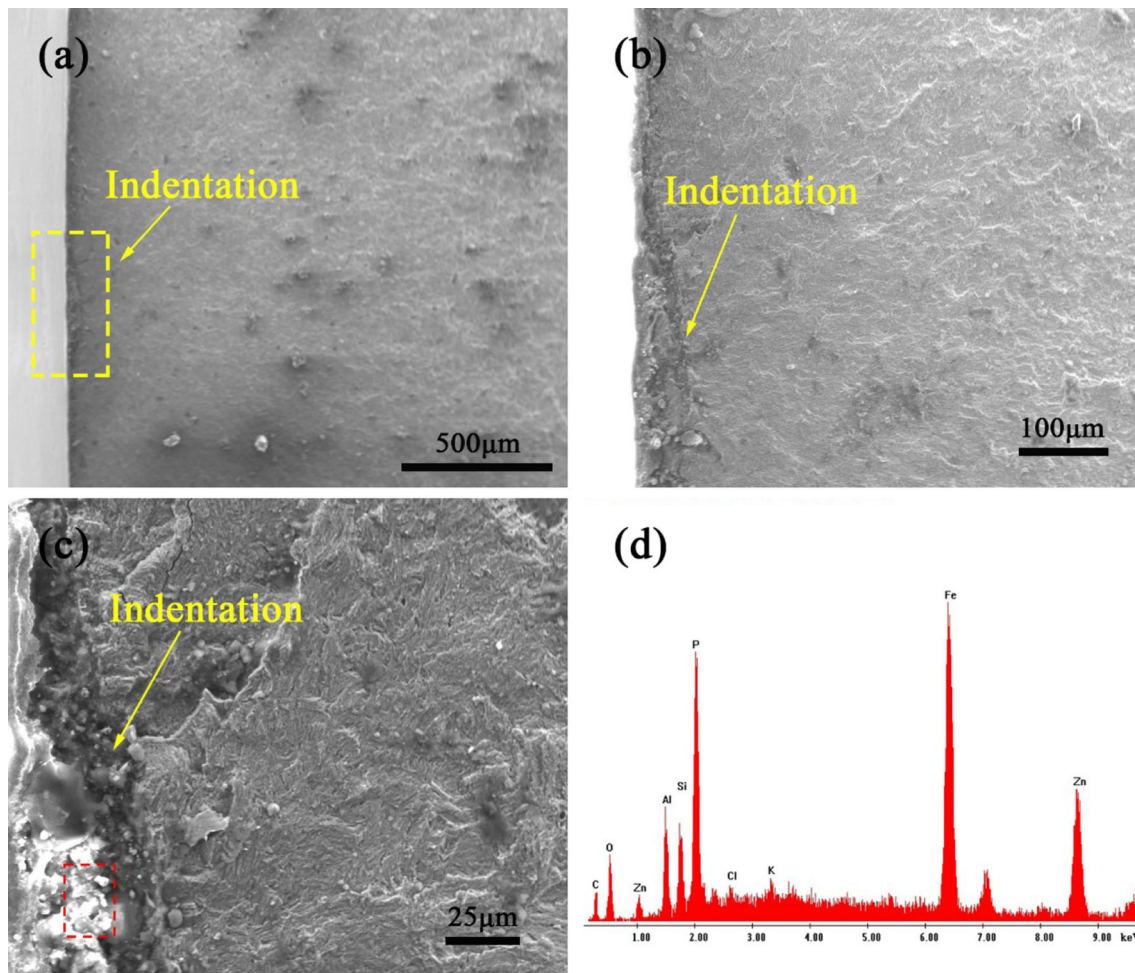
As shown in Fig. 3a, district “A” represents the crack initiation region (the semicircle), and Fig. 4 shows the SEM images of this region. One of the macro-indentations reaching to the center of the semicircle could also be observed in SEM micrographs (Fig. 4a). The higher-magnification micrograph (Fig. 4b) shows radiating ridges emanating from the indentation tip. This pattern is caused by crack initiation, thus indicating that the semicircle is the crack initiation and extension region. Figure 4c shows a globular microstructure which is abnormal in the crack initiation region. EDS analysis indicates the main chemical

composition is Fe, Zn, P, O, Si, C. The main chemical elements in paint are C, Si, Al, and the element of P may penetrate inside during the phosphating process. This abnormal phenomenon implies microcracks existed in the indentation region before installation.

Fig. 4 (a)–(c) SEM micrographs of district “A” of the fracture surface. (d) EDS results on the region marked in (c)

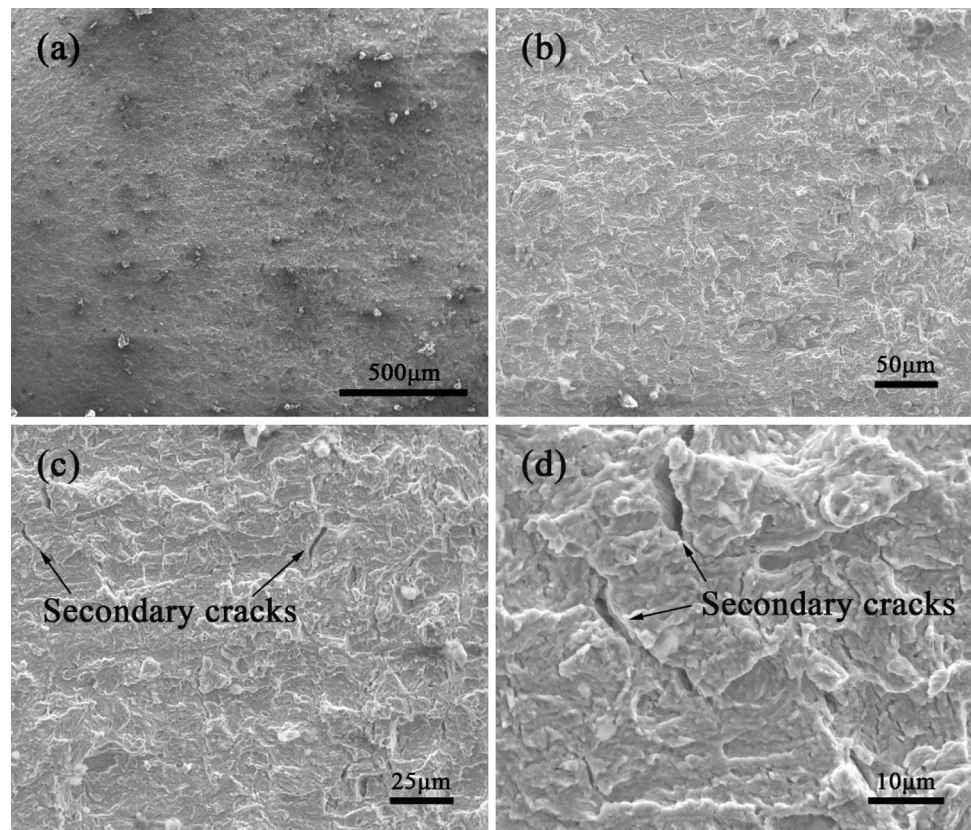
Figure 5 shows the SEM morphology of district “B”. District “B” is defined as crack extension region on which secondary cracks that are vertical to the fracture surface could be observed (Fig. 5c and d). A brittle fracture morphology was revealed in this extension region which indicated cracks propagated under a high stress level. Due to the combined effect of indentation, improper installation, and service load, this region was under a triaxial stress status making this material more brittle.

Fig. 5 SEM micrographs of district “B” of the fracture surface

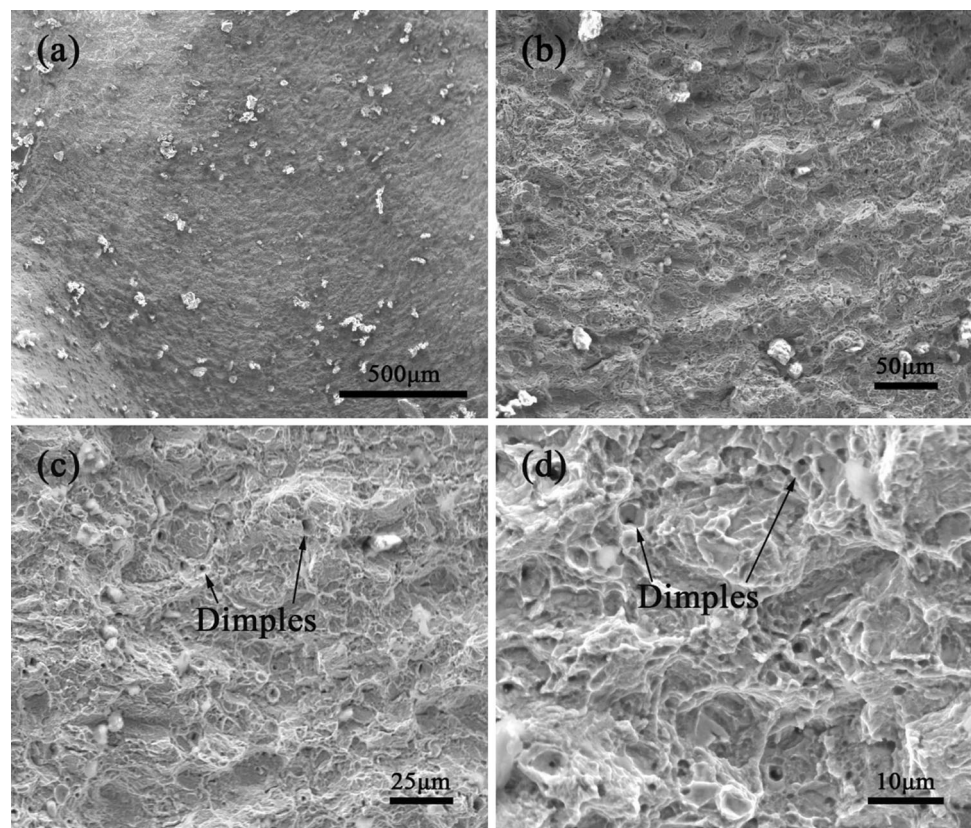
District “C” is also defined as a crack extension region which exhibits a much different micromorphology from district “B”. Fatigue striations and dimples could be observed in Fig. 6a and b which are chief characters of fatigue fracture [14]. This indicates that part of the coil was failed by the fatigue fracture mechanism. The final shearing district “D” (Fig. 7) also shows fatigue striations and a ductile rupture mode.

Fig. 6 SEM micrographs of district “C” of the fracture surface

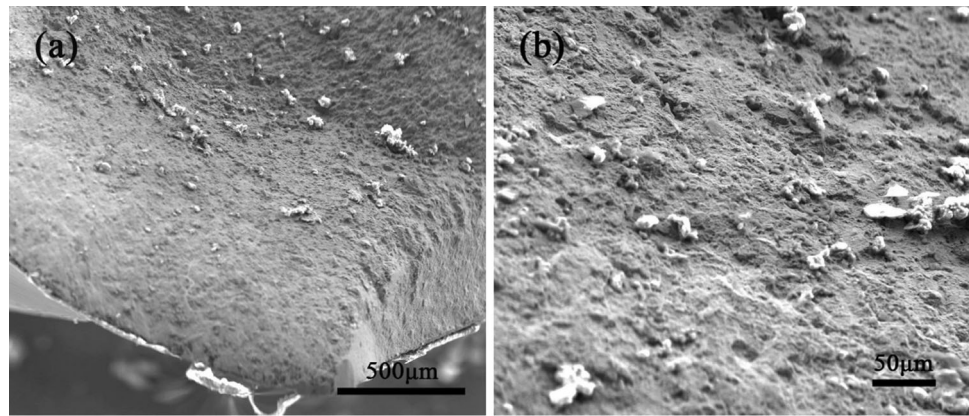
Fig. 7 SEM micrographs of district “D” of the fracture surface
