Failure analysis of gas turbine first stage blade made of nickel-based superalloy

Research & Development, Department of MavadKaran Engineering Company, Mapna Group, Tehran, Iran

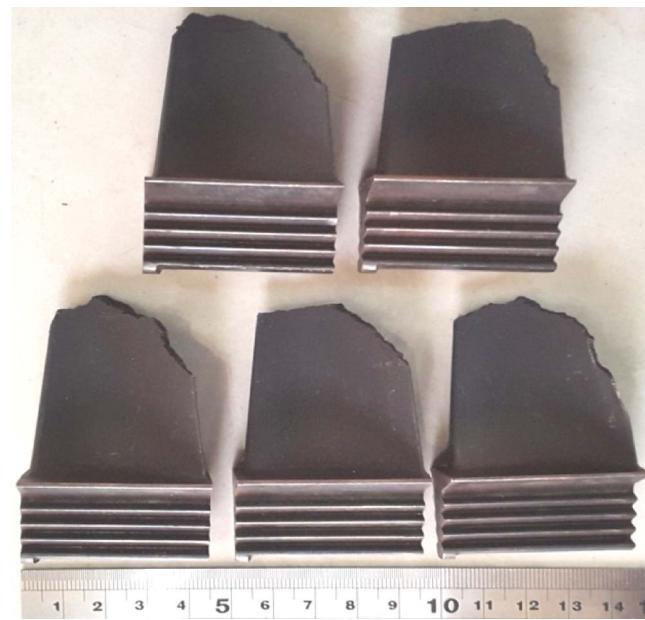
Fig. 3. Damaged rotor blades of first-stage turbine blades after 6500 h of operation at about 750–800 °C a 6.5 MW gas turbine.

In this paper, the damaged first-stage turbine blades (IN738LC) were used to investigate after 6500 h of operation at about 750–800 °C in a 6.5 MW gas turbine. [Fig. 3](#) shows the damaged turbine blades. The blades are designed without cooling channels and coating. The visual inspections of blades indicate that the damage pattern for each blade was observed to be reasonably consistent in all blades, the blade tip portions having fractured from the main airfoil body ([Fig. 3](#)). The surface colour change in this area proves that the oxidation occurred.

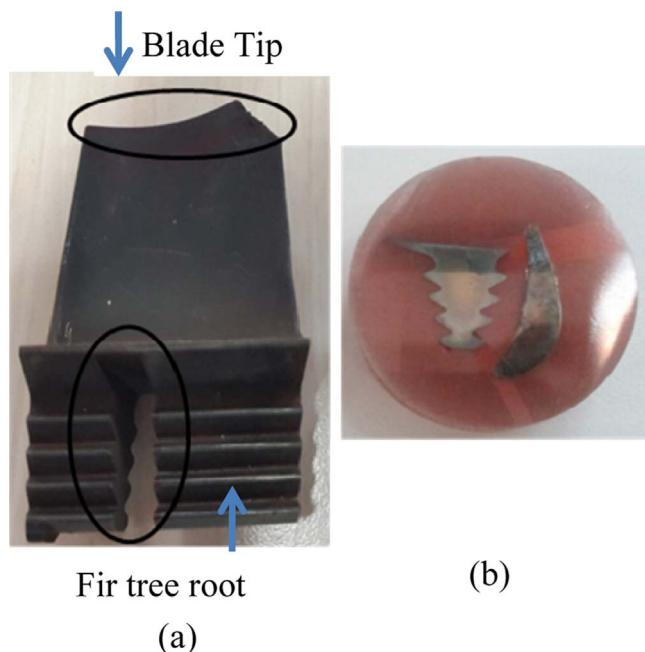
Fig. 4. Prepared Metallography samples of rotor blades of first-stage turbine blades after 6500 h of operation (a) location of prepared samples (b) mounted samples.

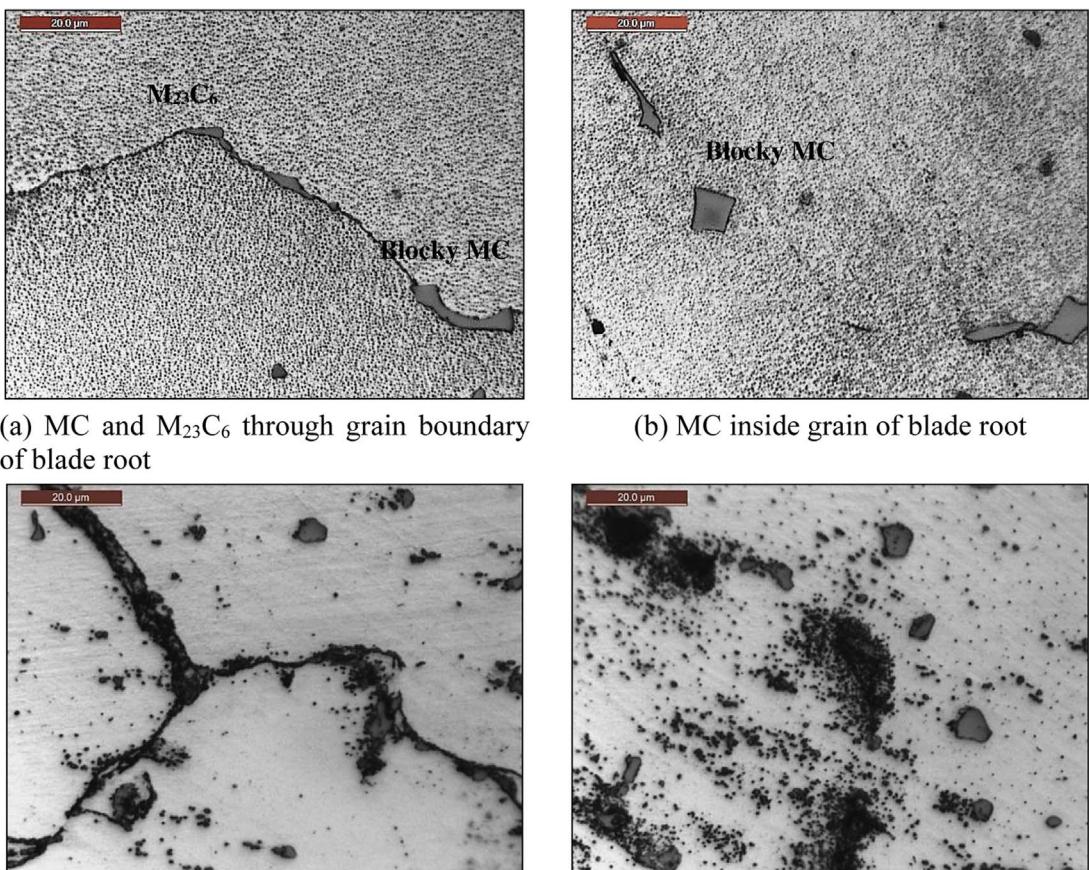
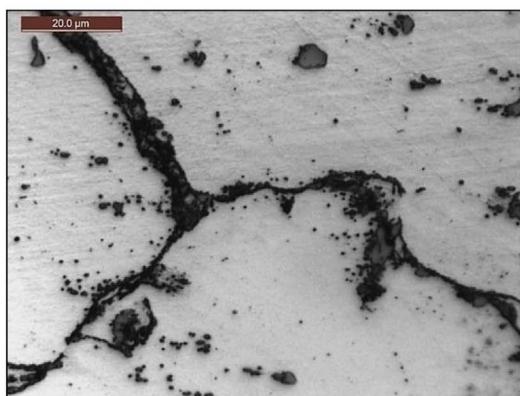
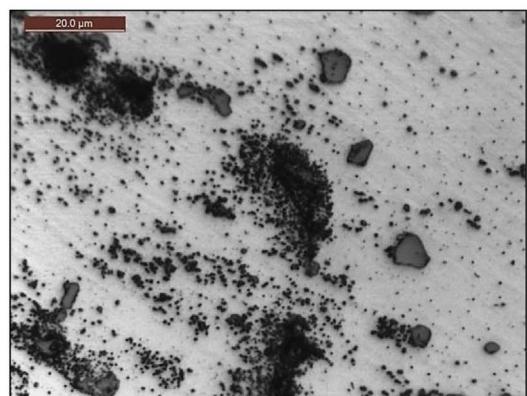
(a) MC and $M_{23}C_6$ through grain boundary of blade root

(b) MC inside grain of blade root

(c) $M_{23}C_6$ through grain boundary of blade airfoil

(d) fine MC in grain of blade airfoil

Fig. 5. The optical image of microstructure of blade (a and b) root and (c and d) airfoil including MC in grain and $M_{23}C_6$ through grain boundary.

Different distributions of carbides are detected in the airfoil of blades, Fig. 5(c and d) are compared to Fig. 5(a and b) blade root. Most M₂₃C₆ carbides are seen as discontinuous in grain boundary of root while in airfoil microstructure, the flaky shape of M₂₃C₆ is seen in grain boundary and inside the grains. According to Eq. (1), M₂₃C₆ may result of the MC type carbide decomposition under service. However, some MC carbides remained after service. In Fig. 5(a and b), γ' is observed, small grey points in root but in Fig. 5(c and d) taken in the same scale, no γ' is detected in the airfoil indicating the size of the γ' should be smaller than that of in root. This condition is a result of proposed γ' solution and reprecipitation in airfoil area.

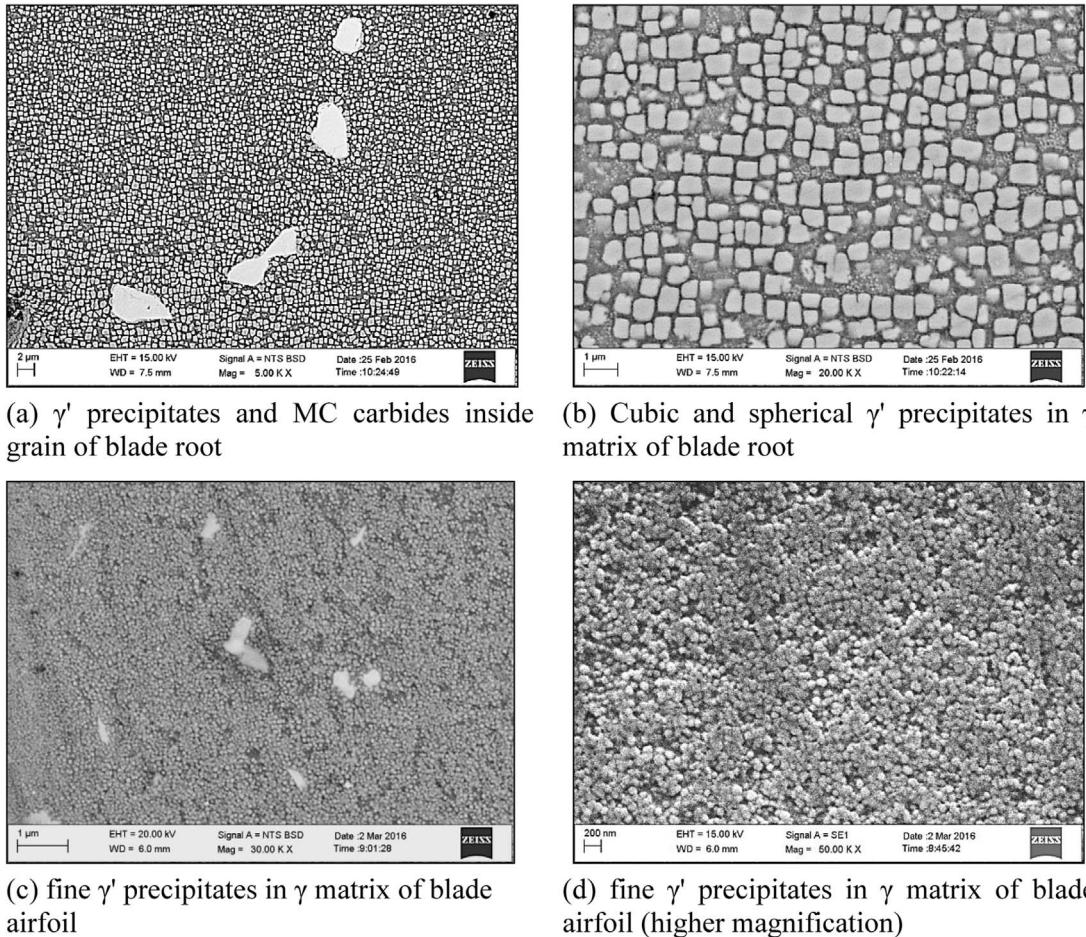
Fig. 6. SEM images of microstructure of blade (a and b) root including cubic, spherical γ' precipitates and MC carbides in grain of γ matrix and MC carbides inside grain of blade root (c and d) airfoil including very fine spherical γ' precipitates in γ matrix.

SEM images are shown in Fig. 6(a-d). Comparison between blade root (Fig. 6(a and b)) and airfoil (Fig. 6(c and d)) microstructures confirm the optical microscopy observations that is there is a significant difference between γ' size; very fine γ' in

blade airfoil. As the blade has just worked 6500 h of operation (expected failure time: 20,000 h), this microstructure is unexpected. The service condition of airfoil (750–800 °C/80 MPa) leads to the occurred creep in this region while stress and temperature are respectively higher and lower in blade root. In airfoil, the primary γ' should be coarsened, moreover the gradual decomposition of MC carbides in matrix and the continuous carbides in grain boundaries should be appeared. But these changes are not observed in airfoil, Fig. 6(c and d). γ' size is measured to be about 50 nm which is extremely smaller than size of γ' in blade root, 500 nm.

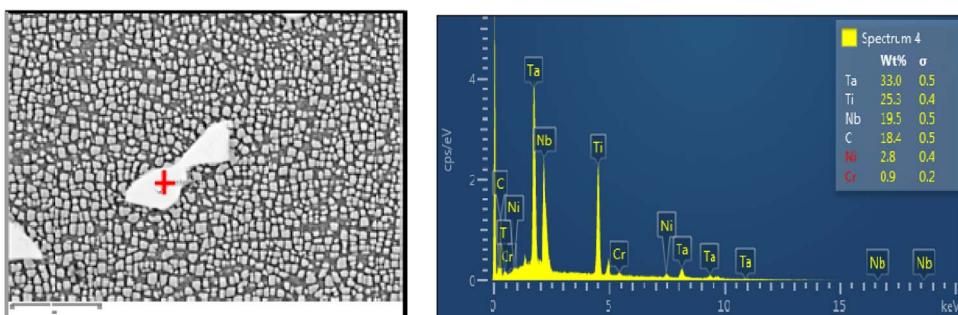
Fig. 7. EDX results of MC in blade after 6500 h of operation.

The chemical composition of carbides (marked by +) is characterized with EDX. Fig. 7 shows the elements: Ti, Ta and Nb in carbide. Therefore, the type of carbide is determined as MC [8,9].

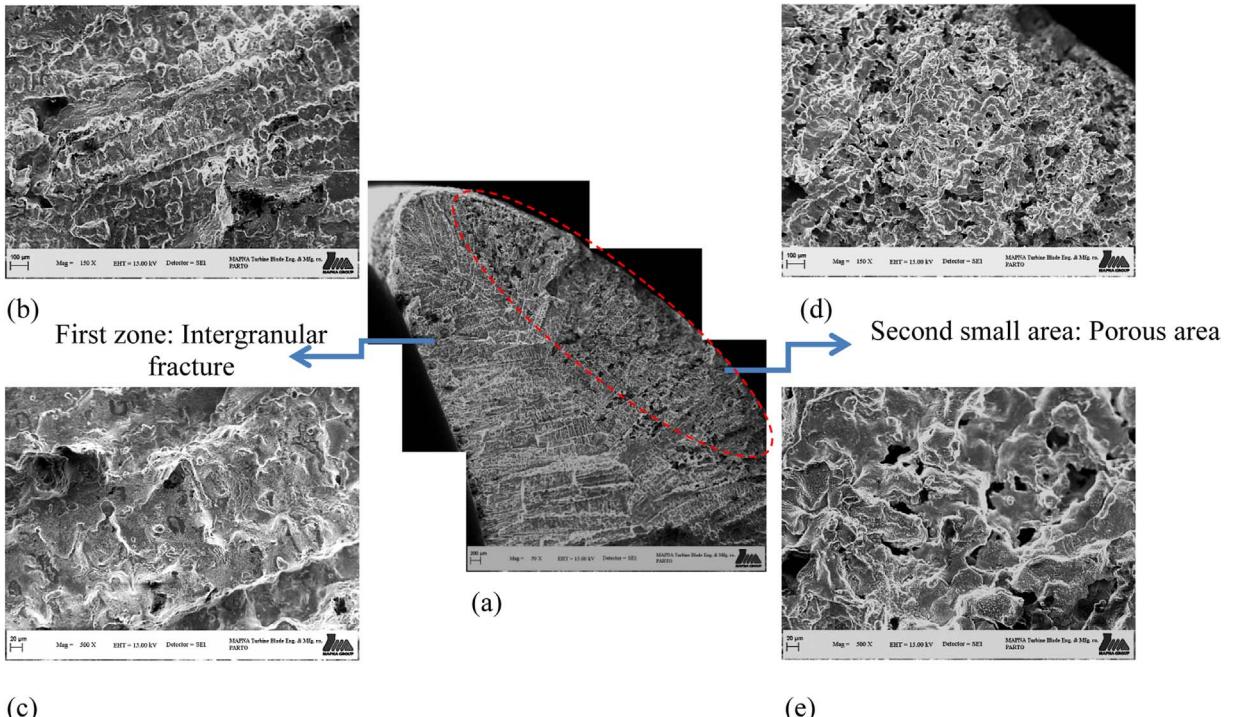
Fig. 8. Secondary electron images illustrating the fracture surface of the blade tip, mostly occurred by Intergranular fracture (a) fracture surface of blade tip; (b and c) dendritic area (Intergranular failure mode); (d and e) porous area (local melting).

obvious evidence of fatigue (fatigue striation) or any other such form of progressive failure mechanism (Fig. 8(a–e)). The fracture surface shows two zones: the first zone shows intergranular fracture (interdendritic area), typically final stage failure, the dendrites which grew from edges of blade into center. The second small area shows local melting occurred and re-solidified as sponge texture. The small porous area seen in the leading edge is evidence of overheating of gas turbine (marked by red dashed line).

The analysis of the blade airfoil, root microstructure and fractography results shows that the hot section temperature of gas turbine increased for unknown amount of time (overheating). The blades were confronted to higher temperature compared to service temperature (750 °C). The size and distribution of γ' in the airfoil (Fig. 6(c and d)) show that these precipitates dissolved in the matrix and re-deposited during shut down of the turbine. Therefore, the temperature should be around solution temperature of γ' , nearby 1160 °C. Furthermore, the optical images of airfoil (Fig. 5(d)) shows the decomposition of MC to $M_{23}C_6$ and remained some MC. Also the temperature should be less than the melting temperature of MC (1250 °C the temperature of partial solution or the initial melting temperature). Moreover, the local melting area in airfoil, confirms this assumption. The temperature of overheating should be above 1000 °C.

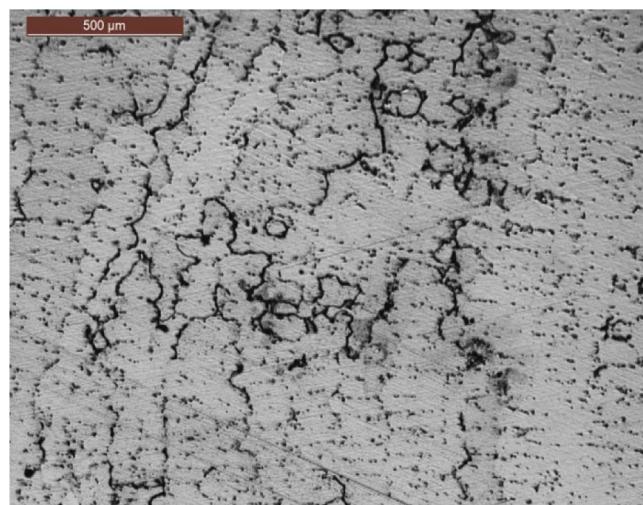
Fig. 9. Optical image of area close to fracture area including discontinuous cracks in grain boundary.

This conjecture is supported by observations made using optical microscope of area located close to the failure region. Fig. 9 shows many cracks nucleated in the interdendritic area and grew along the grain boundaries (intergranular fracture).
