## Stress corrosion cracking in Type.316 plates of a heat exchanger

S.H. Khodamorad<sup>a,\*</sup>, N. Alinezhad<sup>a</sup>, D. Haghshenas Fatmehsari<sup>b</sup>, K. Ghahtan<sup>a</sup><sup>a</sup> Inspection Department of Jam Petrochemical Complex, Asalouyeh, Iran<sup>b</sup> Amirkabir University of Technology, Department of Mining and Metallurgical Engineering, Tehran, Iran

In Jam petrochemical complex (JPC), Iran, the plates (ASTM A.240 Type.316) of some heat exchangers have been damaged due to the occurrence of cracks at the sitting place of gaskets. A comprehensive failure analysis including the chemical analysis, visual inspection, optical microscopy and scanning electron microscopy (SEM) of the cracks spread over the plates together with the energy dispersive X-ray spectroscopy (EDS) of the corrosion products and the measurement of chloride and sulfide ions content of the process water were employed for the examination of the failure mode and its causes. The obtained results indicate the building-up of the chloride and sulfide ions at the crevices between plates and gaskets at high temperature leads to stress cracking corrosion (SCC) of the plates. Moreover, the simultane

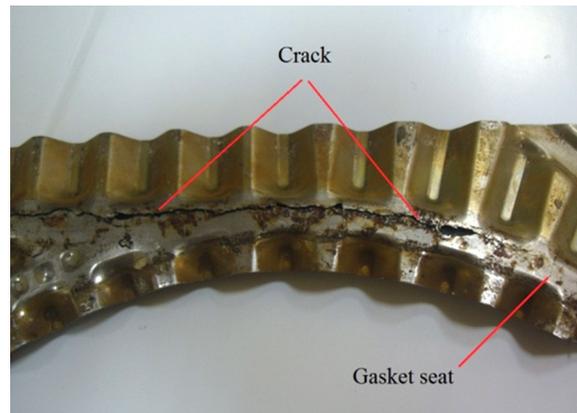
The majority of the cracks have appeared in the upper gasket seat and also some cracks have been observed under two sideward gasket seats of the PHE. In addition, the around of these cracks has been covered with a rusty layer as shown in Fig. 2.

Fig. 2. Appearance of a crack on the gasket seat of heat exchanger plates.

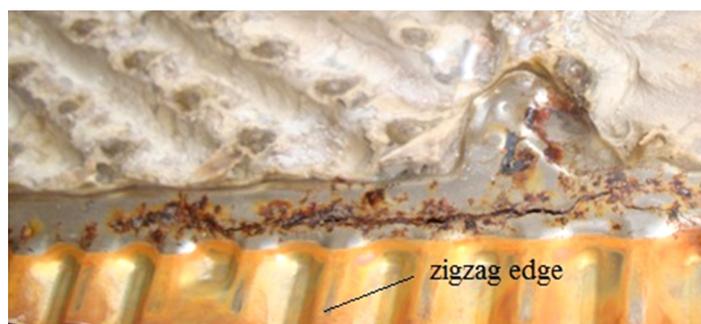
Generally the visual inspection by naked eye is the first step to roughly estimate the type and cause of failures. As it can be observed in Fig. 3, the branched cracks alongside the gasket seat grooves of plates are present and also, some corrosion pits are visible around these grooves. These pits can act as the start points for the propagating of cracks over the plates when the mechanical stress is present in the system [7]. Although the border areas of plates are not in contact with the cooling or transport water, there are many crevices between them which are subjected to the pitting by crevice corrosion. Fig. 4 shows such pits on the border areas of the plates.

In addition of the pitting corrosion, the presence of a brownish layer on the gasket seat grooves is an indicative for the corrosion occurrence. However, there is no significant sign of pitting in the interior/central parts of the plates despite the fact that these parts contribute in the cooling process and the water flows across them.

Fig. 3. Presence of cracks and pits on gasket sitting groove.

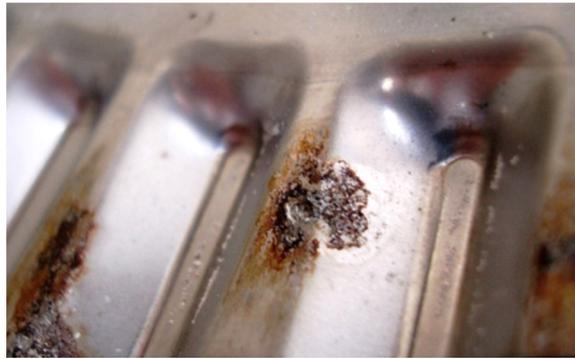
Fig. 4. Pitting corrosion on border area of failed heat exchanger plates.

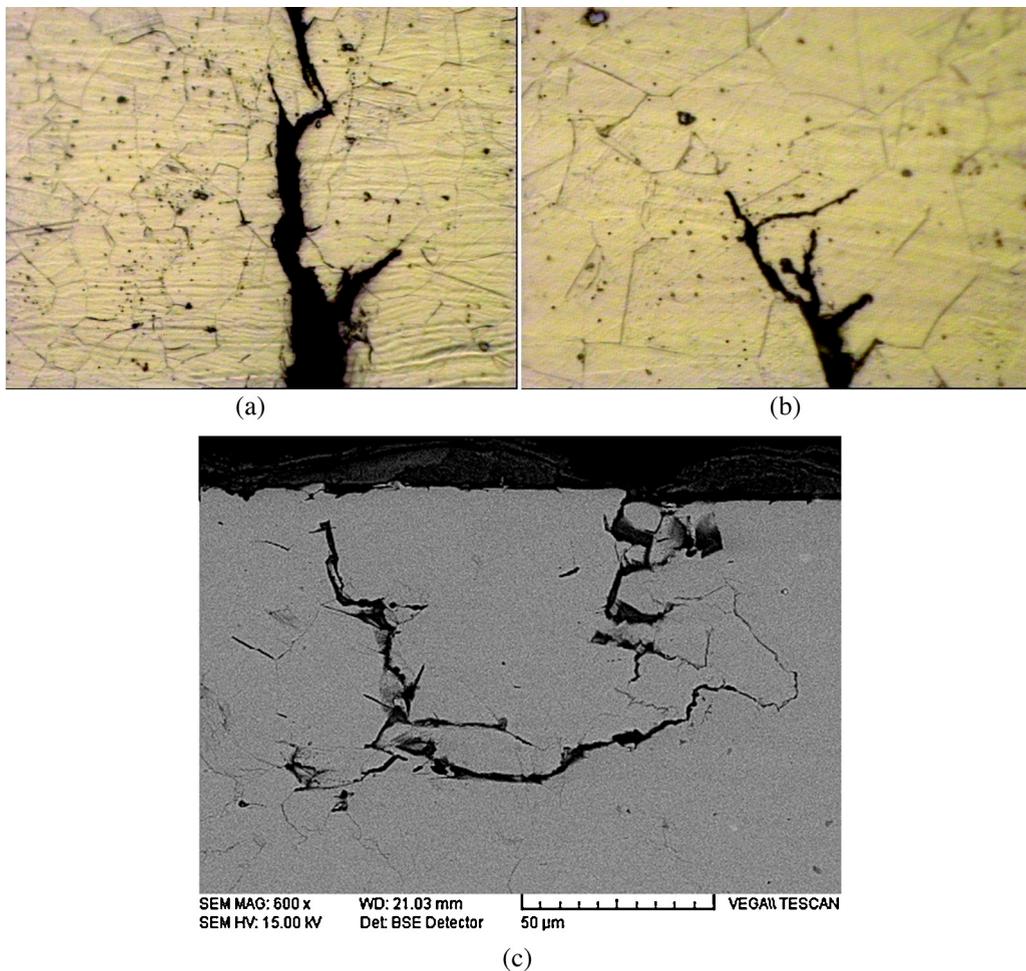
Regarding the microstructure of Sample 1 presented in Fig. 5(a) and (b), the structure includes the austenitic matrix with some intergranular and transgranular cracks. According to SEM image shown in Fig. 5(c), these cracks are relatively sharp and straight passing through the boundaries and austenitic grains. The branched cracks are typical signs of SCC [6–8].

Fig. 5. (a) and (b): Microstructure and (c) SEM of Sample 1.

Intergranular SCC also commonly indicates the contribution of corrosion process in the cracking of plates [9] and on the other hand, the appearance of transgranular SCC in the microstructure of the plates confirms the high mechanical stress conditions [10]. Garcia et al. reported that transgranular SCC susceptibility decreases at lower level of cold stress but the intergranular SCC susceptibility increases [10]. The superimposing of residual stresses leads to the cold forming of the plates and on the other hand, the stresses resulted from temperature/pressure fluctuations as well as the repair and maintenance stresses are the main sources of SCC. The small black dots observed in Fig. 5(a) and (b) are assigned to the micro-pits distributed in the microstructure.

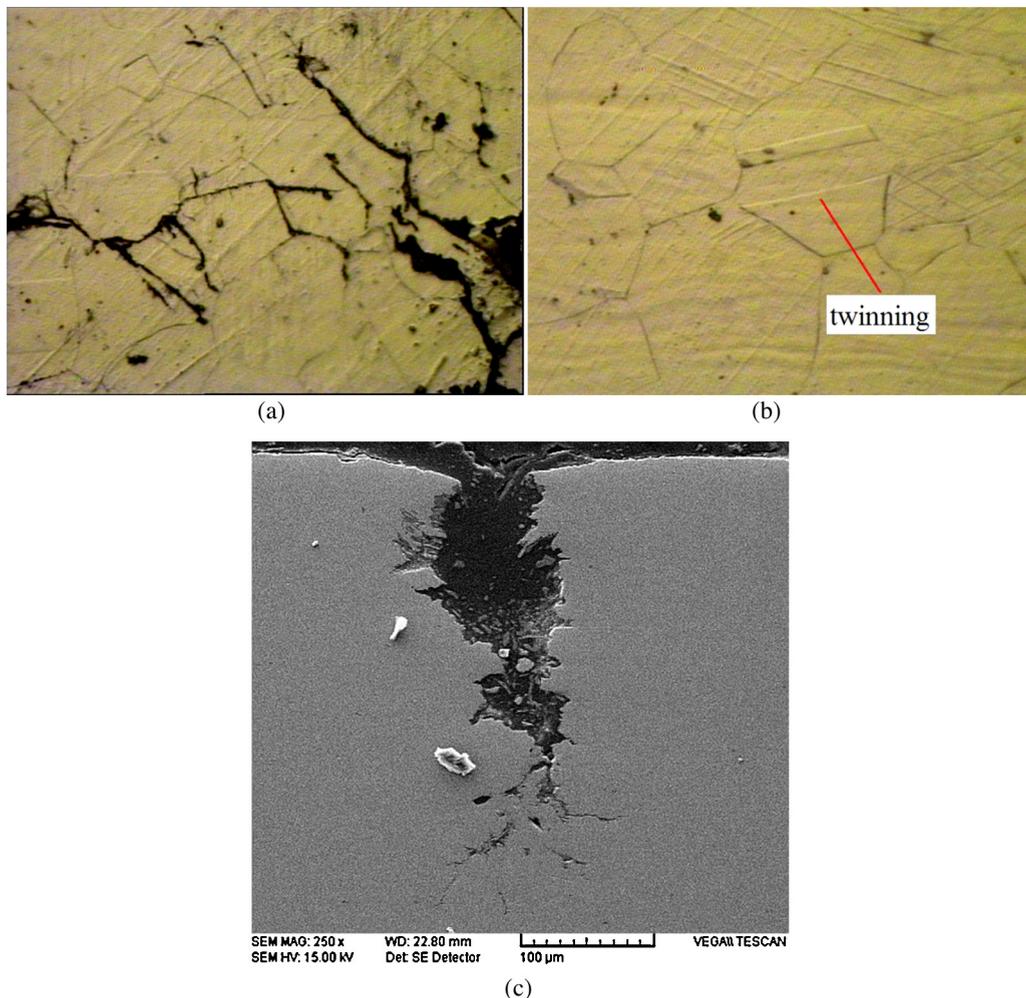
Based on the microstructure of Sample 2 shown in Fig. 6(a), the structure includes the austenitic matrix with some intergranular and transgranular cracks similar to Sample 1. Fig. 6(b) implies the presence of some twinning in the microstructure of sample. As a matter of knowledge, the twinning phenomenon requires high level of stress which can be accounted as a sign for high residual and/or applied stress in the microstructure of plates due to the plastic deformation [11]. The SEM image of Sample 2 (Fig. 6(c)) shows the growth of cracks in several directions in the tip of a primary crack. These micro-cracks are additional supportive evidences for SCC.

Fig. 6. (a) and (b): Microstructure and (c) SEM of Sample 2.

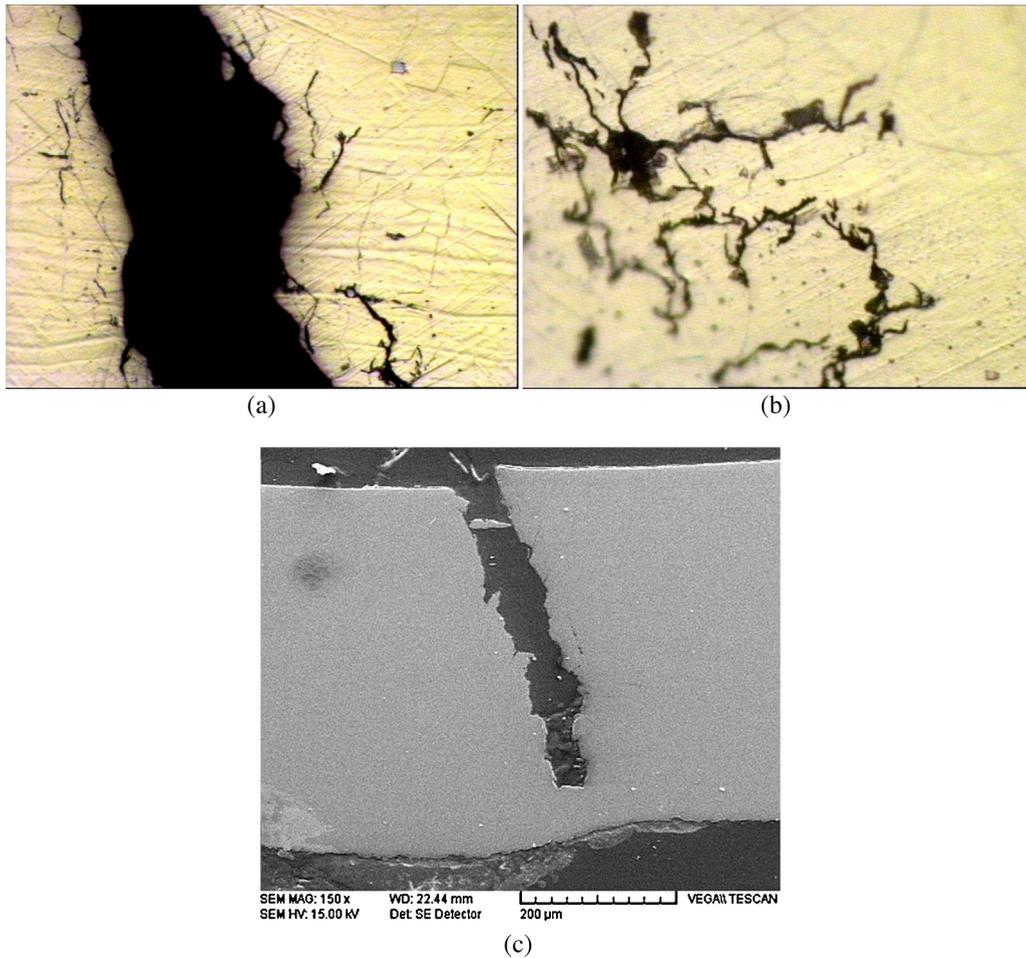
As can be seen in Fig. 7(a) and (b), the microstructural features of Sample 3 is similar to Samples 1 and 2. There is a micro-pit as a start point for SCC (Fig. 7(b)). Also, the tip of crack contains some corrosion products according to the SEM image (Fig. 7(c)). This indicates that the corrosion plays an important role in the failure of plates and the formations of cracks stems from the simultaneous occurrence of corrosion and mechanical stress.

Fig. 7. (a) and (b): Microstructure and (c) SEM of Sample 3.

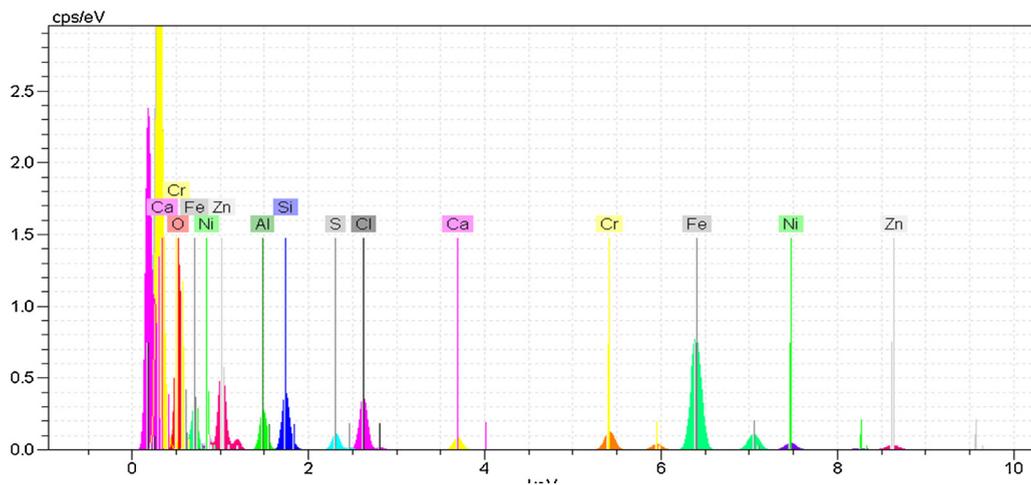
Energy dispersive X-ray spectroscopy (EDS) of the brownish (rusty) layer formed around and in the cracks is shown in Fig. 8. According to EDS spectrum, the brownish (rusty) layer contains Fe, Cr, O as well as S and Cl. Fig. 8 shows the EDS

Fig. 8. EDS analysis of corrosion products in Sample 1.

analysis of Sample 1. The presence of Fe, Cr and O can be attributed to the corrosion products of S.S 316 [11]. The presence of chloride in the EDS spectrum also confirms the contribution of  $\text{Cl}^-$  in pitting corrosion of the protective layer of 316 stainless steel plates. It can be concluded that the formation of the pits and the presence of stress can lead to Cl-SCC failure of plates. Also, sulfide ion can significantly accelerate the SCC failure of the plate [6].

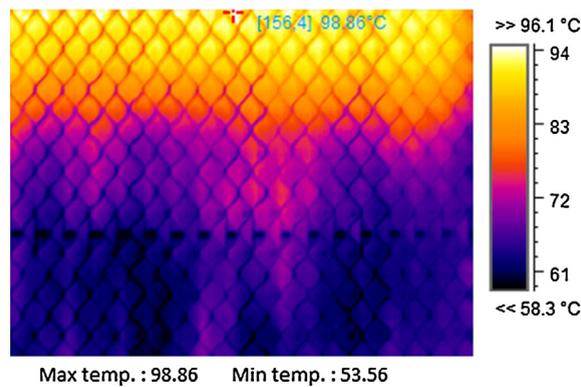
Fig. 9. Temperature profile of TW inlet.

Temperature analysis was conducted via infrared camera for the evaluation of the temperature profile of several areas of PHE. According to thermo-scan result illustrated in Fig. 9, the maximum temperature of the exchanger is around 99 °C in the top of PHE that belongs to TW inlet of exchanger. The value of temperature is higher than the design temperature of heat exchanger. The history of equipment revealed that in a period of operation around one year ago, the temperature of TW increases due to some process changes. During this period, the water that called service water (SW) was poured over the PHE to increase the cooling rate and reduce the TW outlet temperature. Moreover, as it can be seen in Fig. 3, there is a brownish layer over the zigzag edge of plates which imply the presence of suspended soil in the service water.

Since the appearance of the cracks in the heat exchangers occurs after cooling the TW outlet by the service water (SW), the use of higher number of the plates in the heat exchangers together with the higher flow rate of cooling water is strongly recommended; in this way, at a constant flow rate of transport water, not only the temperature of transport water is decreased but also the SCC cracks resulted from the direct contact of the service water (which usually contains some levels of  $\text{Cl}^-$ ) can be effectively avoided.
