A Case Study on Fatigue Failure of a Transmission Gearbox Input Shaft

M. Haghshenas · W. Savich

Abstract In this paper, a root cause analysis of premature failure of a gearbox input shaft, manufactured of AISI 1045-H, was performed through standard procedures for failure analysis. Shaft failed on cross oil hole through a helical fracture and therefore did not meet bogie 100,000 cycles during the verification with 10 Hz frequency cyclic testing. The fracture in the oil hole implied evidence of fatigue (i.e., beach marks on the fracture surface were clearly visible). Prior to improving the fatigue life and suggesting required remedial actions, mechanism of failure has to be understood, especially the initiating point of cracking. To this end, chemical analysis, microstructural characterization, fractography, hardness measurements, and finite element simulation were used to assess the nature of fracture in detail. The fractography analysis showed that fatigue beach marks originate from transition zone of the case on the cross oil hole. This is possibly due to the fact that torsional strength in this area is lower than torsional fatigue strength which leads to fatigue crack initiatio

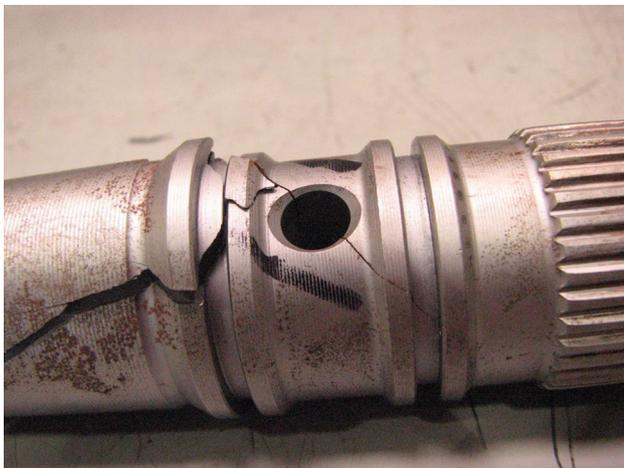
frequency of 10 Hz and angular displacement dynamic of $90^\circ (+/-45^\circ)$. Table 1 provides the fatigue tests that were performed on five input shafts. As shown in the table, one of the shafts passed slightly beyond 100,000 cycles and the rest failed in less number of cycles. The failure mode on all tested shafts was recorded as helical fracture through oil hole (Fig. 2). The fracture of the shaft shows that the crack originated at the position of key slot and evolved gradually, and finally, it led to a fracture and an edge-form 45° helical manners crack in the shaft. It also can be seen that the crack near the key slot is in a typical tooth form which is the typical characteristic of a torsional fatigue fracture. This shows that the fracture may be caused by the cyclic torsion moment in which the shaft is subjected to. Therefore, to measure the moment loaded on the shaft is necessary to verify the existence of cyclic load. Based on the test and measurement, the stress and strength then can be analyzed to assess the causes of the shaft fracture.

Fig. 2 Macroscopic upper view of the fracture surface of the failed shaft which shows torsional fatigue fracture with fracture face 45° to the shaft

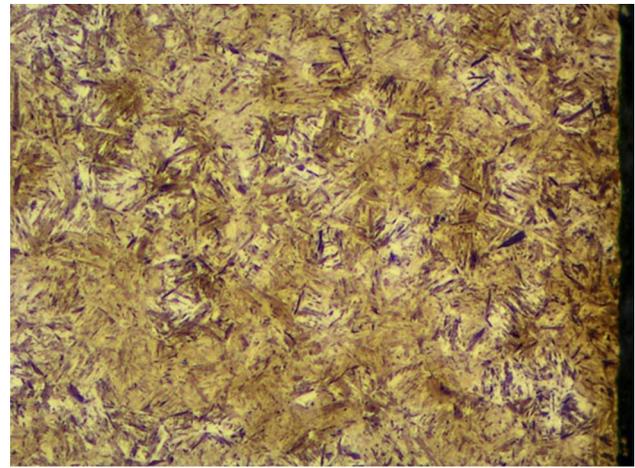
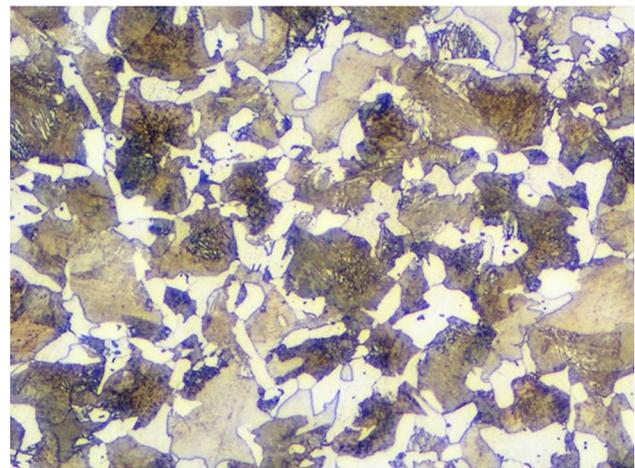
Figure 3 shows the microstructure of the alloy in the core region and in the case. The structure of the case, which has been hardened, consists of bainite/tempered martensitic which is quite typical and desirable for the case. The microstructure in the core, however, consists of pearlite/ferrite and some retained austenite. The white regions represent ferrite which are surrounded by pearlite (a layered phase). This microstructure agrees with the carbon content of the AISI 1045 steel.

Fig. 3 Microstructure of the shaft at (a) case and (b) core

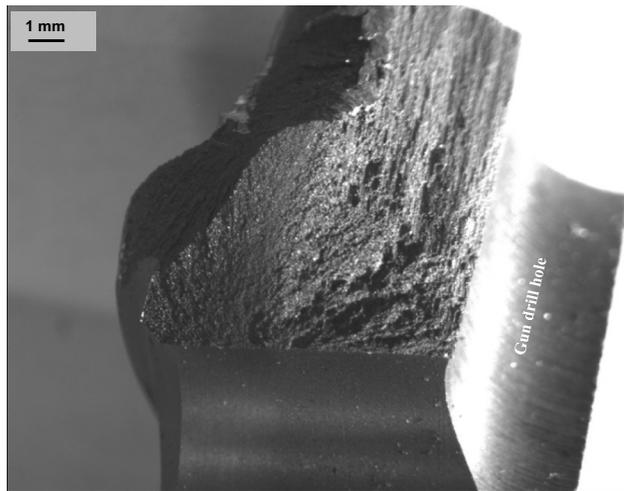
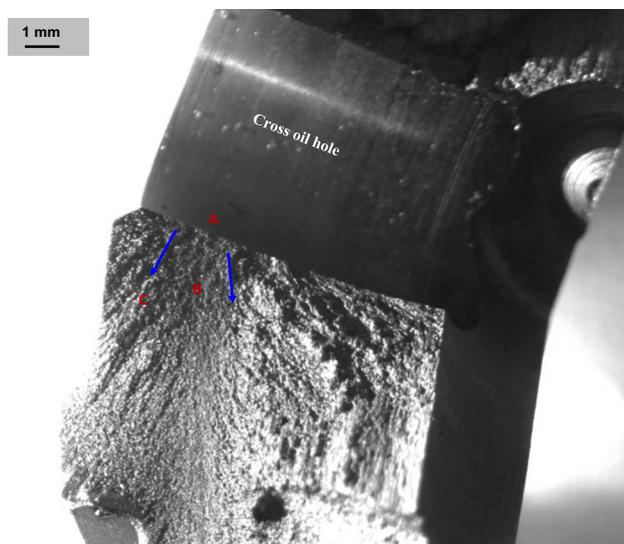
Unlike bending fatigue, torsional fatigue causes excessive twisting that fails the part. Beach (ratchet) marks at the fracture initiation point can be observed in the fractured surface. Figure 4 shows the stereomicroscope image of fracture surface of the shaft damaged by torsional fatigue (both sides of the oil hole have been presented here which shows similar crack initiations). As seen, fatigue fracture starts from the cross oil hole and propagate perpendicular to the hole. The image shows that the river marks (shown

with blue arrows). This means that the initiating point is located in the transition zone of the case.

Fig. 4 Stereomicroscope images of the fracture surface showing crack initiation point and crack propagation path (a) upper half, (b) lower half

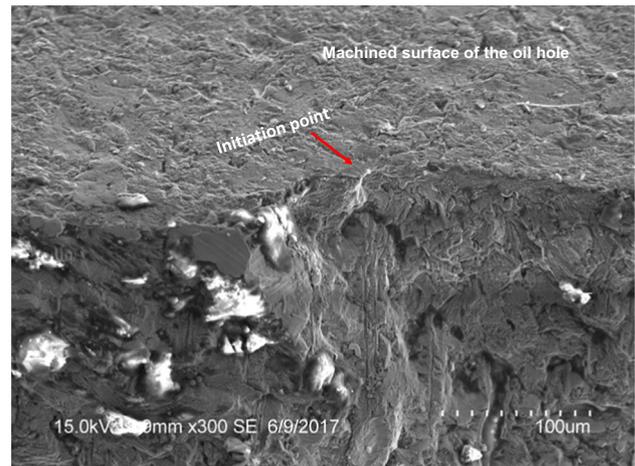
The SEM analysis of the fracture surface confirms that the crack initiates from the oil hole and develops toward the center of the shaft. Figure 5a shows SEM micrograph of the crack initiation point in the oil hole. In the present case, during fatigue testing, once the crack is initiated in the oil hole, it propagates under torsional load over a large portion of the shaft periphery in either direction along the circumference of the shaft. Tracking back the beach marks on the fracture surface, the fracture (failure) origin was determined as transition zone of the case on the cross oil hole.

Fig. 5 (a) SEM image of the crack initiation point (shown with letter “A” in Fig. 4), (b) spot B in Fig. 4 which shows mixed fracture morphology, (c) decohesion of grain boundaries

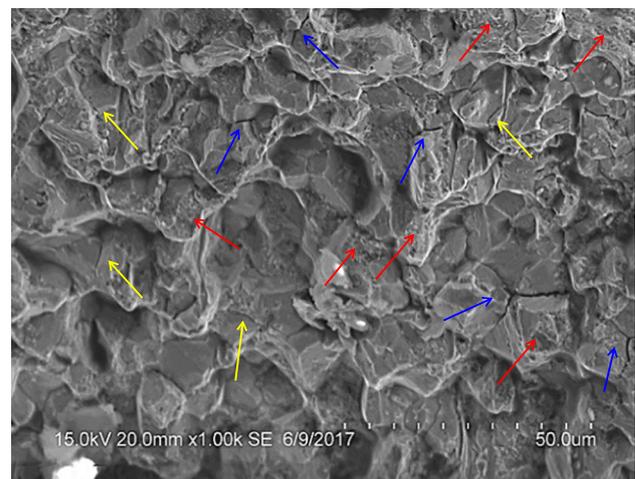
(b)

Figure 5b shows higher-magnification image of the fracture surface near initiation point. In this image, red arrows direct void coalescence which is indications of ductile fracture. Blue and yellow arrows show intergranular and transgranular cracking which are signs of brittle-type fracture and failure. Brittle fracture occurs when the maximum stress in the material reaches a critical value. Intergranular brittle fracture (Fig. 5c) may also occur if the prior austenite grain boundaries are embrittled. That is,

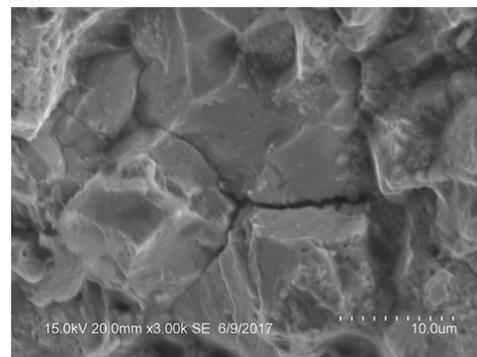
(c)

brittle fracture occurs due to the segregation of brittle elements (i.e., hydrogen, phosphor, sulfur) at the austenite grain boundaries during the carburizing process which encourages decohesion of grain boundaries. If hardening occurs through gas carburizing (when a high hydrogen partial pressure is present in the treatment atmosphere), hydrogen absorption may occur resulting in grain boundary embrittlement [9]. The tendency to induce intergranular

fracture increases with material hardness [10]. The mixed mode of fracture suggests high load and even impact loading as well as low strength (quality) material.

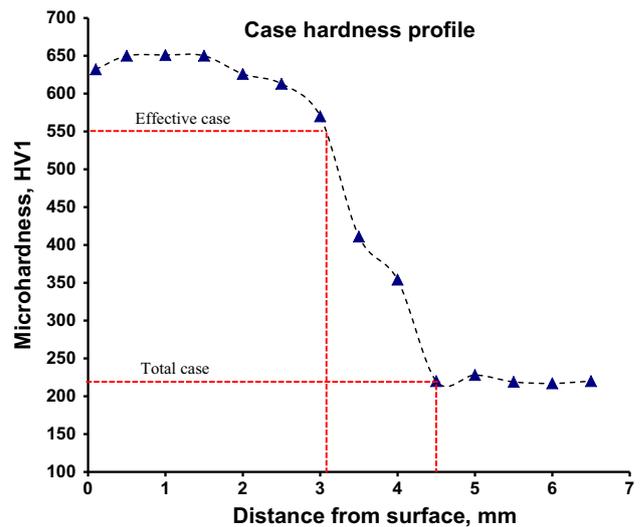
Figure 6 shows the case hardness profile of the shaft. The case depth, measured at 550 HV, and the total case are recorded to be 3.1 and 4.5 mm, respectively. Mechanism of crack formation, theoretical approach, is shown in Fig. 7 which, schematically, displays two different induction case depths, (1) solid line and (2) dashed line. The applied stress is shown as a straight line from zero at the center to a maximum at torsional stress at the surface. As seen in the above photograph, at certain depth, case torsional strength is lower than torsional stress (between A–C on diameter for case depth 1); this is where shaft fails. If case depth is pushed deeper (case depth 2), failure area A–C will move closer to the shaft center, to B–C. Torsional stress at depth at which failure occurs (Δ_1) is accordingly pushed down to Δ_2 . This means that the failure area is located now in lower stress zone which will increase fatigue life. It is worth mentioning that excessive hardening, deeper than case 2 in this situation, will not necessarily be beneficial because the part will, most probably, fail from the surface due to the significant brittleness. That is, the hypothetical case depth 2 is the optimum case depth. In addition, by hardening too deep, the residual surface compressive stress may be reduced. Another way of reducing area of the material strength below the applied stress is to raise core hardness, which maintains stress curve higher and, thus, reduces the

Fig. 6 Case hardness profile; the case depth is measured at 550 HV₁ to be 3.1 mm

- To extend fatigue life, reduction of torsional fatigue stress in the transition zone of the case is required.
- One of the solutions is to make case depth deeper, thus pushing transition zone of case into area of lower torsional stress (i.e., closer to the shaft center).

- Quench delay was extended in this case. As a result, case depth went deeper which resulted on average 40–50% fatigue life increase.
- If fatigue life has to be further improved, in addition to above approach, it is suggested to target higher core hardness as 95 Rb is somewhat soft to withstand any load. By increasing core hardness to above 20 Rc torsional strength of the case would be moved toward higher values (dashed area on figure above with respect to torsional stress will be reduced), thus improving fatigue life too.

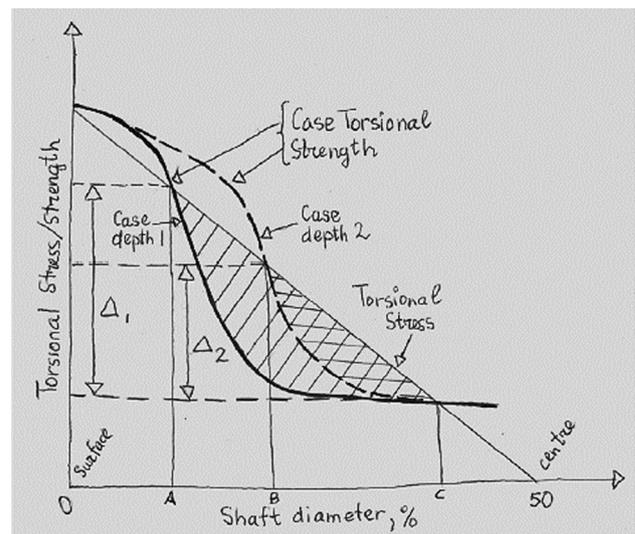
Fig. 7 Mechanism of crack formation (theoretical approach) for this specific case

difference between torsional stress and strength lines which also extends the fatigue life.

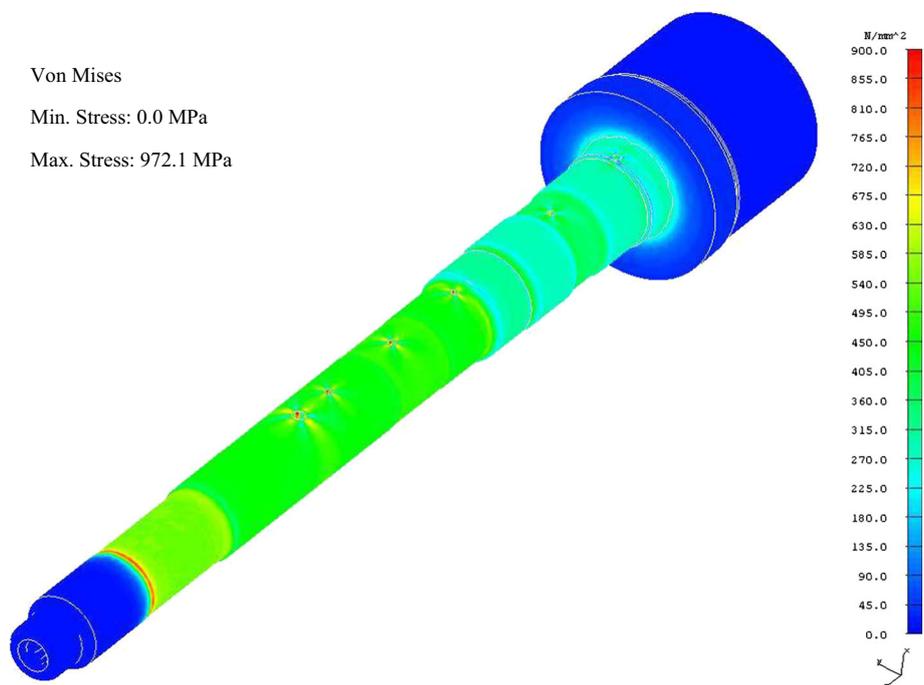
analysis. The FEA confirms that the high stress locations of the shaft are mostly around the small lubrication holes. Figure 9 shows the overall stress contour of the shaft. The minimum and maximum stresses were measured as 16.9 and 972.1 MPa at the oil hole, respectively (Fig. 10).

Fig. 9 Overall stress contour of the shaft

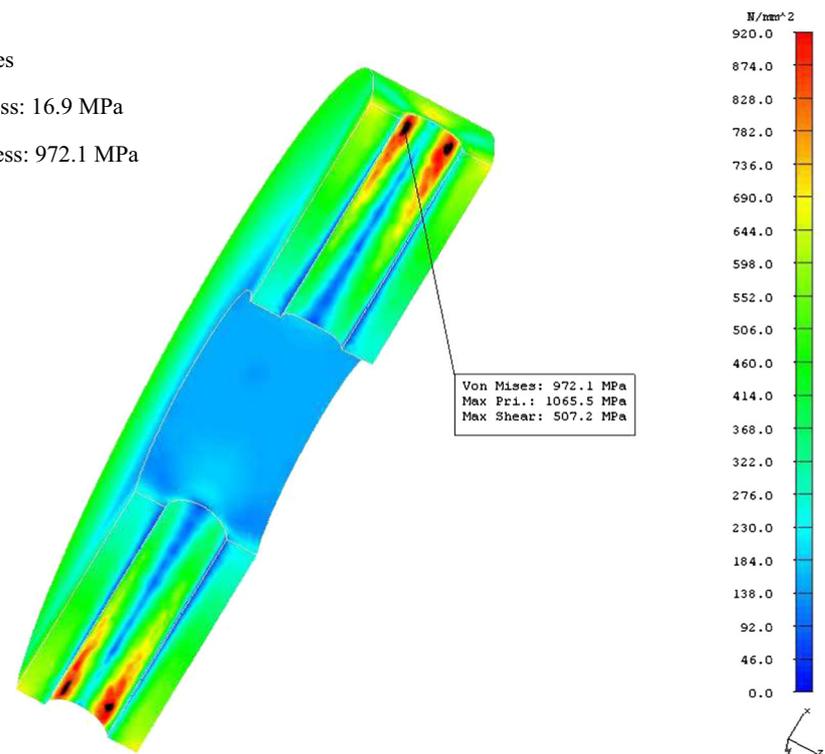
Fig. 10 Stress contour of the oil hole

Min. Stress: 16.9 MPa

Max. Stress: 972.1 MPa
