Failure analysis of a petrochemical plant reducing gear

Sandro Griza^a, Antônio Pereira Santos^a, Thiago Figueiredo Azevedo^a, Carlos Eduardo Fortis Kwietniewski^b, Afonso Reguly^{b,*}, Telmo R. Strohaecker^b

This study aims to investigate the cause of failure of an 845 mm external diameter reducing gear that operated during 30 months in a petrochemical plant. The failure analysis procedure included material characterisation (microstructure, chemical composition and microhardness), fracture surface evaluation, and stress distribution by finite elements on critical regions of the gear. Fracture mechanics and fatigue crack growth were also used to develop a $da/dN-\Delta K$ curve and then determine the gear material crack growth resistance. Results indicate that the gear was not properly manufactured and failure occurred as a result of a fatigue process facilitated by a manufacturing defect.

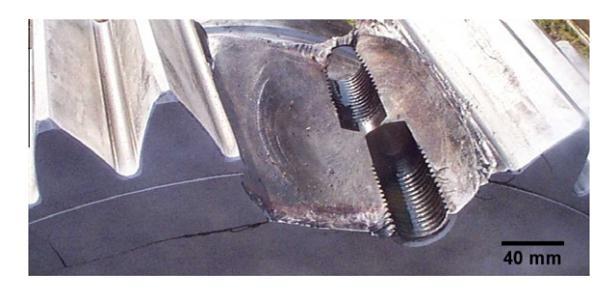
This investigation aims to point out the reasons that caused the failure of an 845 mm diameter reducing gear that operated during 30 months. The gear was part of the main polypropylene extruder of the company with the total cost of the failure estimated in around U\$ 460,000 dollars. Fig. 1 shows a general view of the fractured gear. The fatigue crack propagated tangentially to the longitudinal plane of the gear resulting in the separation of three gear teeth. The failure analysis included a closed observation of the gear design, its material characteristics (chemical composition, microstructure and hardness), and stress distribution analysis within critical regions of the gear. Fracture mechanics applied to fatigue was also used to determine the FCG rate as well as the fatigue threshold.

Fig. 1. General view of the fracture surface of the spur gear.

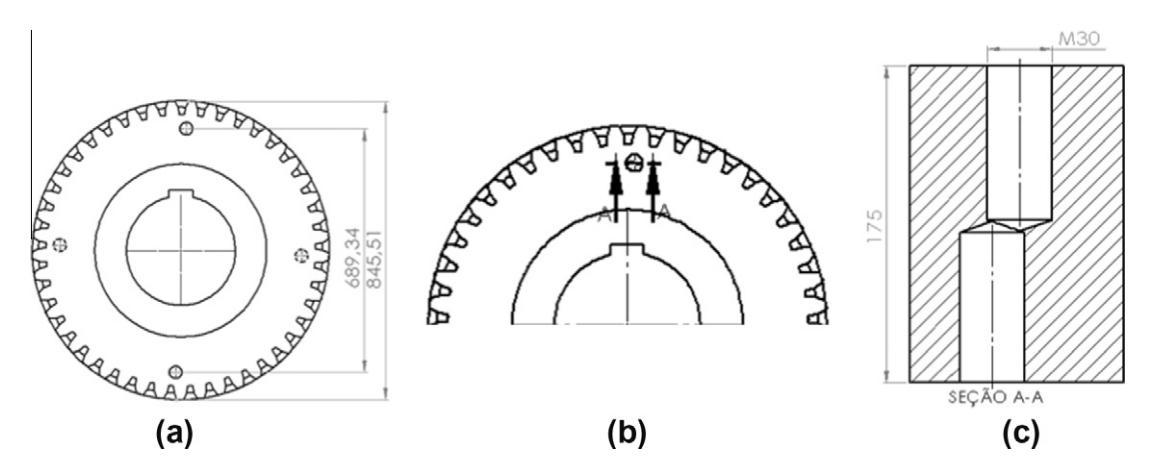
Fig. 2 shows a basic drawing of the fractured gear. The design project included several holes for handling and transport of the large gear. Those holes where placed 90° apart and a perfect alignment between matching holes were not achieved as can be seen in Fig. 2c.

Fig. 2. General dimension of the spur gear. (a) Positioning of the holes for handling the gear, (b) location of the holes adjacent to fracture surface, (c) alignment between matching holes at the fracture.

To prevent future failures, the adoption of an inspection plan after manufacturing that also consider the region of the holes is recommend. Furthermore, the position of the holes for handling the gear is too close to a region under the gear teeth where stresses are concentrated during gear operation. The possibility of slightly decreasing the 689 mm distance between hole centers (see Fig. 2) so that they move away from the region of higher stress should be evaluated. A reduction to 600 mm, for example, should not significantly alter the gear transportation logistics but would have a decisive influence in terms of the stress level at the singularity.

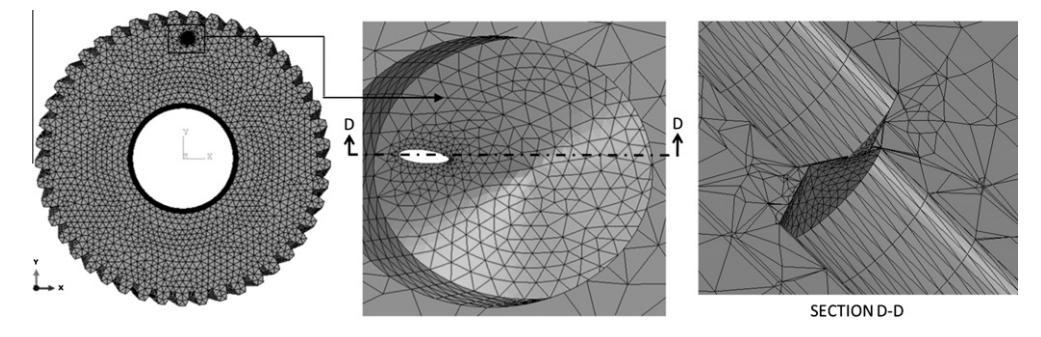
Stress distribution within the gear was determined by the finite elements method. A solid with dimension of the gear was generated including two of the machined holes used for the gear handling. The intersection between the two holes resulted in an elliptical flaw with a larger diagonal of approximately 6 mm. For the modeling the gear was restricted by its inner diameter. The load applied on modeling was derived from the gear operating torque. It was distributed over three teeth adjacent to the flaw and applied in the pressure line direction on a surface of 3670 mm² over each the three teeth, so that the tooth just above the flaw experienced a stress of 80 MPa, and its neighboring teeth experienced stresses of 65 MPa. A tetragonal quadratic mesh was used in the simulation with a mesh refinement applied at the region of the defect as shown in Fig. 3.

Fig. 3. General representation of the mesh used in the modeling with a detailed view of the defect region.

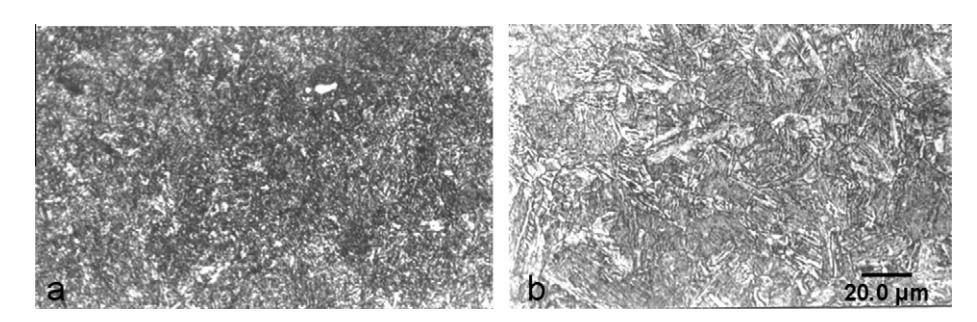
Table 1 shows the chemical composition of the material used to fabricate the reducing gear. After machining, the gear was carburized, quenched and tempered. The final microstructure was tempered high carbon martensite at the case with a mixture of bainite and low carbon martensite at the core (Fig. 5). The microhardness profile shown in Fig. 6 indicated an effective case depth of 3.1 mm which is in accordance with the specification for this component.

Fig. 5. Representative microstructure observed for the gear tooth. (a) Case – high carbon tempered martensite with dispersed carbides, (b) core – low carbon tempered martensite and bainite. MO. Etchant 2% Nital.

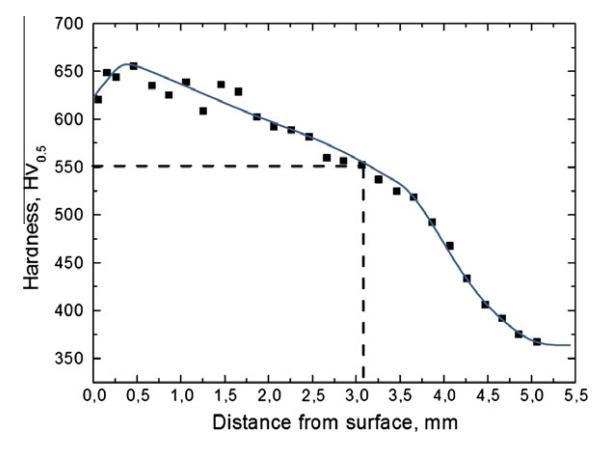
Fig. 6. Vickers hardness profile from gear tooth surface to core.

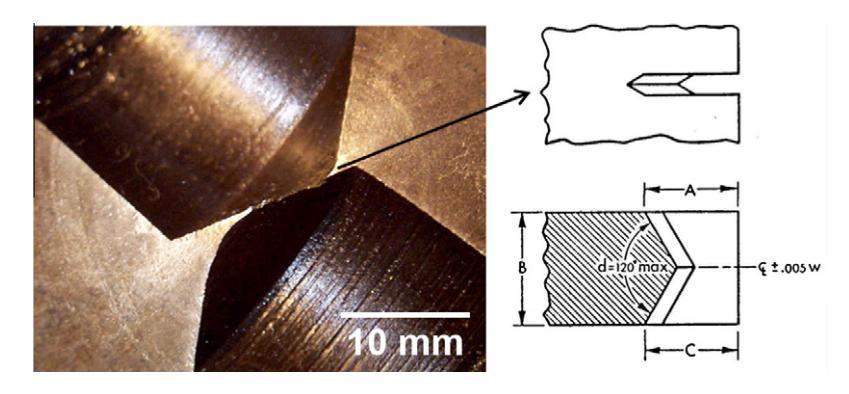
A closer examination of the fracture surface indicates that the fatigue crack has nucleated at the intersection of two machined holes used for handling the gear. From Fig. 7, it was also possible to observe that after nucleation, the cracks have

Fig. 7. Closer view of the fracture surface highlighting the Chevron notch like defect. Two crack initiation fronts can be observed at the intersection of the machined holes.

propagated by fatigue as indicated by beach marks. Two crack propagation fronts can be observed: one along the direction in which the gear rotates and the other propagating against the gear rotation direction. The initial machined flaw has worked as a stress concentrator resembling a Chevron notch, which is indicated by ASTM E-399-90 [6] procedure to facilitate the creation of fatigue pre-cracks (Fig. 7).

The failure occurred by fatigue facilitated by poorly designed holes drilled for shipping and handling the gear. The holes made on both sides of the gear were not aligned, and this produced an elliptically shaped defect which acted as a stress concentrator, promoting fatigue crack propagation in two fronts. The numerical simulations based on the geometry of the defect and service loads applied to the gear indicated that the stress intensity at the defect lies in the stable fatigue crack propagation region.

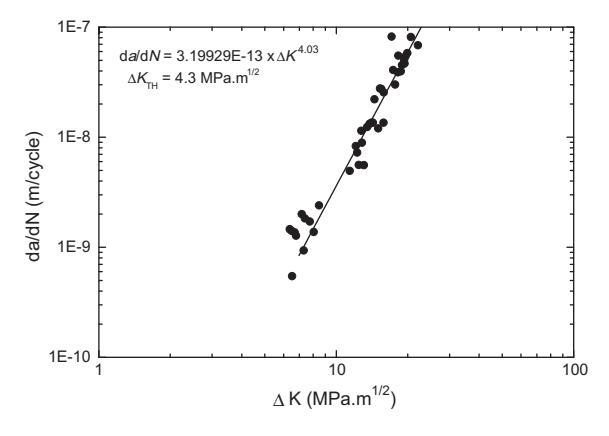
Fig. 8 shows the fatigue crack grow rate curve for compact tension specimens extracted from the fractured gear. The Paris law parameters $(da/dN = C\Delta K^m)$ as well as fatigue threshold $(\Delta K th = 4.3 \text{ MPa m}^{1/2})$ are presented.

Fig. 8. Fatigue crack grow rate curve for compact tension specimens extracted from the fractured gear.

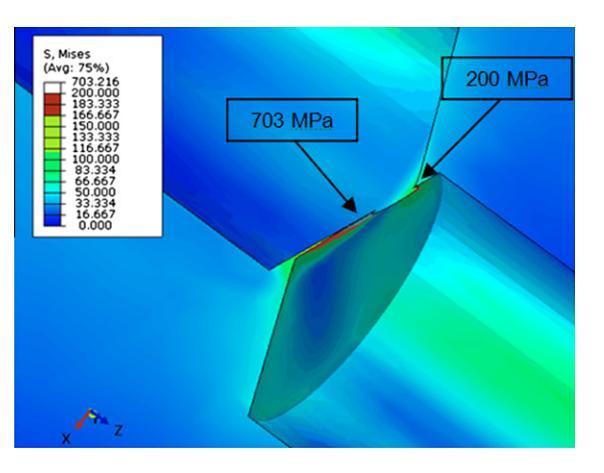
Finite element modeling indicates stresses in the order of 703 and 200 MPa at crack initiation points (Fig. 9). These stress differences at both singularity ends are due to their geometry differences. As can be seen in Fig. 9, the 703 MPa arise from a sharp wall resulting from the cone intersection, whereas the 200 MPa occur in a section with a thicker wall. Eq. (1) can be applied to this case if one considers the defect much smaller than the gear (semi-infinite body) and that a mode I type can be used to describe the loading mode. Applying the 200 MPa stress to Eq. (1) with a defect geometry *a* = 3 mm, one can obtain a $\Delta K = 19.4$ MPa m^{0.5} (load ranging from max. load = 200 and 0 MPa). According to Fig. 8 for this ΔK value the material is in the stable crack growth region indication fatigue crack propagation for this condition. Even higher stresses, 703 MPa, were obtained at the other initiation point but a rapidly decrease in this load is expected once the sharp interface between holes is crossed.

Fig. 9. Stress distribution along the end of the matching holes.
