Failure Analysis of Metallic Components of a Battery Fitted in a Naval System

Abstract A battery based on Mg–AgCl with sea water as electrolyte was developed for propulsion of a naval system. In one occasion, the tie rod, conduit pipe and the copper bus rod each covered with polymer sleeve were found damaged. The copper bus rod was melted probably by amplified resistance and subsequent heating. Localized cross-sectional reduction (and thus increased resistance, R) seems to have aggravated heating by Joule heating ($J = I^2R$) effect. Subsequently, it led to partial dissolution, embrittlement, softening and final fracture of the steel tie rod in the said sequence. There was no material deficiency. Chemical composition, microstructure and hardness values of the failed components indicate that the steel tie rod was made of the as-specified EN 24 type of low alloy steel in hardened and tempered condition, while copper bus rods were made of pure copper of 99.50% purity. Damage of the conduit tube was not related to the failure of steel tie rod and copper bus rod, although it indirectly offers clues that melting of copper happened and the molten copper reached many locations within the

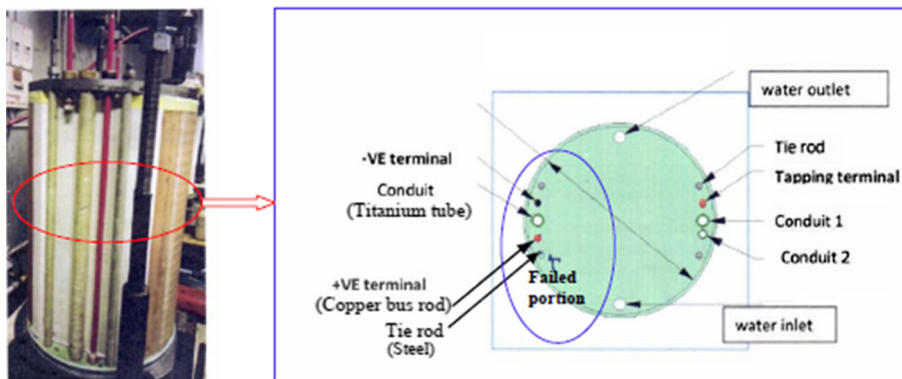
Fig. 1 Positions of the failed steel tie rod, copper conductor rod and titanium conduit tube, as seen in a transverse sectional view of the battery

Damage of the titanium conduit tube is a separate phenomenon and has no relationship with fracture of the steel tie rod, as is clear from observations on failure type, failure nature and arrangement of components within the battery chamber (Fig. 1). However, it indirectly indicates the melting of copper rod and deposition of the same on the titanium tube, as is supported by Figs. 5 and 12. Damage of the tube seems to have happened by the following sequence: (1) steel tie rod melted and got deposited on the tube, (2) polymer sleeve in contact with the molten copper got damaged and the tube became exposed to the hot molten metal, (3) creation of a very rough surface under the action of molten copper on titanium surface, (4) subsequent failure (thinning of the tube and creation of a hole) happened by corrosion of the tube under Mg–AgCl and/or sea water.
