Failure analysis and finite element simulation of deformation and fracture of an exploded CNG fuel tank

Majid Mirzaei *, Mohammad Malekan, Ehsan Sheibani

Department of Mechanical Engineering, Tarbiat Modares University, Tehran, Iran

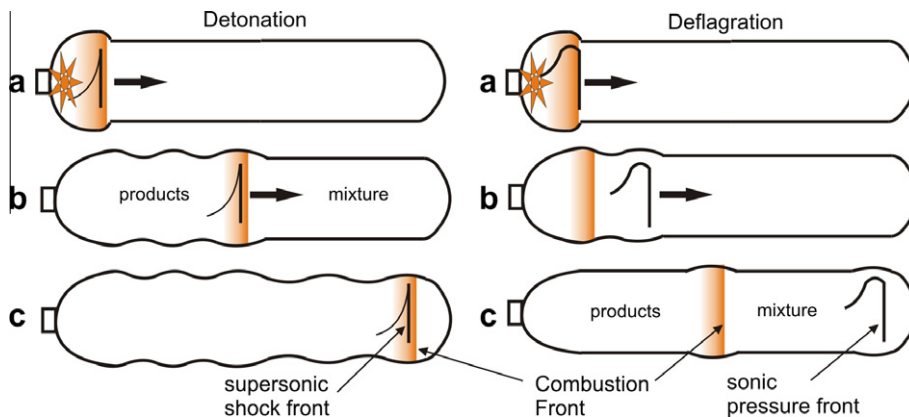
Fig. 5. Schematics of pressure loadings for two different types of internal gaseous combustions in closed-end cylinders. The amplitudes of deformations and structural waves are exaggerated for clarity.

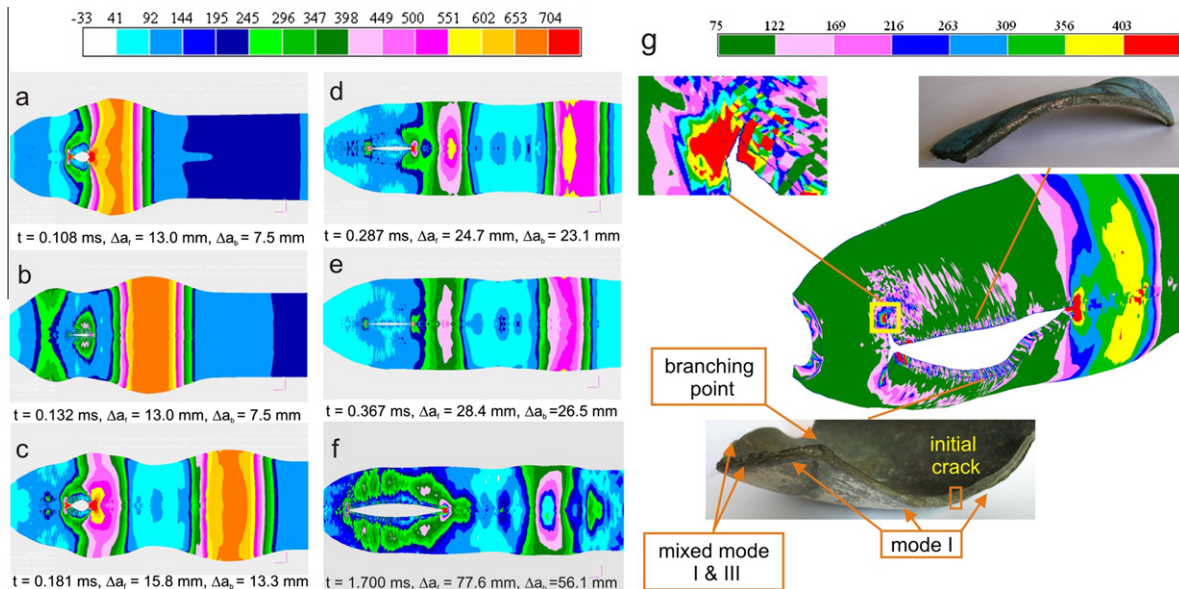
Fig. 7. FE simulation of deformation and fracture of an exploded hydrogen cylinder [21]. The snapshots show the crack initiation, the cyclic crack growth by structural waves, the cyclic flap bulging, and the resultant branching of an axial crack caused by traveling of a *supersonic* pressure wave from the neck towards the bottom of the cylinder. The stresses are in MPa.

caused by gaseous detonation in a hydrogen cylinder at different time intervals [21]. A distinctive characteristic of the structural response of a cylindrical tube to a detonation-induced *supersonic* pressure wave is the formation of flexural waves [26–28]. As depicted in Fig. 7, the successive opening and closing of the crack flaps is a clear indication of a *cyclic crack growth* governed by the flexural waves. This type of crack growth can create very distinct and specific markings on the fracture surfaces [20,21]. In brief, the detonation-induced *supersonic* pressure wave excites the cylinder and the resulting flexural waves cause cyclic crack growth, whereas the crack growth caused by deflagration-induced *sonic* pressure wave is monotonic and driven by the pressure wave itself. The above arguments can help to analyze similar failures in the future and also find answers for some of the questions posed in the past, like the reasons behind the accidents that occurred in the nuclear power plants in Japan and Germany in 2001 [29]. In both incidents, sections of steel steam pipes were fragmented due to combustion of hydrogen–oxygen mixtures created by radiolysis. One of the most important questions that arose during the accident investigation was whether the type of accidental combustion can be deduced from the fracture patterns. At that time, it seemed that the state of knowledge on combustion-driven fractures was not enough to answer this question.
