Failure analysis of a petrochemical plant reducing gear

Sandro Griza^a, Antônio Pereira Santos^a, Thiago Figueiredo Azevedo^a, Carlos Eduardo Fortis Kwietniewski^b, Afonso Reguly^{b,*}, Telmo R. Strohaecker^b

This study aims to investigate the cause of failure of an 845 mm external diameter reducing gear that operated during 30 months in a petrochemical plant. The failure analysis procedure included material characterisation (microstructure, chemical composition and microhardness), fracture surface evaluation, and stress distribution by finite elements on critical regions of the gear. Fracture mechanics and fatigue crack growth were also used to develop a $da/dN-\Delta K$ curve and then determine the gear material crack growth resistance. Results indicate that the gear was not properly manufactured and failure occurred as a result of a fatigue process facilitated by a manufacturing defect.

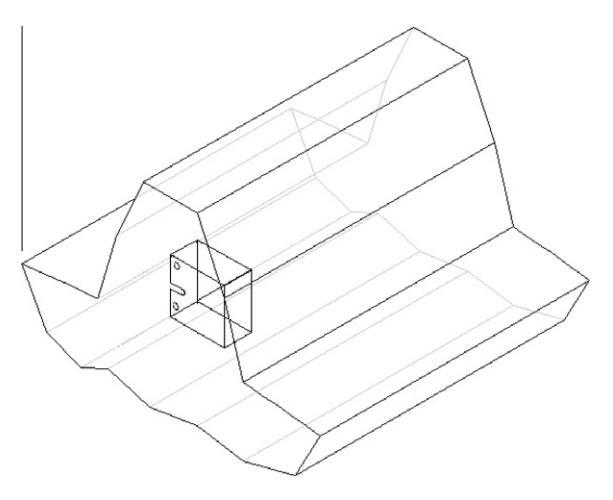
Fig. 4. Position of the specimens machined from the fractured gear.

FCG tests were conducted in accordance with the ASTM E647 [5] test method using compact tension specimens with thickness (*B*) of 15 mm and width (*W*) of 30 mm machined from the core of fractured gear. Fig. 4 shows the plane of the gear teeth from where the FCG specimens were machined. Both fatigue pre-cracking and the FCG tests were performed in a MTS 810 servo hydraulic. Load decreasing up to a crack growth rate of 10^{-9} m/cycle was used to determine the fatigue threshold. For the fatigue crack growth testing a loading ratio *R* = 0.1 was used.
