Engineering Failure Analysis

Failure analysis of a pressure vessel bolt in a nuclear fuel fretting wear simulator

This paper presents a failure analysis on a pressure vessel bolt of a fretting wear simulator. After 500 h tests, in an upper pressure vessel of a fretting wear simulator, one bolt among eight was fractured near the bolt neck regions. The fracture surface was examined by using a scanning electron microscope (SEM) to determine the failure initiation and failure mode. The result indicates that the fracture surface shows intergranular fracture features. Based on the mechanical property data of a bolt material, it is concluded that the exerted stress on the bolt applied by an internal pressure of the pressure vessel has a negligible effect on the major failure causes. In order to verify the mechanical properties of the fractured bolt, tensile test has been performed and its result was compared with material specification. As a result, it is thought that both excess heat treatment during the surface hardening procedure and loose parts in the thread hole have significant effects on the pressure vessel bolt failure. In this paper, the reasons for this failure were discussed

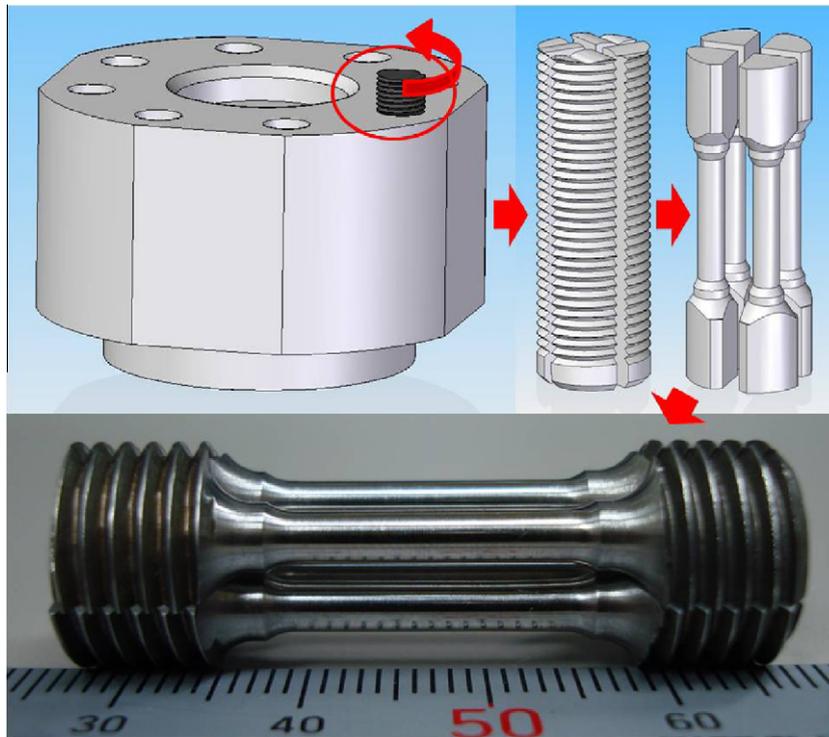
Fig. 3 illustrates the preparation of the tensile specimen by using the failed bolt. First, the thread region of the failed bolt was carefully removed from the pressure vessel. Next, the removed bolt thread region was machined and parted to four sections. Finally, four tensile specimens were fabricated with 18 mm of the gauge length and 3 mm of diameter. Before the tensile test, it is necessary to verify whether the excess heat treatment was carried out during the surface hardening process. So, a micro-vickers hardness of the fractured pressure vessel bolt was measured by using a conventional hardness tester (SHIMADZU HMV-2T) with 10 s of loading time and its result was shown in Fig. 4. It is apparent that the micro-vickers hardness value did not show a noticeable change between the bolt surface and internal matrix. So, it is expected that the applied heat treatment condition was not suitable for the bolt surface hardening.

Fig. 3. Preparation procedure of the tensile specimen by using the failed pressure vessel bolt.

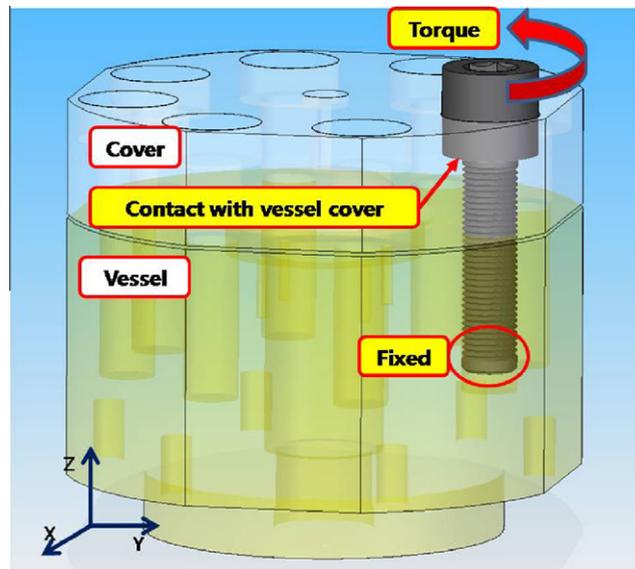
Fig. 8. FE model of the pressure vessel bolt with considering loose parts in the thread hole.

In order to analyze the stress distribution of the pressure vessel bolt, the FE model with 14 mm in diameter and 77 mm in length was created by using the commercial 3D modeler, SolidEdge V19 as shown in Fig. 8. The end region of the constrained

bolt where loose parts are contacted is fixed and the torque of 60 N m is applied on the bolt head. The FE model consisted of about 28,900 nodes and 16,200 elements. The material properties used in this analysis such as elastic modulus, yield strength, density and Poisson's ratio of commercial SUS 440C are listed in Table 2. The commercial code, ANSYS[®] Workbench V10.0, was used to post-process the model in order to calculate the Von-Mises stress exerted on the bolt. The Von-Mises stress distribution in the pressure vessel bolt showed that the high stress concentrations were appeared at the neck region of the bolt as shown in Fig. 9. In particular, the maximum stress was approximately 350 MPa and this value is about a quarter of the yield stress of the failed bolt even though the thermal stress due to the temperature change and the contact condition between the bolt head and the autoclave cover were not considered in this analysis. Therefore, the failure position of the pressure vessel bolt is in good accord with the FE analysis result. Consequently, the faulted heat treatment condition and loose parts in the thread hole of the autoclave played major role of the bolt fracture. Based on this result, the bolt material was changed to austenite stainless steel in order to increase the fracture toughness and the thread hole of the autoclave is always cleaned before each fretting wear test.

- (1) The fracture surface shows the intergranular morphologies but has no evidence of fatigue failure. Also, it is difficult to explain the bolt failure with the exerted tensile stress on each bolt generated by internal pressure.
- (2) Based on the results of the micro-vickers hardness and tensile test with the failed bolt, it is confirmed that the failed bolt was fully hardened by the faulted surface hardening condition.
- (3) Due to the loose parts in the thread hole, it is possible to generate the excess stress induced by the torque during fastening. Also, the stress concentration region of the FE analysis results corresponded well with the bolt failure.
- (4) It is recommended that the bolt material is changed to austenite stainless steel in order to increase the fracture toughness and the thread hole of the autoclave is always cleaned before each fretting wear test.
