A Case Study on Fatigue Failure of a Transmission Gearbox Input Shaft

M. Haghshenas · W. Savich

Abstract In this paper, a root cause analysis of premature failure of a gearbox input shaft, manufactured of AISI 1045-H, was performed through standard procedures for failure analysis. Shaft failed on cross oil hole through a helical fracture and therefore did not meet bogie 100,000 cycles during the verification with 10 Hz frequency cyclic testing. The fracture in the oil hole implied evidence of fatigue (i.e., beach marks on the fracture surface were clearly visible). Prior to improving the fatigue life and suggesting required remedial actions, mechanism of failure has to be understood, especially the initiating point of cracking. To this end, chemical analysis, microstructural characterization, fractography, hardness measurements, and finite element simulation were used to assess the nature of fracture in detail. The fractography analysis showed that fatigue beach marks originate from transition zone of the case on the cross oil hole. This is possibly due to the fact that torsional strength in this area is lower than torsional fatigue strength which leads to fatigue crack initiatio

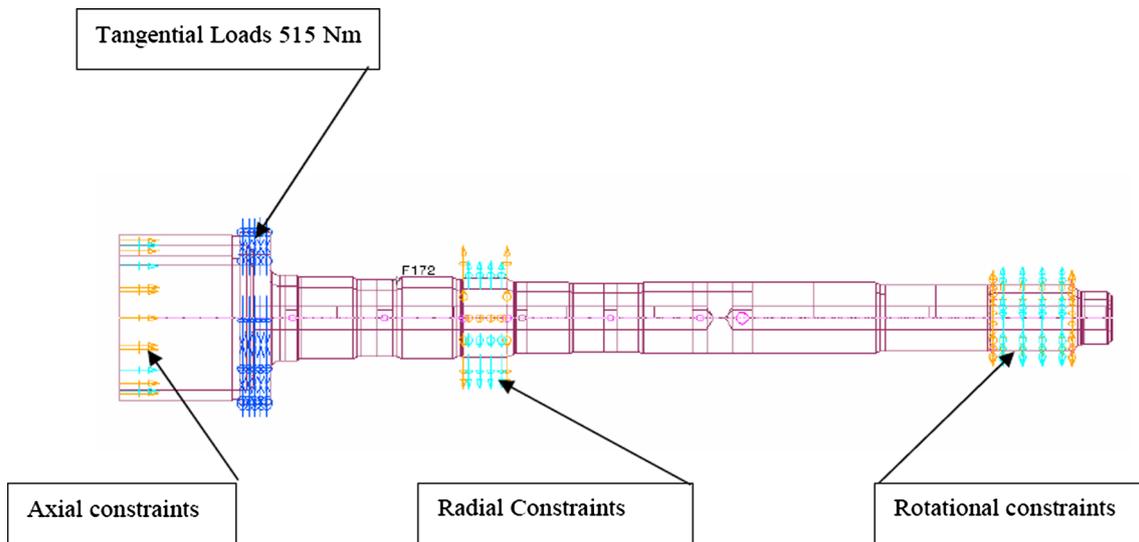
Fig. 8 Loads and boundary condition

For the purpose of FEA, the material properties were considered as $E = 206.8$ GPa and $\nu = 0.29$. Also, there is only one load case considered in the FEA as torque input is equal to 515 Nm (Fig. 8). No bending loads were taken into consideration as their magnitude was

unknown to us. Model was fixed in radial direction, in axial direction at the end surface of the carrier flange and in rotational (see Fig. 8 which shows the load and boundary conditions of the model). In critical areas, mesh size is 0.3–0.5 mm. Global mesh size was 2 mm. Tetrahedral second-order 3D elements were used in the
