# Engineering Failure Analysis

## Failure investigation of a large pump-turbine runner

A failure investigation was conducted on a high-pressure machine with a large pump-turbine runner that was 2.9 m in diameter and had a maximum discharge rate of 32 m<sup>3</sup>/s.

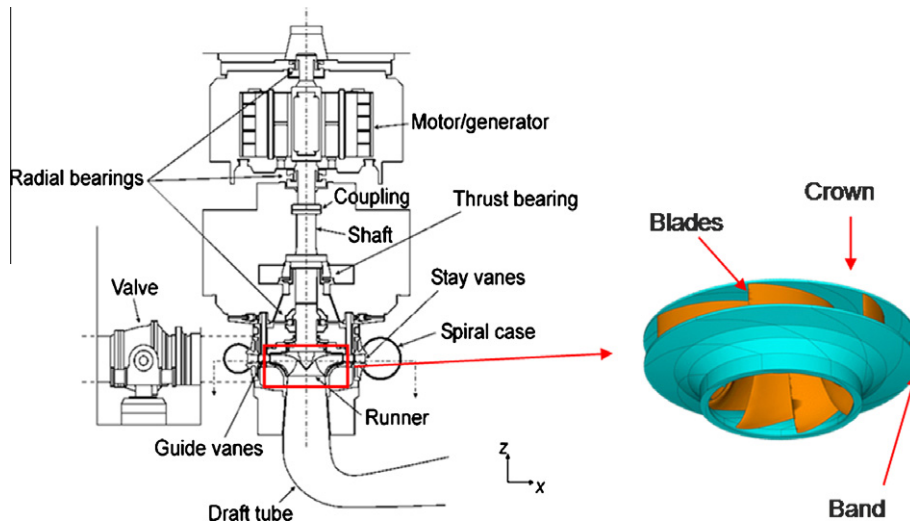
Fig. 1. Sketch of the hydropower unit and runner.

The case reported here corresponds to a single-stage PT with a 400 m head and a maximum power of 110 MW. It is a vertical shaft machine with a hydraulic runner at the bottom and an electrical generator at the top. The runner has 7 blades, is 2.9 m in diameter and is made of stainless steel. The distributor has 16 guide vanes. Fig. 1 shows a sketch of the machine and the runner.

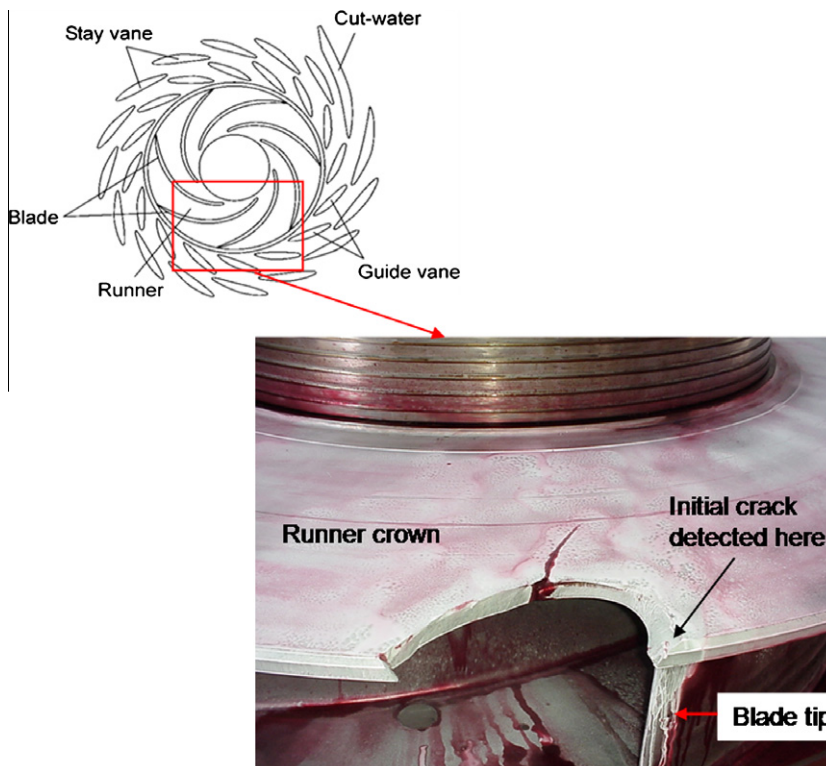
A small crack was identified in the runner during a maintenance inspection. The runner was repaired and reinstalled. A few months later, a part of the crown detached from the runner while the machine was in operation (see Fig. 2). The detached part passed through the machine, causing further damage.

Fig. 2. Sketch of the runner and distributor and a picture of the broken runner.

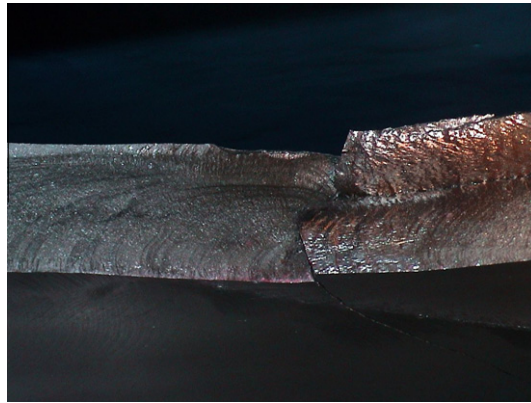
Fig. 3 shows a close-up of the broken part of the runner. The analysis of the part revealed a fatigue problem. Beach marks can easily be identified in the crack, which was propagated from the T-joint between the runner blade and the crown.

Fig. 3. View of the crack on the runner with the beach marks.

A deficient finishing of the fillets after the repair was considered to be the cause of the damage. The problem was solved by increasing the radius of the T-joint and ensuring an accurate construction of the fillets.

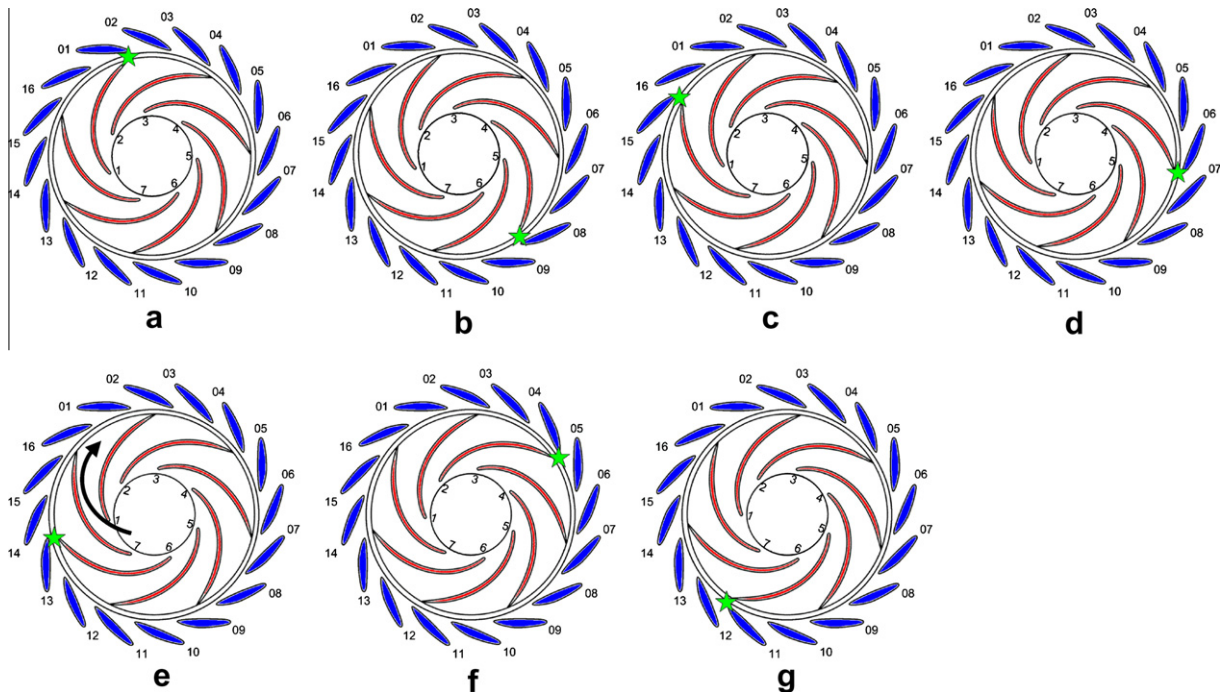
Fig. 4 shows the RSI sequence corresponding to this machine (7 blades and 16 guide vanes). In the first interaction, blade 1 faces vane 1 (Fig. 4a); when the runner rotates a little clockwise, blade 4 meets vane 8 (Fig. 4b), blade 7 then faces vane 15 (Fig. 4c) and so on. Table 1 shows the complete sequence of events, and indicates which blades interact.

Fig. 4. RSI phenomena and sequence of interaction. Runner rotating clockwise.

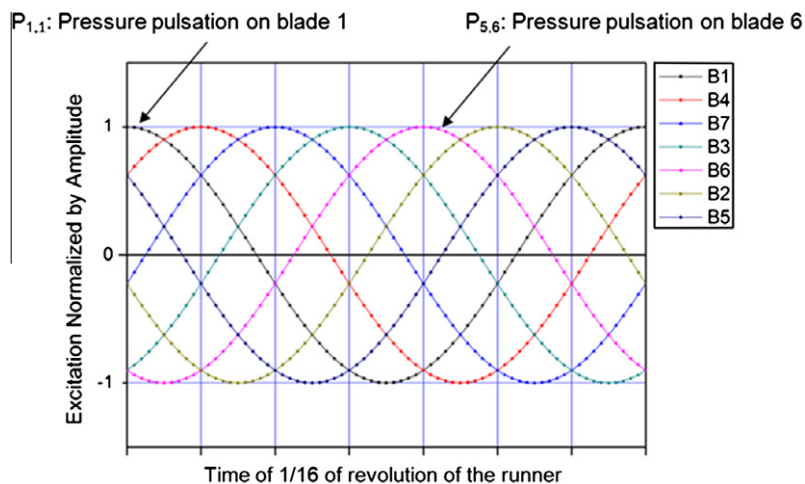
where  $f_p$  is the pressure fluctuation frequency on the runner,  $Z_v$  is the number of guide vanes and  $f_n$  is the shaft rotating frequency. Each blade receives the same pressure pulsation but with a phase shift. For instance, when the pulsation in blade 1 is at a maximum, it is almost at a minimum in blades 3 and 6 (see Fig. 5).

Fig. 5. Pressure pulsation on each blade of the runner.

All excitation parameters can be determined in this manner. Here,  $P_0$  is taken from Table 2 and the frequency is 160 Hz. Fig. 9 shows a sketch of the dynamic model. In the numerical model of the runner, the pressure pulsations described above are applied with their corresponding phase. For instance, blade 1 shows excitation  $P_{1,1}$ , blade 2 shows excitation  $P_{6,2}$  with the same characteristics but a different phase, and so on (see Fig. 5). This numerical model can be used to calculate the runner response.

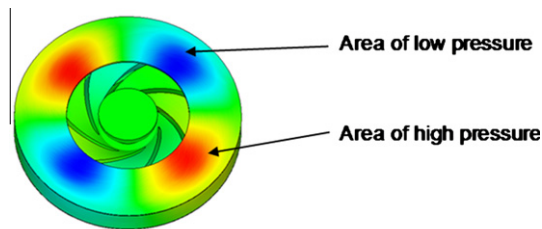
where  $n$  and  $m$  are integers,  $z_g$  is the number of guide vanes,  $z_b$  is the number of runner blades, and  $k$  is the diametrical mode. For this combination of blades and vanes (7/16), the main diametrical mode of the excitation is  $k = 2$  rotating opposite the runner rotation. This means that at any instant there are two positive and two negative pressure pulses around the runner (see Fig. 6). This is a two-nodal diameter (2ND) excitation.

**Fig. 6.** Distribution of pressure on the runner due to the RSI.**Table 2**  
Pressure values of RSI measured with machine in operation.

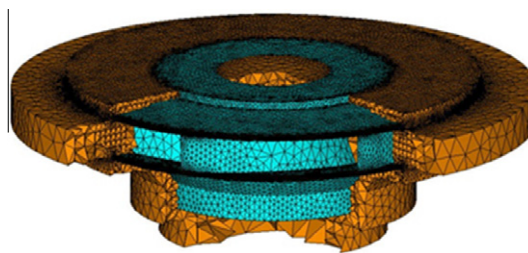
Given the previous experience with the sensitivity of the element shape, the mesh density and the effects of the added mass of water [6–9], the runner was modeled with 680,772 elements and 856,551 nodes. To consider the effect of the water, the runner was surrounded by the fluid domain. The fluid mesh was built by extending the structure mesh so that the nodes on the interface could be shared by both domains. The final fluid mesh contains 19,04,774 elements and 301,098 nodes. Fig. 7 shows the runner mesh.

**Fig. 7.** Runner mesh with surrounding water.

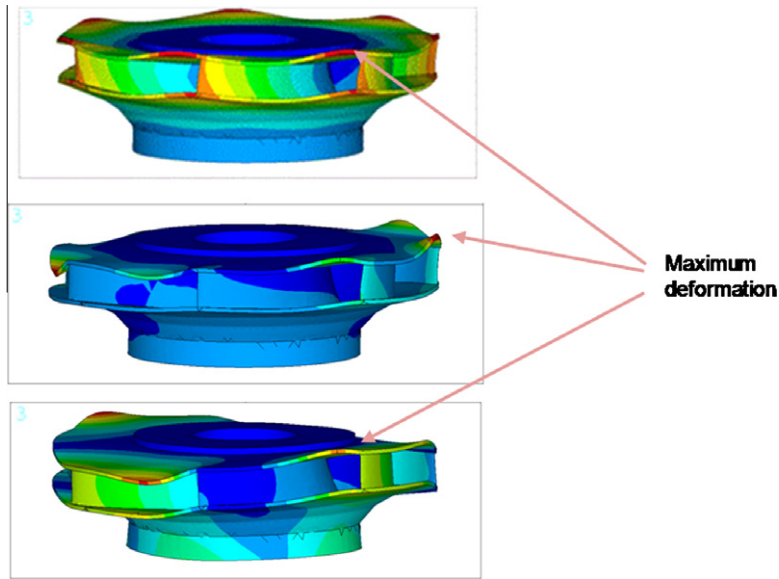
Fig. 8 shows the results of the modal analysis. The first natural frequencies correspond to a zero-nodal diameter (0ND), a one-nodal diameter (1ND) and a two-nodal diameter (2ND) mode-shape. The natural frequency of interest (2ND) has a frequency of 186 Hz [10].

The mode shapes of the runner crown are somewhat similar to the ones of a disk but they are much more complex. Because the stiffness in the runner is not uniform, the deformation varies greatly. The main deformation in all modes occurs in

the outlet diameter, as shown in Fig. 8, especially in the crown and band near the suction side of the blades, which remain almost non-deformed. The displacement on the crown is greater than that on the band. This is the exact position where damages are expected to happen on this type of runner.

Fig. 8. Mode-shapes of the runner.

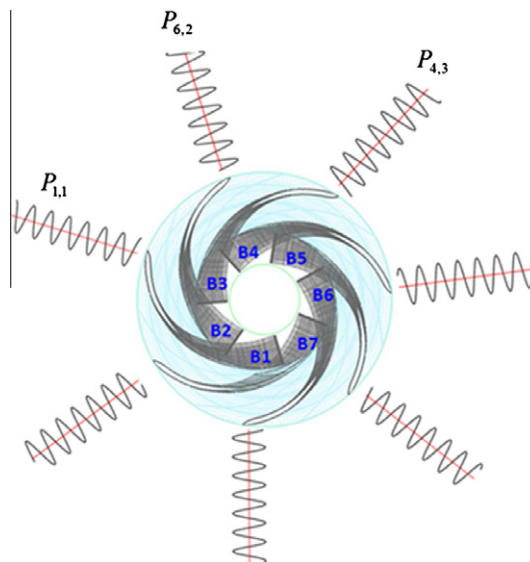
Fig. 9. Dynamic model. The pressure pulsation is applied to each blade but with a phase shift.

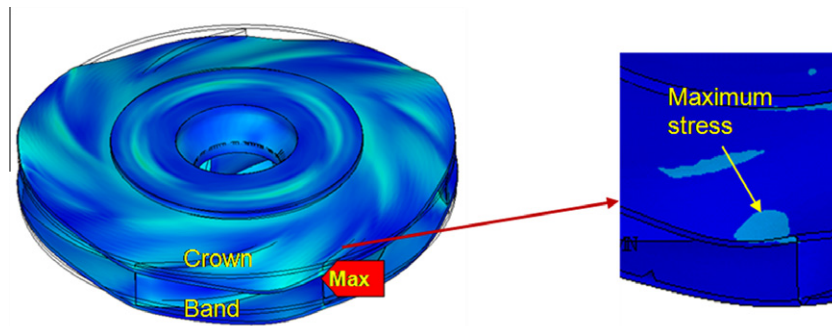
Fig. 10. Distribution of equivalent stress on the runner.

Fig. 10 shows the result of the computation and the deformation of the runner at an instant of time. Thus, the maximum deformation occurs in the crown, in the external diameter of the impeller close to the blade.

An analysis of the whole deformation of the runner reveals a clear 2ND mode, with two nodal diameters between the deformations.

The dynamic model indicates that the maximum stress concentration is located at the inlet of the flow passage in the T-joint between the crown and blade (see Fig. 10). This is where the first cracks appeared in the runner. A solution can be found once the critical location has been identified.

Because no resonance has been detected, a simple way of eliminating further problems in the runner is to reduce the stress level where the maximum stresses are identified. This can be done by increasing the radius of the T-joint fillets.
